# VW Elsa Newsletter

Edition 85: May 12, 2014

## ElsaPro Tip: "Notes"

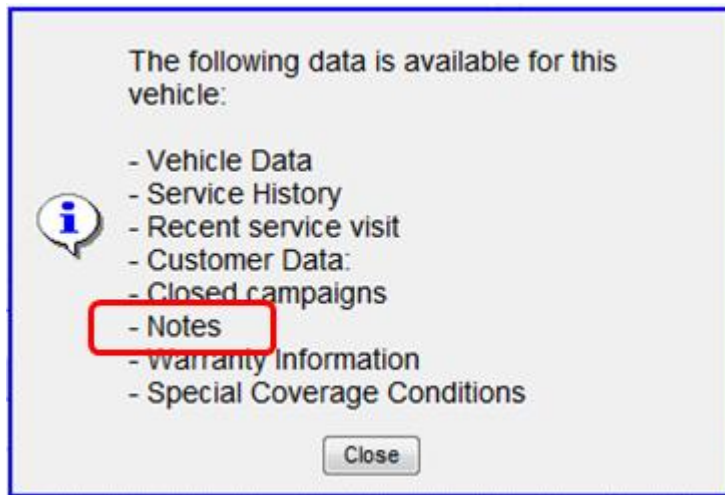
After you have entered a VIN or selected an existing Job in ElsaPro, a dialog box pops-up showing what additional information is available for that vehicle. This may include "Notes":

This means that there are Pending Service Solutions (PSS) available for this vehicle.

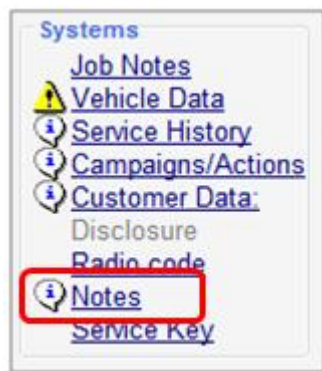
1. On the Systems menu, click "Notes". A pop-up will display with a list of relevant documents:

We are currently having issues with the displayed list of documents when selecting "Notes" from the Systems menu (location 1, above).

The list may include erroneous items or broken links.
