| | GROUP ELE | MODEL 2014MY Sorento (XMa) |
| | NUMBER 057 (REV 2, 03/05/2014) | DATE January 2014 |
| SUBJECT: BCM UPGRADE - IPM LOGIC IMPROVEMENT | | |

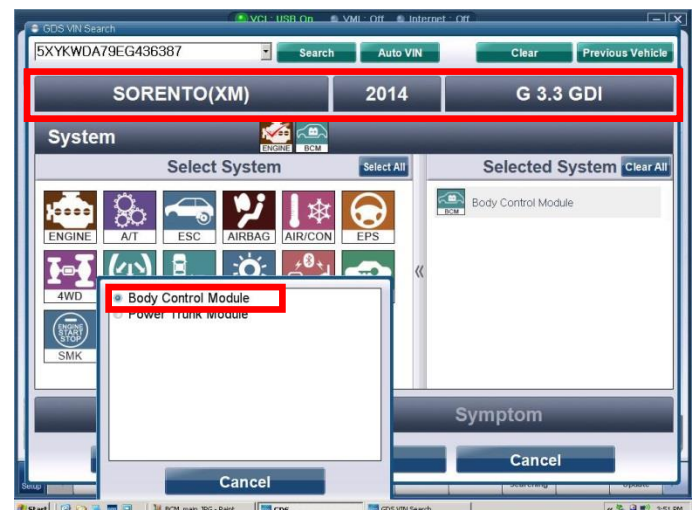
- At the GDS System Screen, select **BCM**. Then, select **Body Control Module** from the pop-up window and click **OK**.

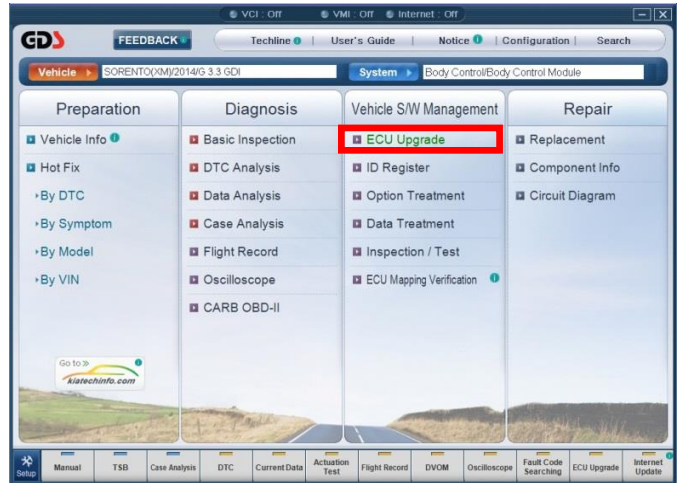
9. Select **ECU Upgrade** from the GDS main screen.

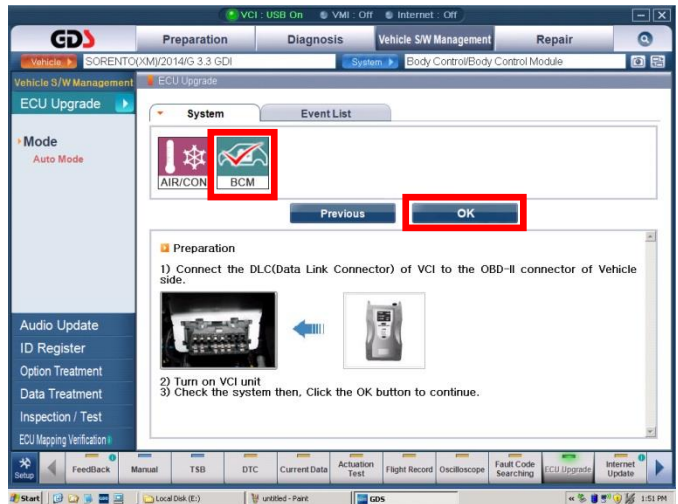
10. Select **BCM** and Click **OK**.

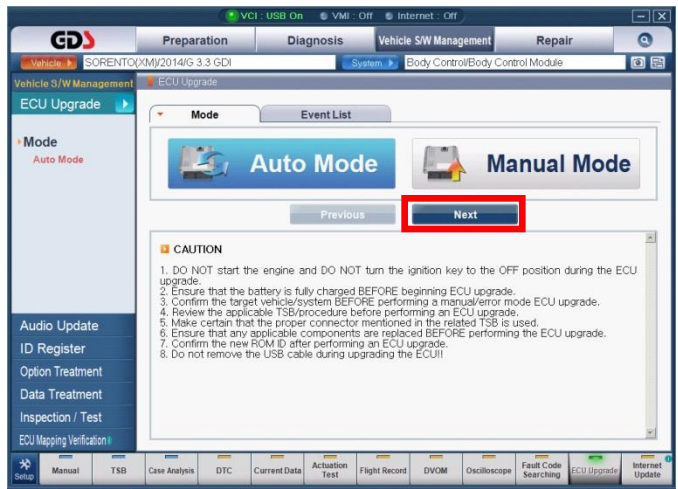
11. Select **Auto Mode** and click **OK**.

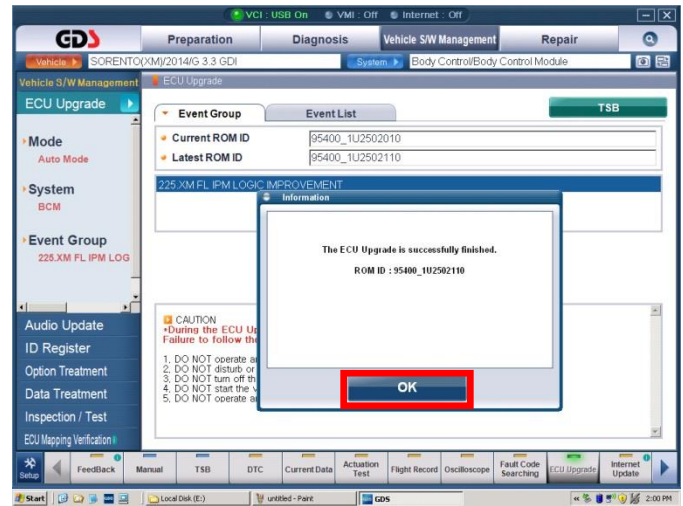
15. Click **OK** on the final screen. Upgrade event 225 is now complete.
