MODEL  
2014MY  
Sorento (XMa)

## TECHNICAL SERVICE BULLETIN

SUBJECT: SERVICE ACTION: BCM UPGRADE - IPM LOGIC  
IMPROVEMENT (SA163A)

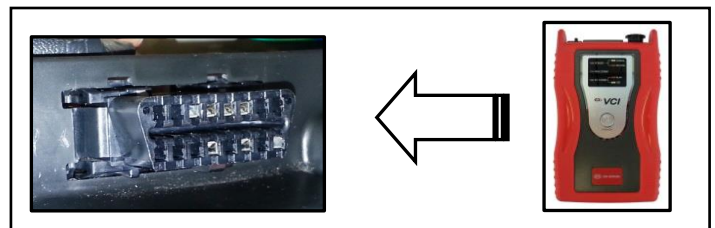
- Connect the Main 16-pin DLC cable (GHDM – 241000) to the VCI.

- Connect the Main 16-pin DLC cable (GHDM – 241000) to the OBD-II connector, located under the driver's side of the instrument panel.

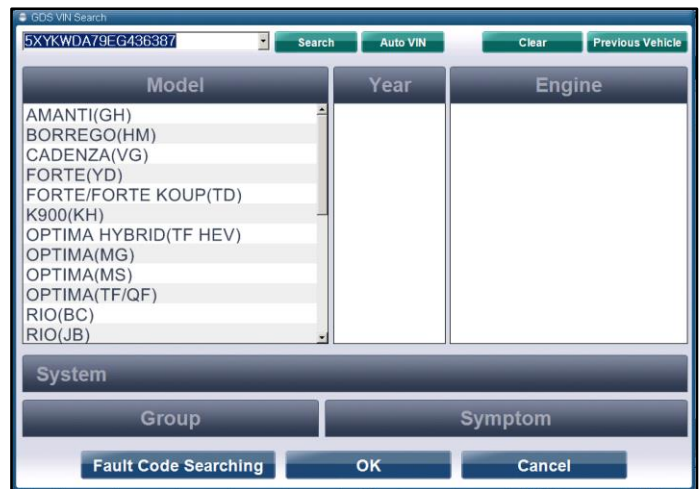
- With the ignition key OFF, turn ON the VCI and GDS and manually input the VIN into the search box. Then, click the **Search** button.

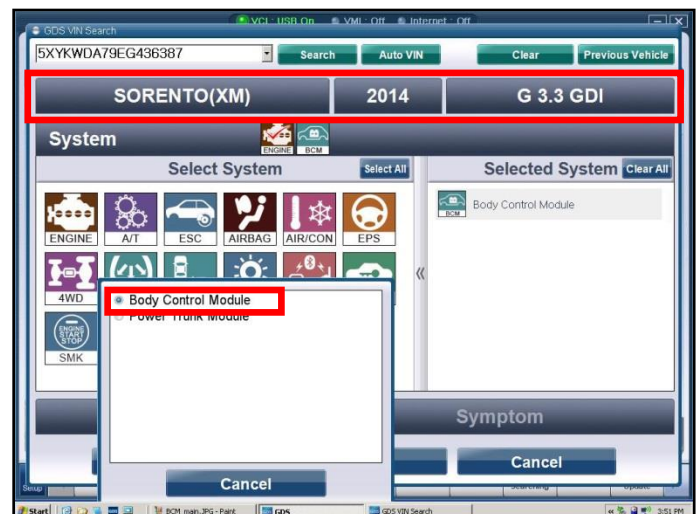
- At the GDS System Screen, select **BCM**. Then, select **Body Control Module** from the pop-up window and click **OK**.

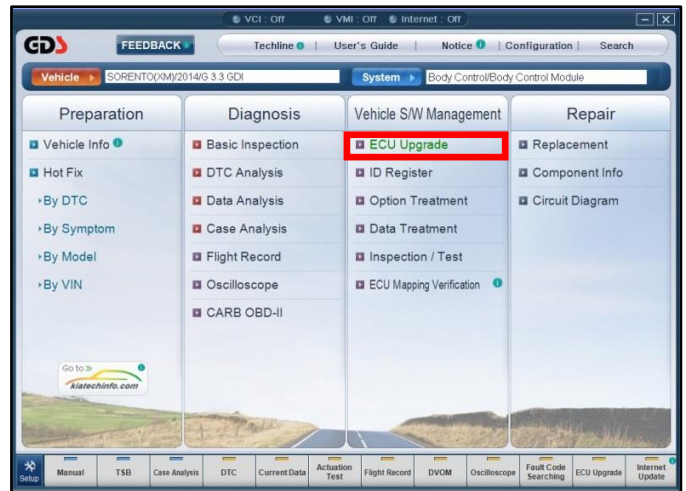
- 9. Select **ECU Upgrade** from the GDS main screen.

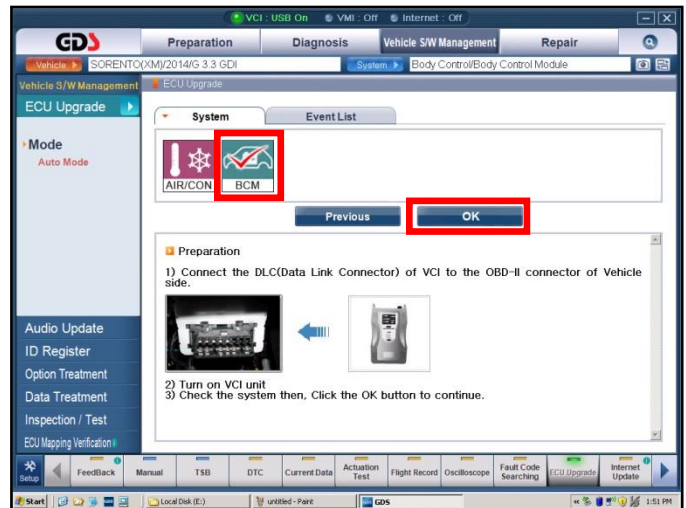
- 10. Select **BCM** and Click **OK**.

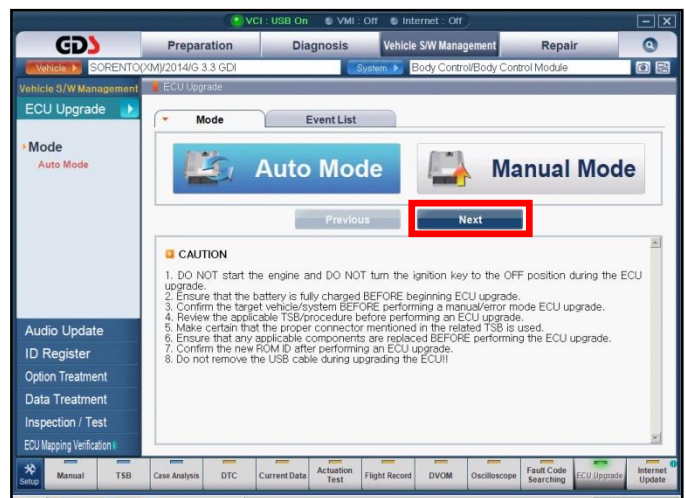
- 11. Select **Auto Mode** and click **OK**.

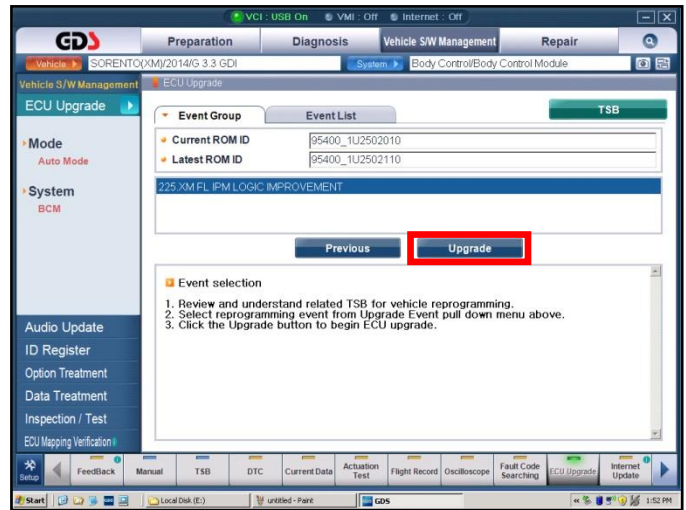
12. After the system reads the ROM ID, select Event: **225. XM FL IPM Logic Improvement** and Click **Upgrade**.

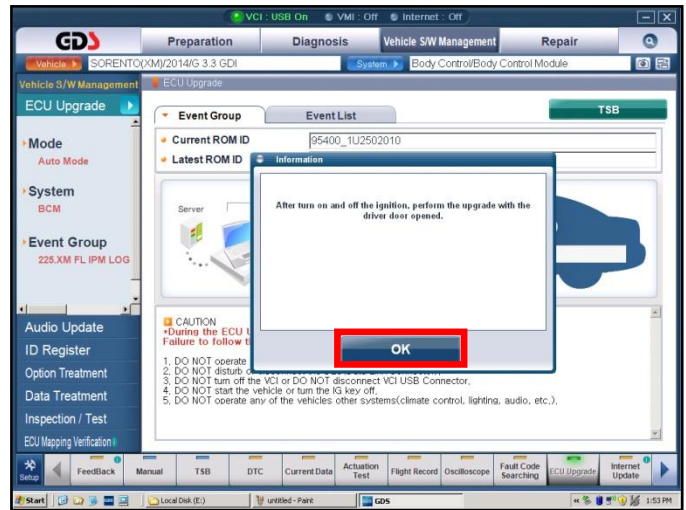
13. Click **OK** on the voltage check screen and cycle the ignition ON and OFF once. Then, open the driver's door and click **OK**.

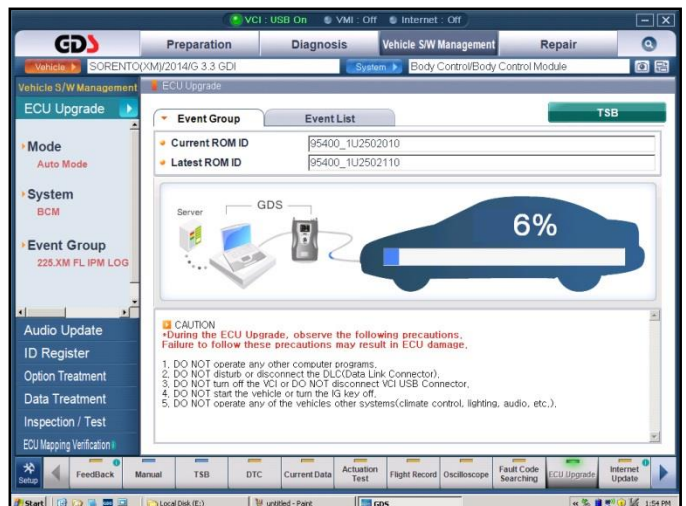
14. The upgrade will begin and the progress of the upgrade will appear on the bar graph.

If the upgrade fails, disconnect the negative (-) terminal from the battery for 20 seconds and restart the procedure.

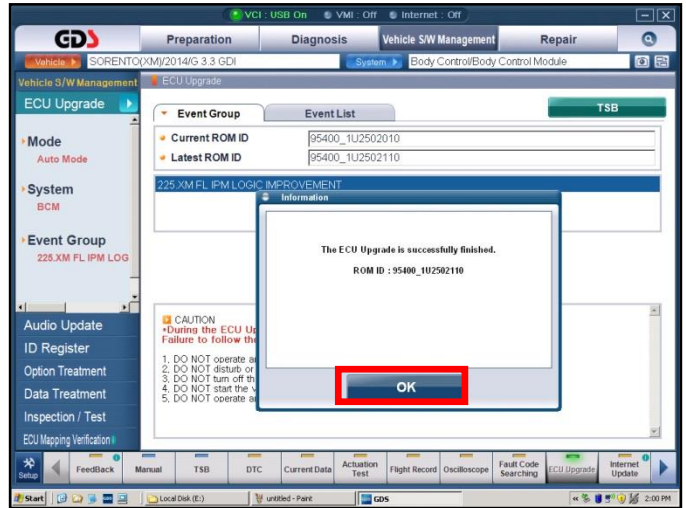
- 15. Click **OK** on the final screen. Upgrade event 225 is now complete.
