GROUP ELE	MODEL 2015MY Sedona (YP) (L, LX Only)
	NUMBER 073 (REV 1, 11/26/2014)	DATE November 2014
TECHNICAL SERVICE BULLETIN		
SUBJECT: SERVICE ACTION: INSTRUMENT CLUSTER LOGIC IMPROVEMENT (SA176)

SERVICE ACTION: INSTRUMENT CLUSTER LOGIC IMPROVEMENT (SA176)

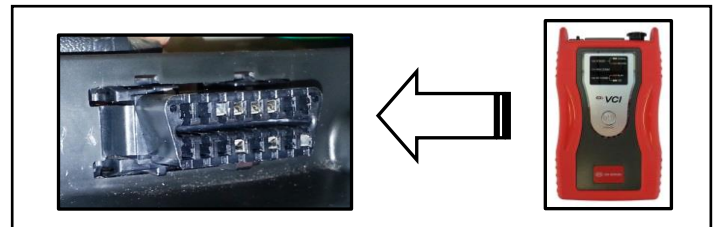
4. Connect the Main 16-pin DLC cable (GHDM – 241000) to the OBD-II connector, located under the driver's side of the instrument panel.

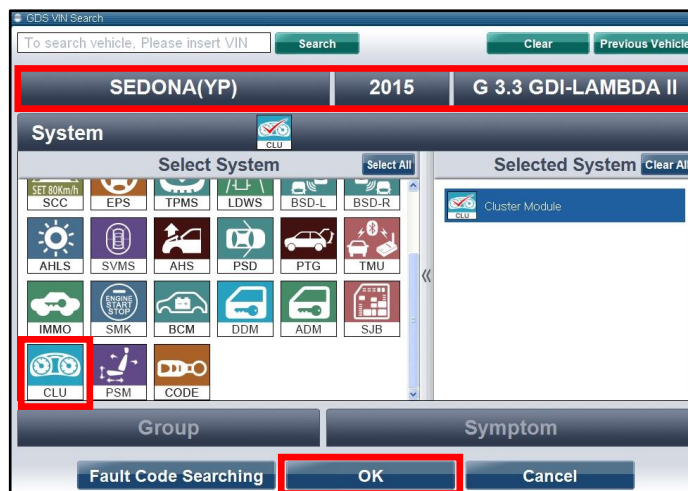
6. Select **CLUSTER** system and click **OK**.
