Service Bulletin

Subject: **BAS+ (HYBRID) eAssist Drive Motor Generator Battery Module (Powerpack) or Drive Motor Generator Battery Section Exchange Process And Order Instructions**

Models: **2012 - 2015 Buick Lacrosse, Regal**
2013 - 2014 Chevrolet Malibu ECO
2014 Chevrolet Impala
All equipped with eAssist (RPO HP6)

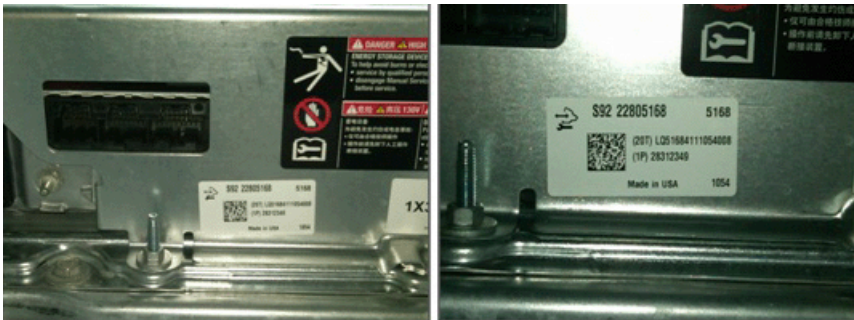
8. Prior to contacting TAC, make sure you know:
 - The parts department fax number
 - The Powerpack serial number (Battery Identification Number)
9. The Battery Identification Number (BIN) tag is located on the side of the assembly cover. Locate the tag and record the 16 digit Battery Identification Number. The BIN number begins with digits "20T" (See Photo Below). If the Generator Control and Battery Module is not out of the vehicle yet, you can find the assembly ID number by installing the MDI and using GDS2. Access the Battery Energy Control Module menu and look under the ID Information section for the sixteen digit number. It will be listed under the parameter: Hybrid Battery Pack Identification Number. You will need to record the serial number and supply it to TAC when requesting a Powerpack or Battery Sections

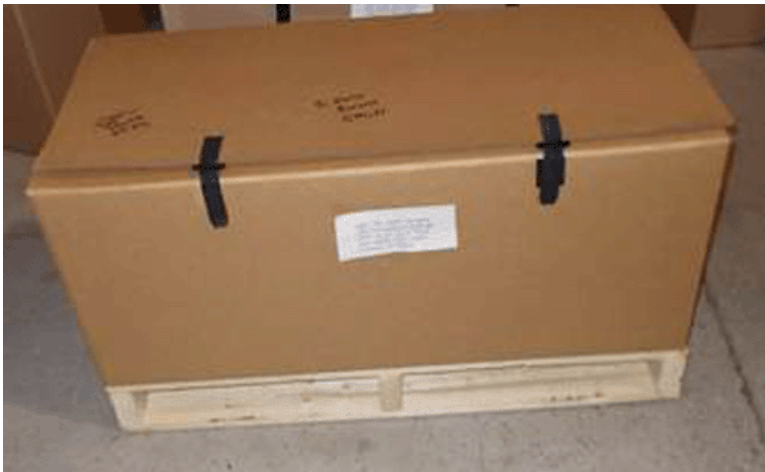
7. Ensure the Manual Service Disconnect (MSD) is properly retained in the open position with a zip tie.
8. Place the Drive Motor Generator Control and Battery Module into the plastic shipping bag and original shipping container.

9. Place a copy of the completed repair order with any technician comments, inside the shipping container with the failed battery
10. Close the top lid and adhere using the two Velcro straps
