**Title: Aftertreatment Soot Level Reset after AFI, DPF or DOC Cleaning or Replacement**

**Applies To: 2008 - 2009 MaxxForce® 11 and 13 Engines 2010-2012 MaxxForce® 11 and 13 Engines**

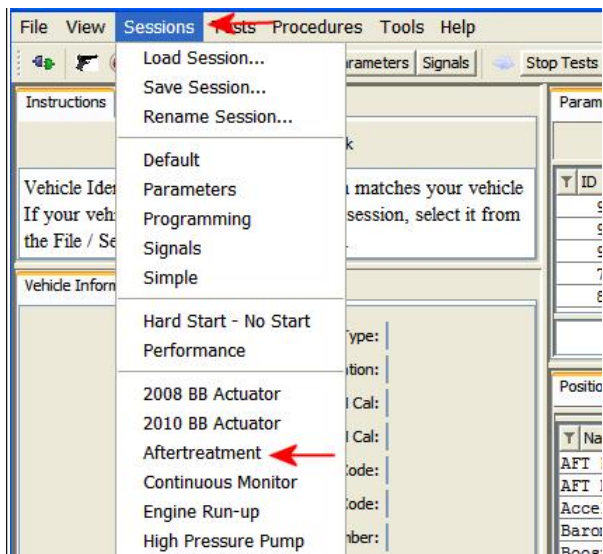
Figure 1 - Sessions - Aftertreatment

1. Connect ServiceMaxx® to the vehicle.
2. Top Menu Go to Sessions. Figure 1
3. Select Aftertreatment. Figure 1
4. Select HistoryTab Figure 2 -1
5. Select Parameter - Aftertreatment Reset Request Figure 2 -2
6. Use Chart 1 to make the proper reset choice based on component and action
7. Select the choice from the drop down in the value field next to the parameter name Figure 2- 3
8. Select Program Engine after the selected reset choice has been made. Figure 2-4

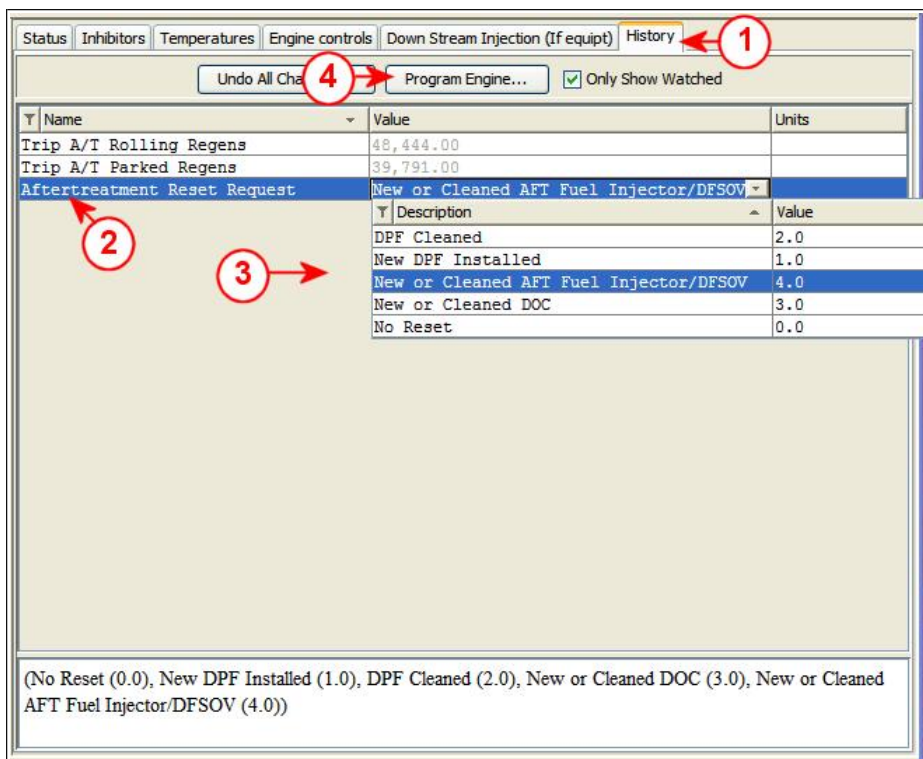
Figure 2 - Aftertreatment Session

- 1 - History Tab
- 2 - Aftertreatment Reset Request
- 3 - Select Reset Action
- 4 - Select Program Engine

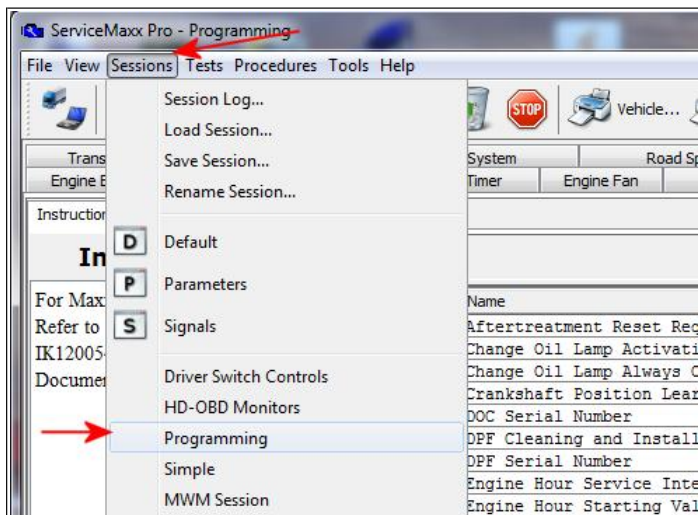
Figure 3 - Programming Session

1. Connect ServiceMaxx® to the vehicle.
2. Top Menu go to Sessions. -Figure 3
3. Select Programming. -Figure 3
4. Select Service Interval Tab -Figure 4
5. Select Parameter 95202 - Aftertreatment Reset Request - Figure 4
6. Select **DPF Replaced** Select the choice from the drop down in the value field next to the parameter name Figure 4
7. Select Parameter 66072 -DPF cleaning and installation date - Figure 5
8. Enter Replacement or Cleaning Date in the parameter field. - Format MM/DD/YYYY - Figure 5
9. Select **Program Engine** after the changes . Figure 5

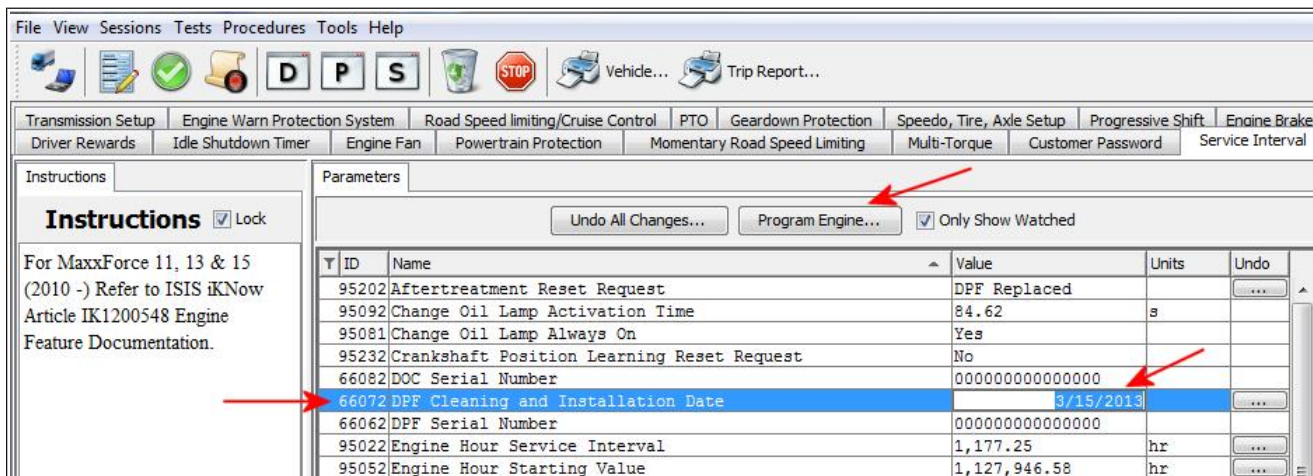
Figure 5 - Select Parameter 66072 - DPF Cleaning and Installation Date

> Enter Cleaning or replacement Date  
> Program Engine
