WE02 - Re-programming Instrument Cluster (Workshop Campaign)

Model Year: **As of 2012 up to 2014**

Model Line: **Boxster (981)
 Cayman (981)
 911 (991)**

Concerns: **Instrument cluster**

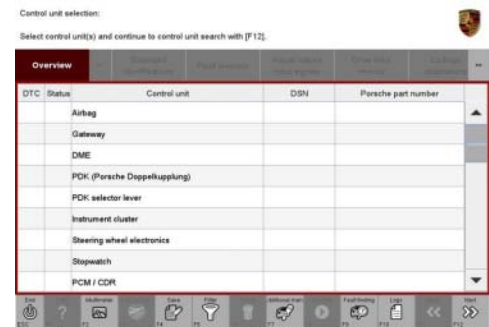
Control unit selection

- Once you have erased the fault memories, select the ⇒ **'Overview'** menu and press •<<" to return to the control unit selection screen ⇒ *Control unit selection*.
