**WE44 - Re-programming DME Control Unit (Workshop Campaign)**

**Vehicle Type:** Cayenne Diesel (92A)/Cayenne S Diesel (92A)

**Concerns:** DME control unit

**Action Required:** Re-program DME control unit using an updated data record.  
 With this data record, the cooling-air flaps are forced to open as soon as a speed of 100 mph (160 km/h) is reached.

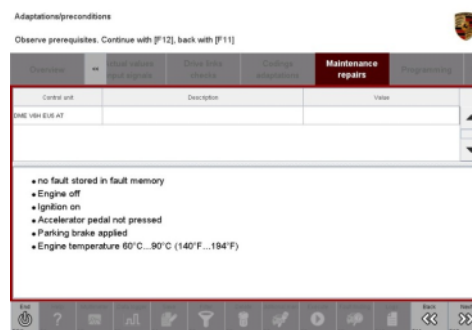
*Adaptation preconditions*

- Check the displayed preconditions and press **•>>** to confirm ⇒ *Adaptation preconditions*. It is not absolutely necessary to comply with any temperature ranges specified in the preconditions in order to perform the adaptation. The adaptations will still be performed even if the temperature conditions are not met.

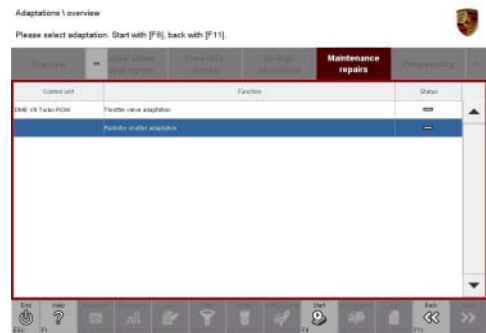
*Radiator shutter adaptation*

- 5 Select the ⇒ **'Radiator shutter adaptation'** function so that the corresponding text line turns blue and then press •F8" to start radiator shutter adaptation ⇒ *Radiator shutter adaptation*.
