VOLUNTARY CAMPAIGN BULLETIN

SUBJECT: Dosing Control Unit (DCU) Software Enhancement

BULLETIN NO.: RCB-005-14

AFFECTED MODELS: Certain 2011 thru 2014 Model Year NE8J, NJ8J, NV8J Model Vehicles.

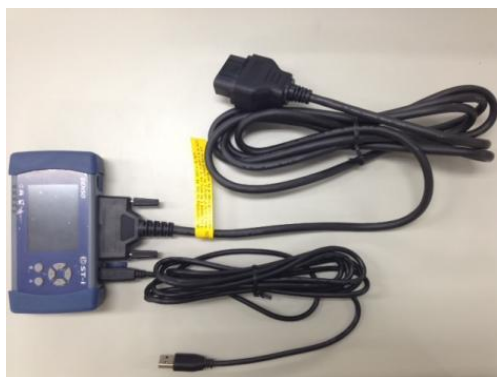
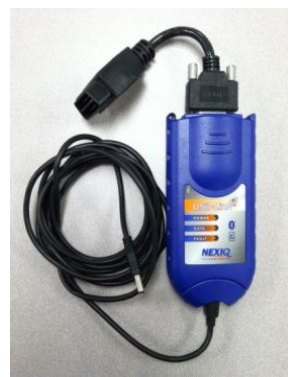
2. Connect the electronic interface tool between the DLC (Diagnostic Link Connector) and USB port of the programming computer.

Use ONLY the DST-i or Nexiq USB Link electronic interfaces. Use ONLY the USB cable connection from the electronic interface to the computer - do NOT use the Bluetooth feature for programming.

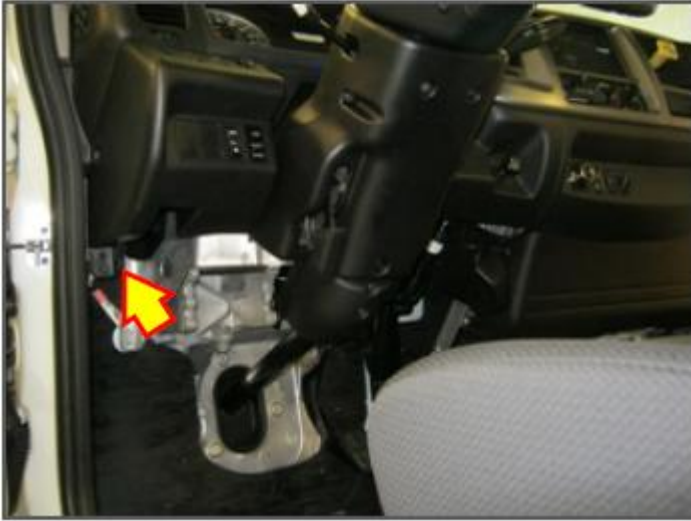
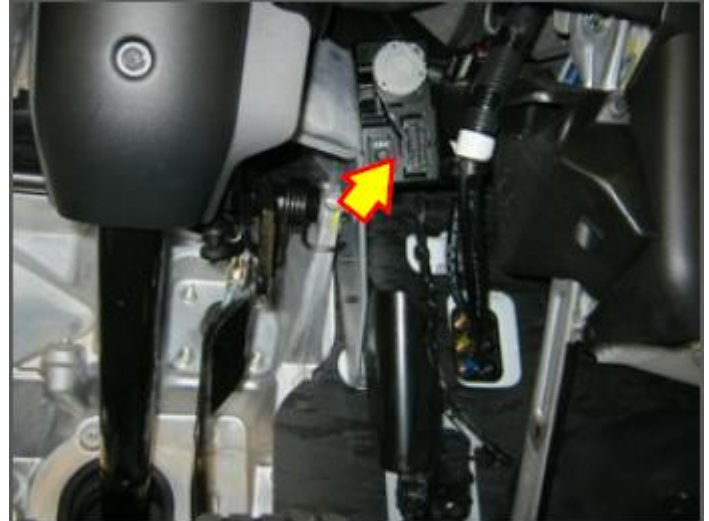
3. The vehicle's DLC is located under the dash on the right side of the steering column for 11-13MY trucks (right photo) and on the left side of the steering column for 14MY trucks (left photo).

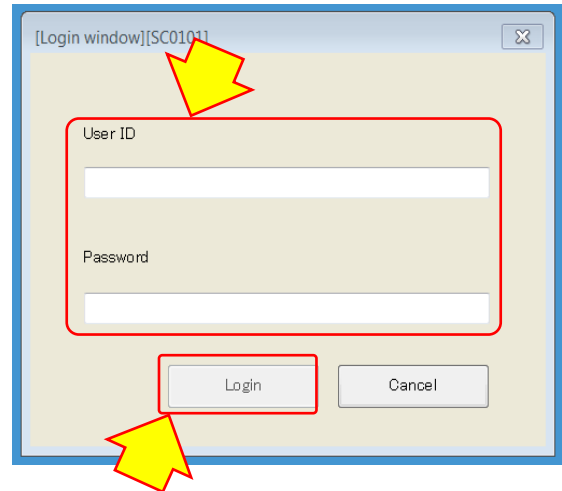
5. Sign onto the DXII program using your User ID and Password established at the time the TSM installed the program.
6. Click the “Login” button once the User ID and Password are entered.

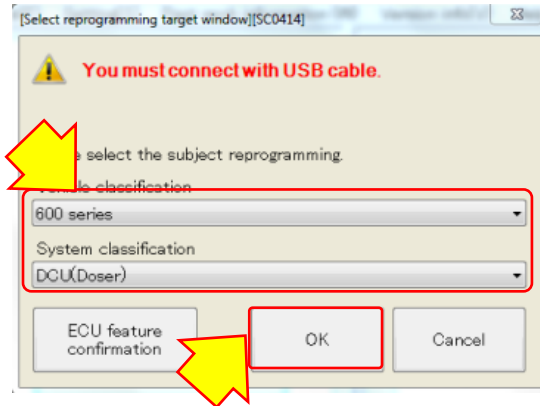
11. Use the drop-down features shown and select the following:

- “600 Series (North America)”
- “DCU (Doser)”

12. Now click the “OK” button to continue.

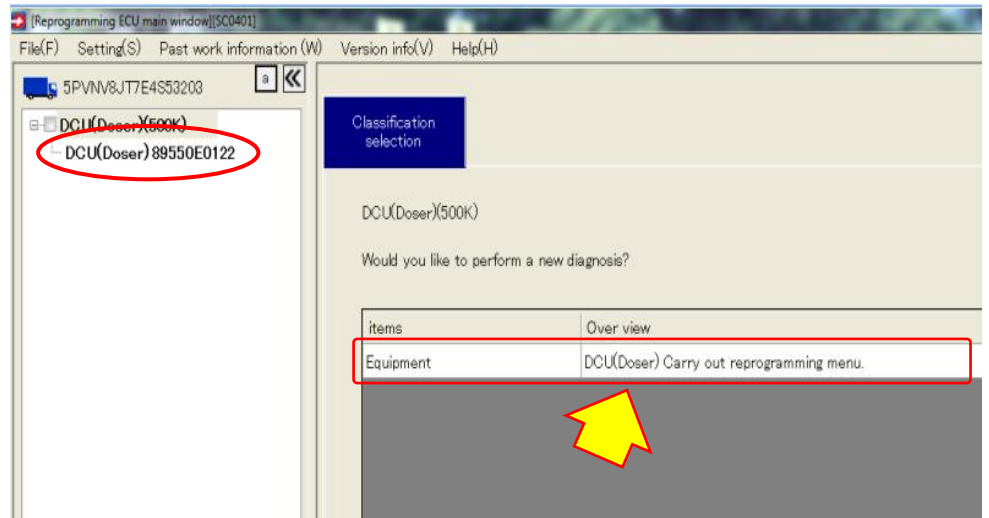
13. Inspect the current DCU software level, is the software version 89550E0123?

Yes- Programming is not required. Exit the program and proceed to “Final Inspection”

No- Select “DCU Carry out reprogramming” and continue to Step 14

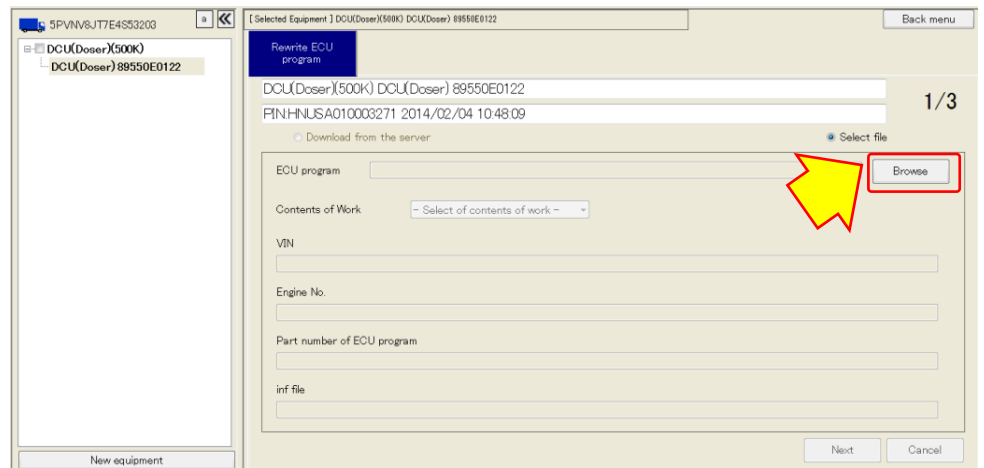
14. Click the “Browse” button to Select File for reprogramming the DCU.

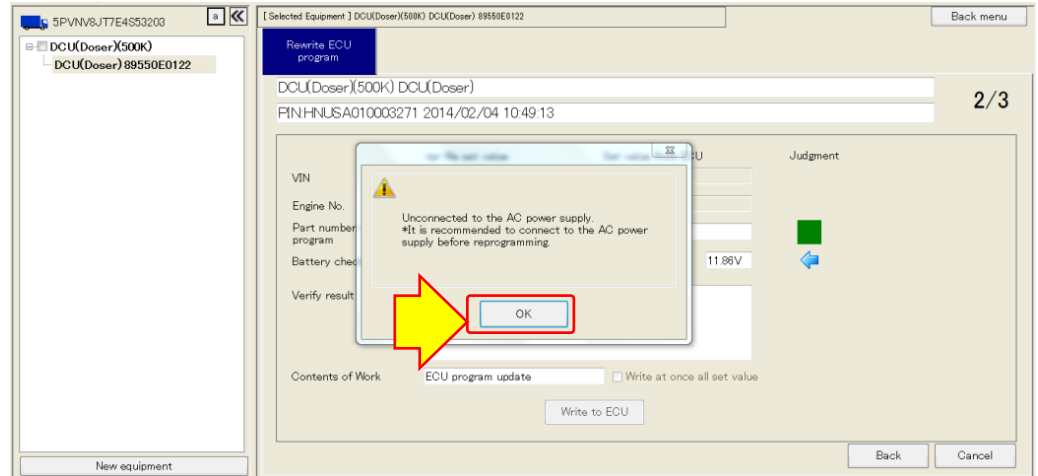
18. The caution message will appear if the computer is not connected to an AC power source. Make certain the computer is connected to an AC power source then click the “OK” button to continue.

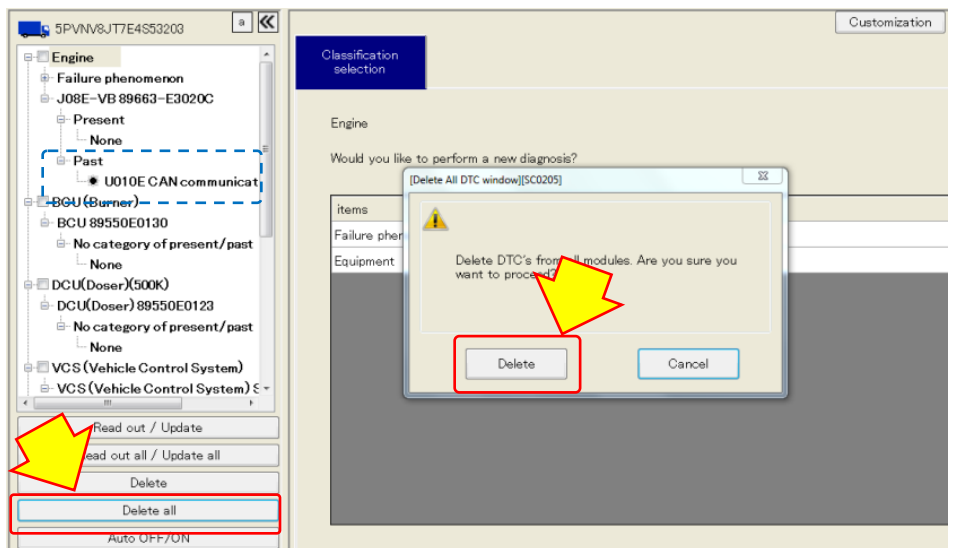
26. Click the “Delete All” button as shown to the right then click the “Delete” button when prompted.

27. Step 26 should be repeated once again to completely erase all past faults.
