## VOLUNTARY CAMPAIGN BULLETIN

**SUBJECT:** Dosing Control Unit (DCU) Software Enhancement

**BULLETIN NO.:** RCB-004-14

**AFFECTED MODELS:** Certain 2014 Model Year 195 and 195h model vehicles.

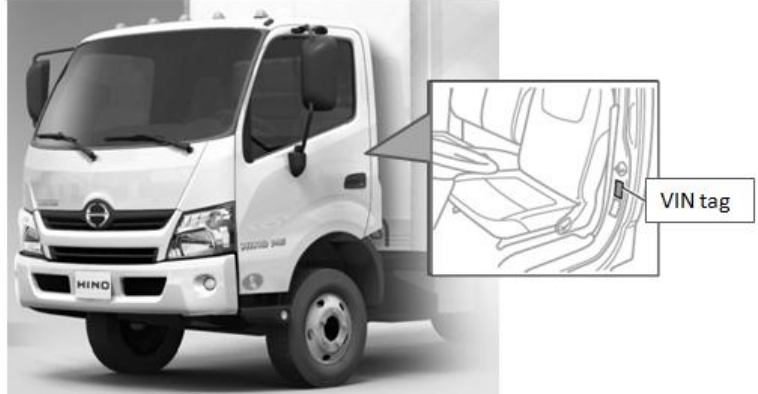
Complete the campaign sticker shown below and affix it to the door jamb above the VIN tag.

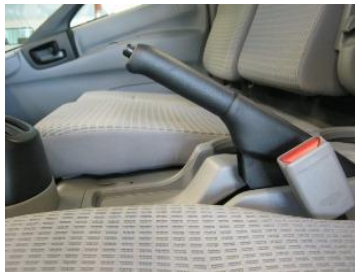
3. Apply the parking brakes.

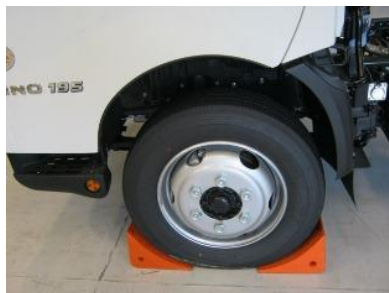
4. Chock the wheels.

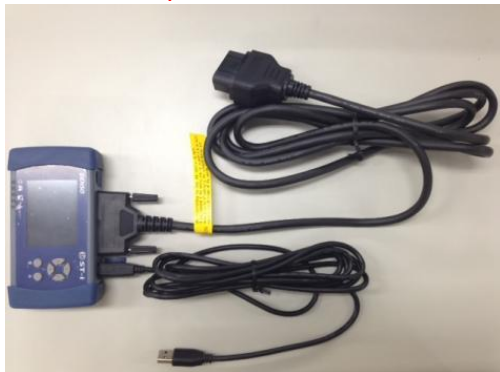
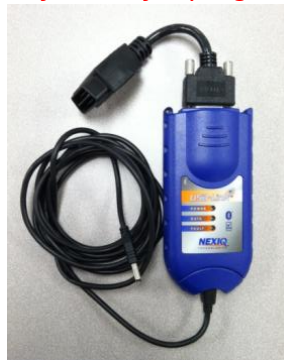
2. Connect the electronic interface tool between the DLC (Diagnostic Link Connector) and USB port of the programming computer.

*Use ONLY the DST-i or Nexiq USB Link electronic interfaces. Use ONLY the USB cable connection from the electronic interface to the computer - do NOT use the Bluetooth feature for programming.*

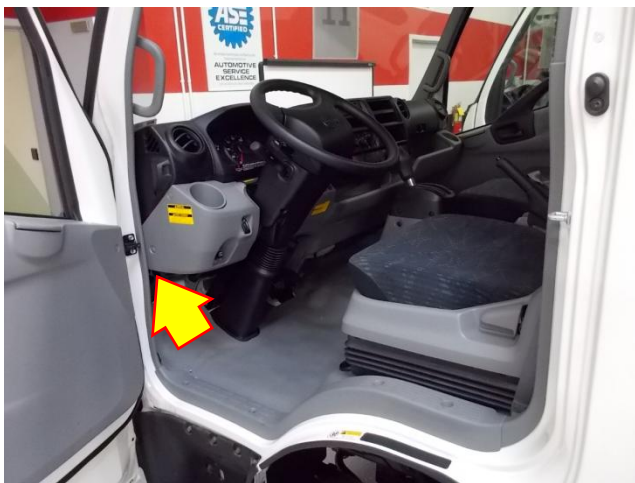
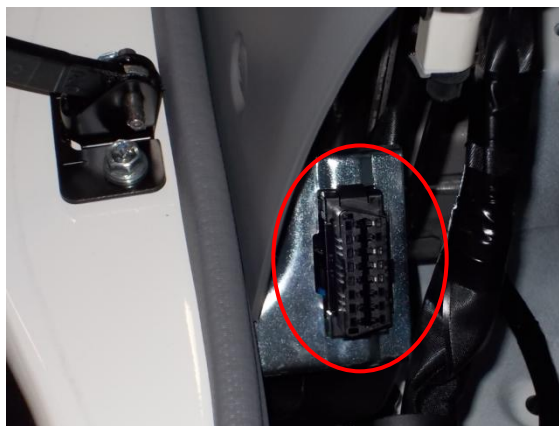
3. Locate the vehicle's DLC located under the instrument panel on the left side of the steering column.

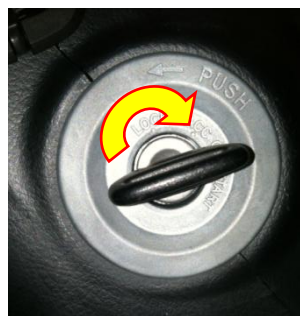
7. Insert the key into the starter switch and turn the key to the "ON" position. **Do NOT start the engine.**
