# Audi Elsa Newsletter

Edition 85: May 12, 2014

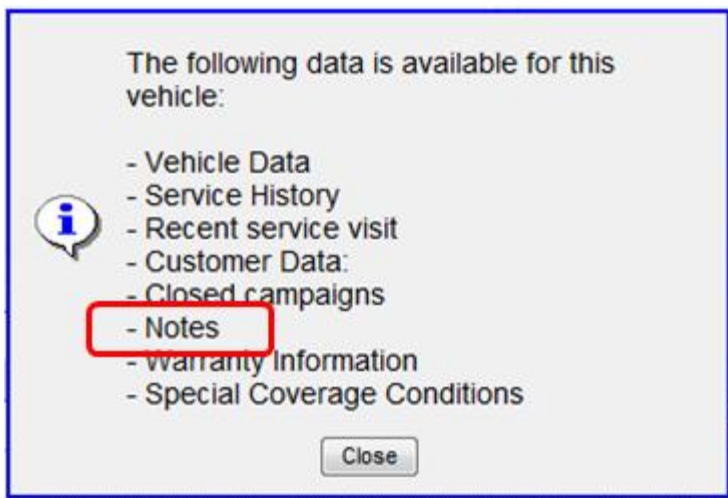
After you have entered a VIN or selected an existing Job in ElsaPro, a dialog box pops-up showing what additional information is available for that vehicle. This may include "Notes":

This means that there are Repair Authorizations (RA) and/or Pending Service Solutions (PSS) available for this vehicle.

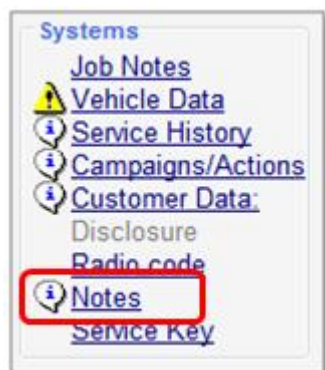
1. On the Systems menu, click "Notes". A pop-up will display with a list of relevant documents:

We are currently having issues with the displayed list of documents when selecting "Notes" from the Systems menu (location 1, above).

The list may include erroneous items or broken links.
