## VW Elsa Newsletter

Edition 79: March 31, 2014

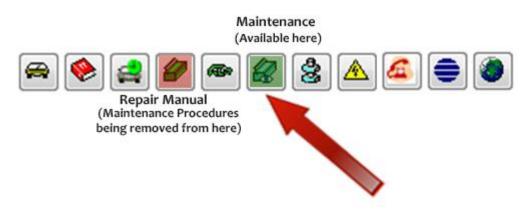
The maintenance procedures under the Repair Manual infomedia in ElsaPro will be moved. Maintenance information will now be accessible through the Maintenance tab located on the Infomedia Toolbar Menu at the top right within ElsaPro. This move is to help take advantage of behind—the-scenes capabilities of ElsaPro.

(See diagram below)

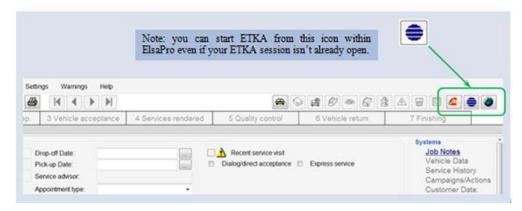
### 3. From ElsaPro

Enter a VIN or perform a Vehicle Identification search by Model and Year.

Click on the ETKA icon in the header to open ETKA and automatically transfer the VIN (or Model and Year information).

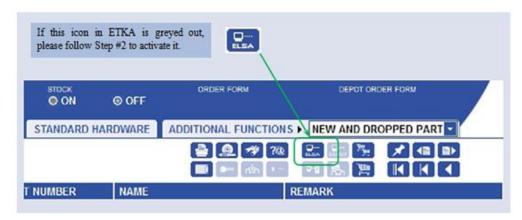
#### 4. From ETKA

While using ETKA, you can click on the ELSA icon in the header to maximize a session of ElsaPro that is already open (you cannot open ElsaPro with this icon).

Note: no information can be transferred from ETKA to ElsaPro, there is a one-way transfer from ElsaPro to ETKA.
