# VW Elsa Newsletter

Edition 77: March 17, 2014

## Offboard Diagnostic Information System Service (ODIS Service) is Now Integrated with ElsaPro

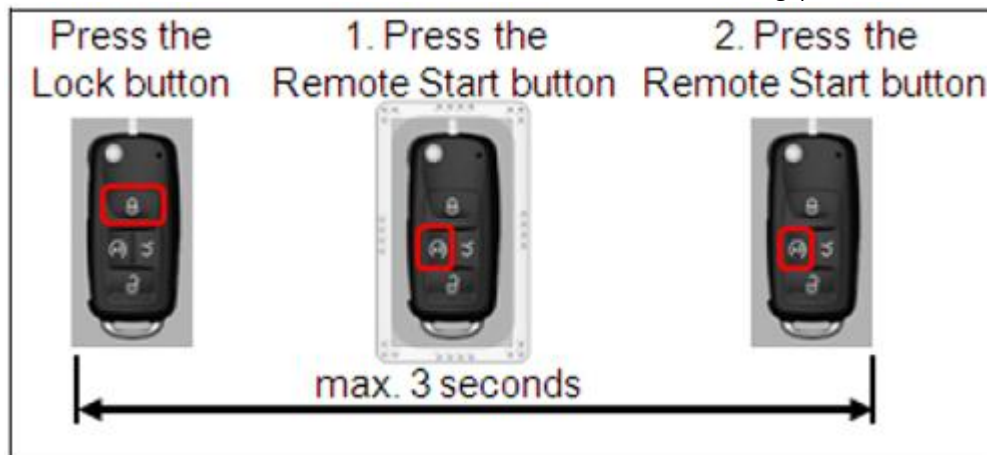
To remote start a 2012-2014 Passat, use the following procedure.

- Press the lock button once. The parking lights will flash.
- Press the remote start button twice. The parking lights will flash with each button press. All 3 button presses (lock, remote start x2) must be completed within 3 seconds.
- Wait up to ten seconds before pressing any other buttons. The vehicle should start in this time.
