ATB 51861 (1408)

HFL Does Not Make or Receive Calls or HFL Buttons Do Not Work

AFFECTED VEHICLES

Year	Model	Trim	VIN Range
2013–14	Fit EV	ALL	ALL

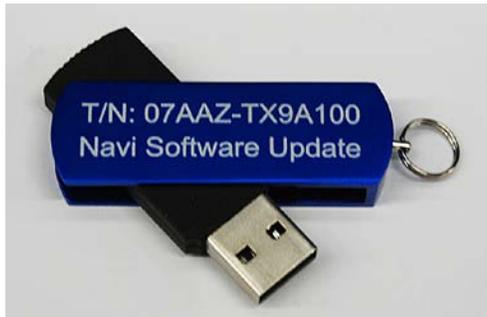
NOTE: The USBs are dedicated tools. **Do not save other files onto the USB update device.**

The USB update devices were recently shipped to all dealers. Additional USB update devices are available for purchase through the parts system.

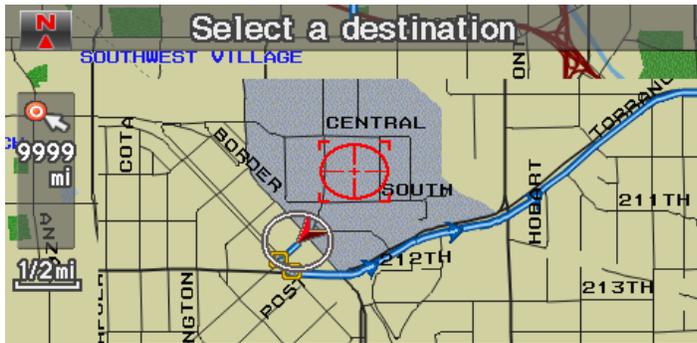
- Apply this software update only to the vehicles listed under AFFECTED VEHICLES, otherwise this software update can permanently damage the unit.
 - If you accidentally update the wrong vehicle, contact Tech Line; if the audio-navigation or audio unit must be replaced, your dealership may be debited for the replacement cost.
1. Connect a battery charger or a fully charged jumper battery to the vehicle and leave it connected during the entire update procedure to maintain a steady voltage.
 2. Press the engine START/STOP button to select the vehicle ON mode.
 3. Press **OK** on the Confirmation screen, then make sure you are on a map screen.

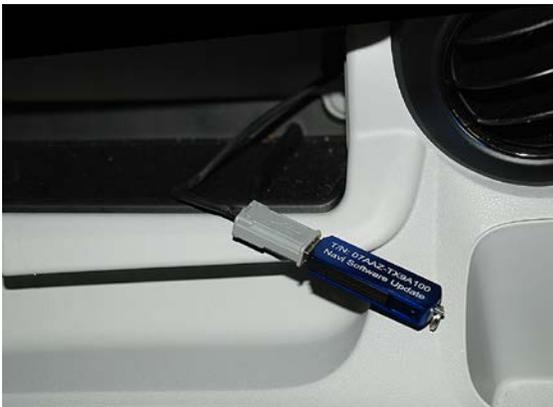
4. Connect the USB update device to the USB cable in the center console above the glove box.
NOTE: Once you connect the USB update device, **do not remove it until the LED blinks.**

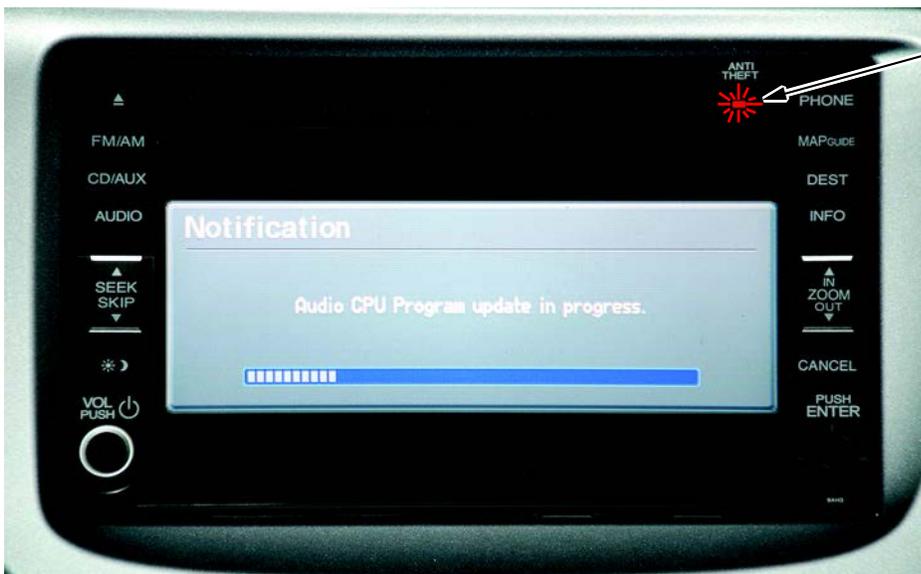
5. The navigation system will automatically begin after about 12 seconds. There is a blank screen followed by a Notification screen loading bar.

- When the audio-navigation unit has transferred the update from the USB update device, about 1 minute, the indicated red LED blinks. Remove the USB update device.

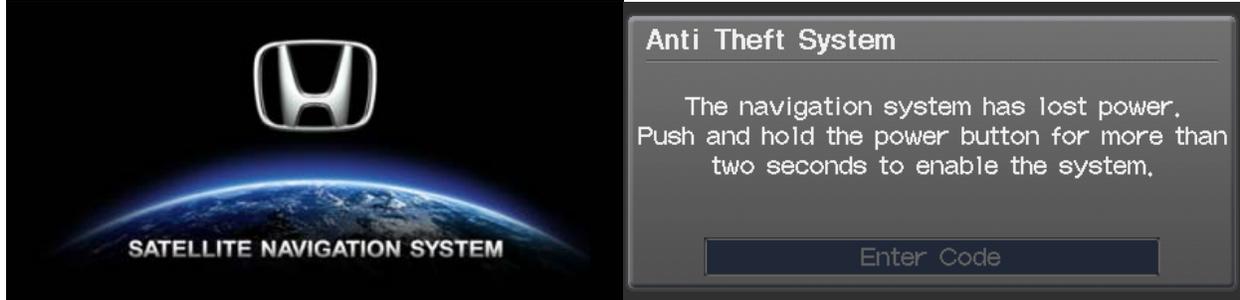
- Make sure you remove the USB update device as soon as the LED starts blinking. If you do not remove it and the system reboots, you will need to leave the USB plugged in and update the vehicle again.
 - The navigation system takes about 3 minutes to finish the update after the USB update device is removed.
- After the USB update device is removed, the navigation system will continue updating. When it is finished, the system will reboot, and the Anti-Theft System screen appears.

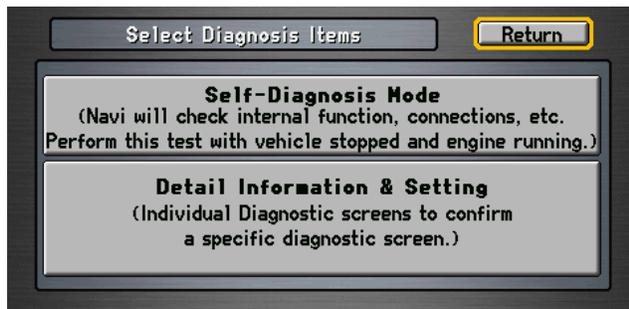
- Press and hold the VOL PUSH button until you hear a beep.
- Press and hold the MAP, DESTINATION, and CANCEL buttons until the Select Diagnosis Items screen appears.

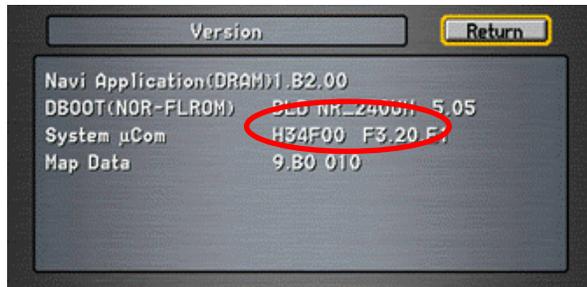
- Select **Detail Information & Setting**.
- Select **Version**.
- Verify that the software was updated to the new version as shown below. If the software is not updated, turn the vehicle to the OFF mode, and go back to step 2 and repeat the update procedure.
