# PREVOST

## MAINTENANCE Mi14-34C INFORMATION

| SUBJECT : | PREVOST AWARE ADAPTIVE CRUISE BRAKING (ACB) • FLR20 RADAR SENSOR ALIGNMENT | |

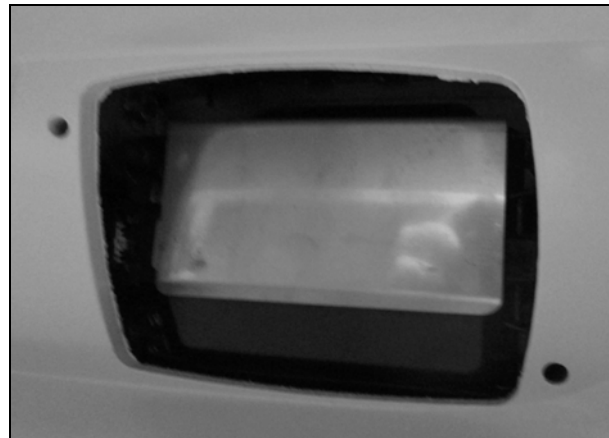
FIG.5 : H3 SERIES – STEEL CLIP INSTALLED ON RADAR SENSOR

7. Park the coach on a level surface. The suspension must be at normal ride height.
8. **H3 Series:** Open the reclining bumper and install the steel clip (#688078) over the radar sensor (fig.4 & 5). Steel clip must lean flat on the radar sensor.
9. **H3 Series:** Close reclining bumper.

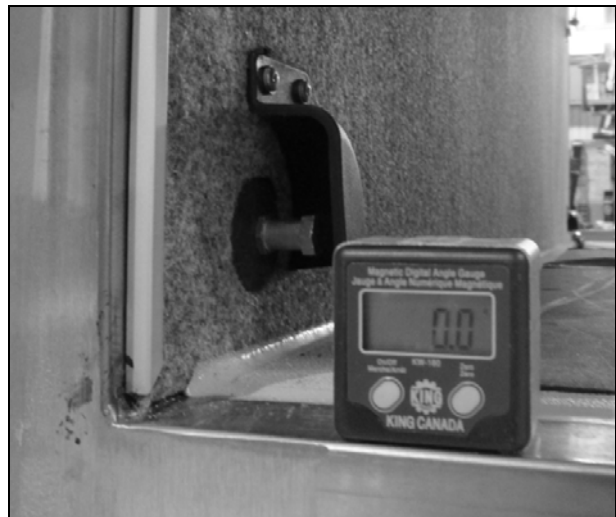
FIG.9

14. Set the digital inclinometer flat on a horizontal baggage compartment member. Place the digital inclinometer as shown on figure 9.
15. Press the ZERO button to set the gauge to 0.0°. LCD display will show **0.0°**.

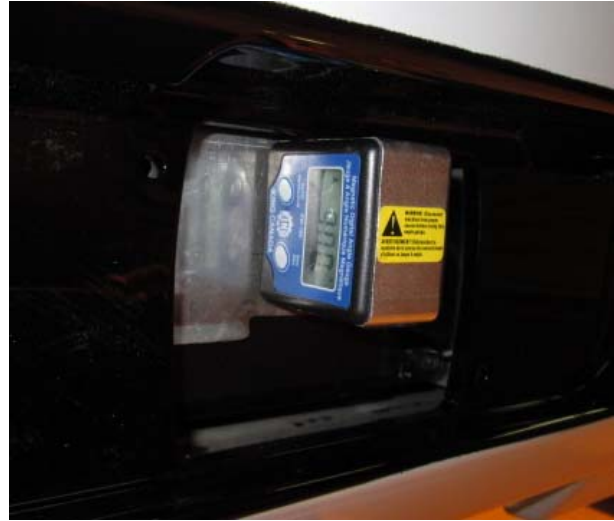
FIG.10

16. Place the digital inclinometer on the steel clip as shown on figure 10.

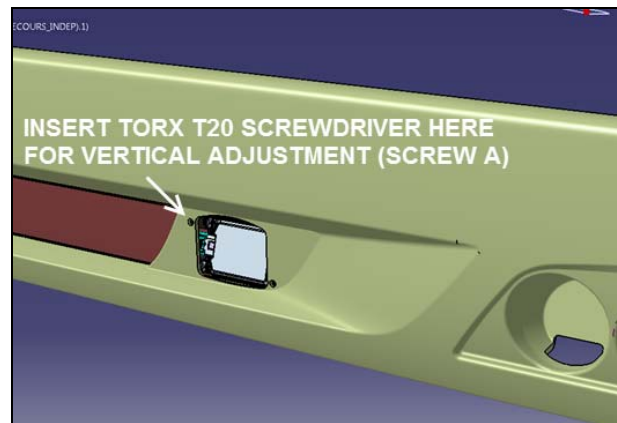
17. Screw **A** serves as vertical adjustment screw. Use a Torx T-20 screwdriver to turn by hand the top-left adjustment screw (screw A). During the adjustment, observe the digital display on the inclinometer and turn the vertical alignment screw **A** clockwise or counterclockwise depending on the vertical direction (up or down) needed, **until the reading is  $90.0^{\circ} \pm 0.2^{\circ}$** . (see figures 11 & 12).

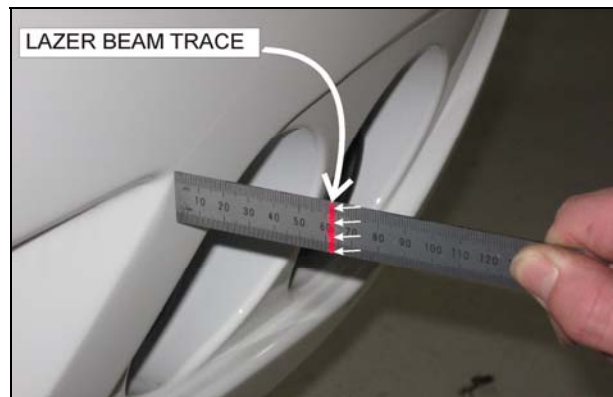
FIG.16

21. Turn on each laser and select the flat beam type.
22. Using a measuring tape, measure distance between the laser beam and the bumper at the reference point. For a perfect alignment, this measure should be equal on both sides.

***The radar horizontal adjustment is within tolerances if the difference between both measurements does not exceed 19/32" (15mm)***
