# Entune Audio Head Unit Software Update (Panasonic)

Service  
Category Audio/Visual/Telematics

Section Audio/Video

| YEAR(S) | MODEL(S) | ADDITIONAL INFORMATION |
|---|---|---|
| 2014 | 4Runner, Highlander,<br>Highlander HV,<br>Sequoia, Tacoma,<br>Tundra | |

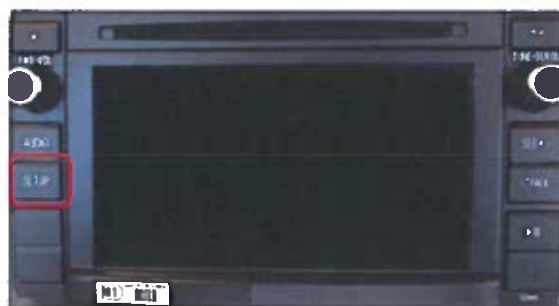
Figure 3. Tacoma, Sequoia

#### A. For Entune™ Audio:

Press the *SETUP* button on the panel.

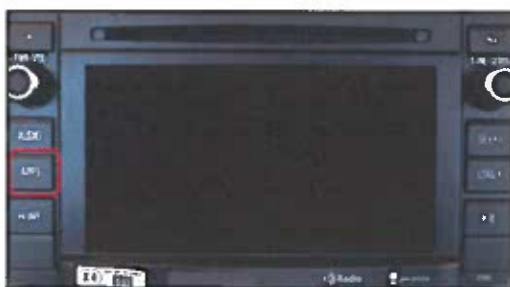
Figure 5. 4Runner, Highlander, Highlander HV, Sequoia, Tacoma and Tundra

#### B. For Entune™ Audio Plus / Entune™ Premium Audio:

(1) Press the *APPS* button on the panel.

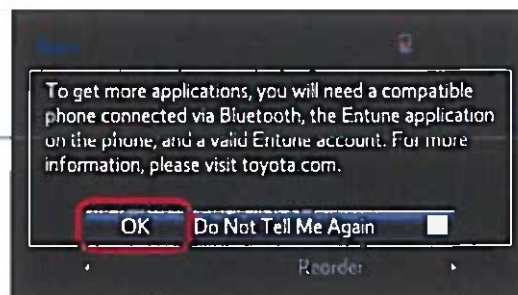
Figure 7.

If Entune™ pop-up displays, select *OK*.

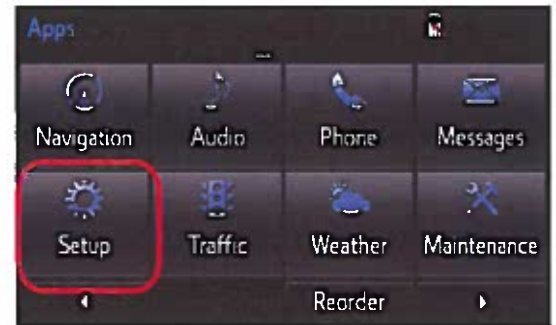
**Figure 8.**

- (2) Select *Setup* on the *Apps* screen.

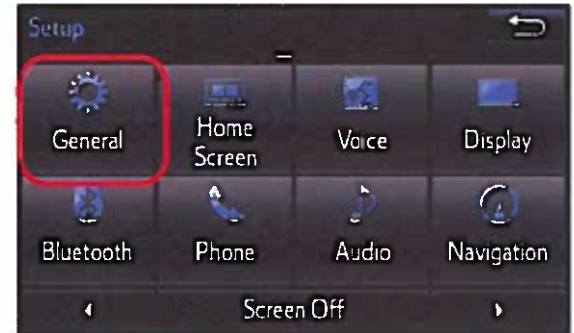
**Figure 9.**

5. Select *General* on the *Setup* screen.

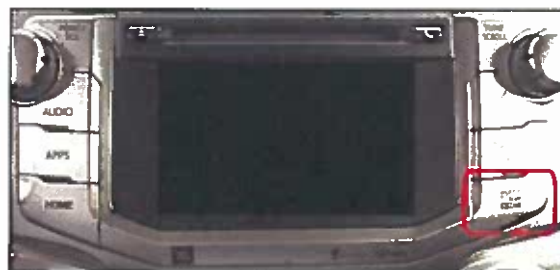
Figure 17.

For Entune™ Premium Audio:

If update fails and the error message "New software is not compatible with the system." displays, cycle the ignition OFF, remove the Map Micro SD Card from the head unit, and repeat steps 2 – 11.
