Techstream ECU Flash Reprogramming Procedure

Service Category Engine/Hybrid System

Section Engine Control

YEAR(S)	MODEL(S)	ADDITIONAL INFORMATION
2004 – 2015	FR-S, iQ, iQ EV, tC, xA, xB, xD

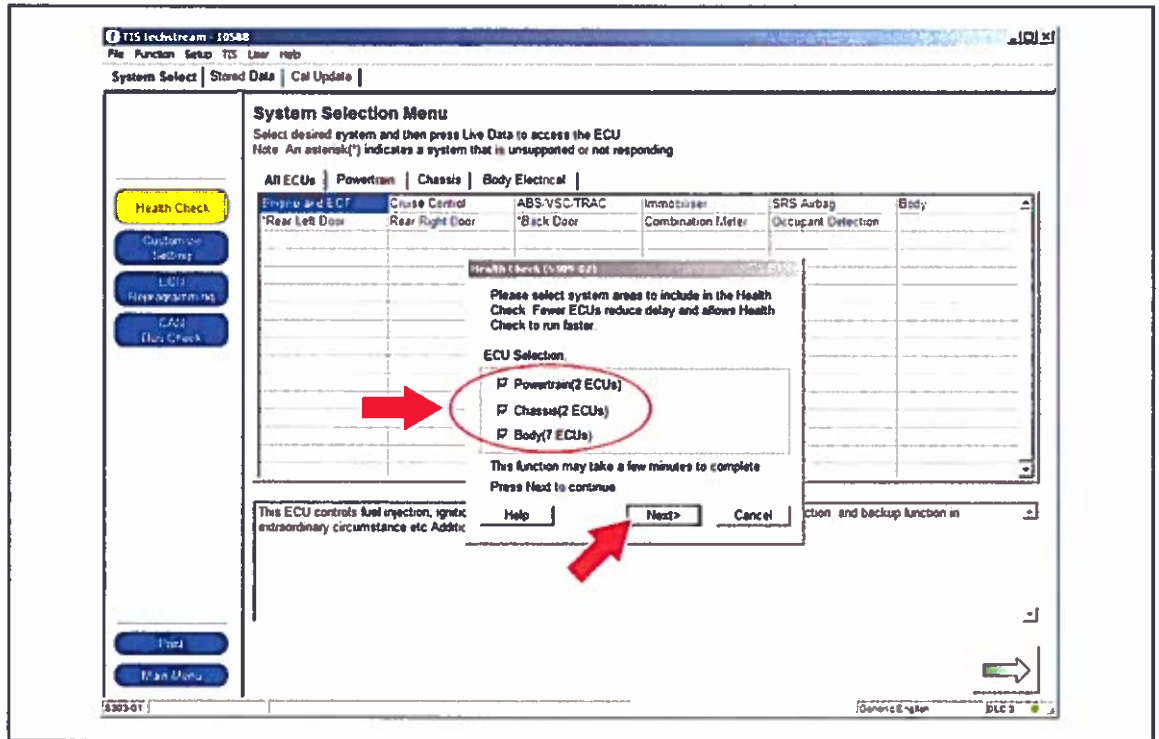
Figure 3.

C. Choose desired ECU group(s) in the *Health Check* dialog box.

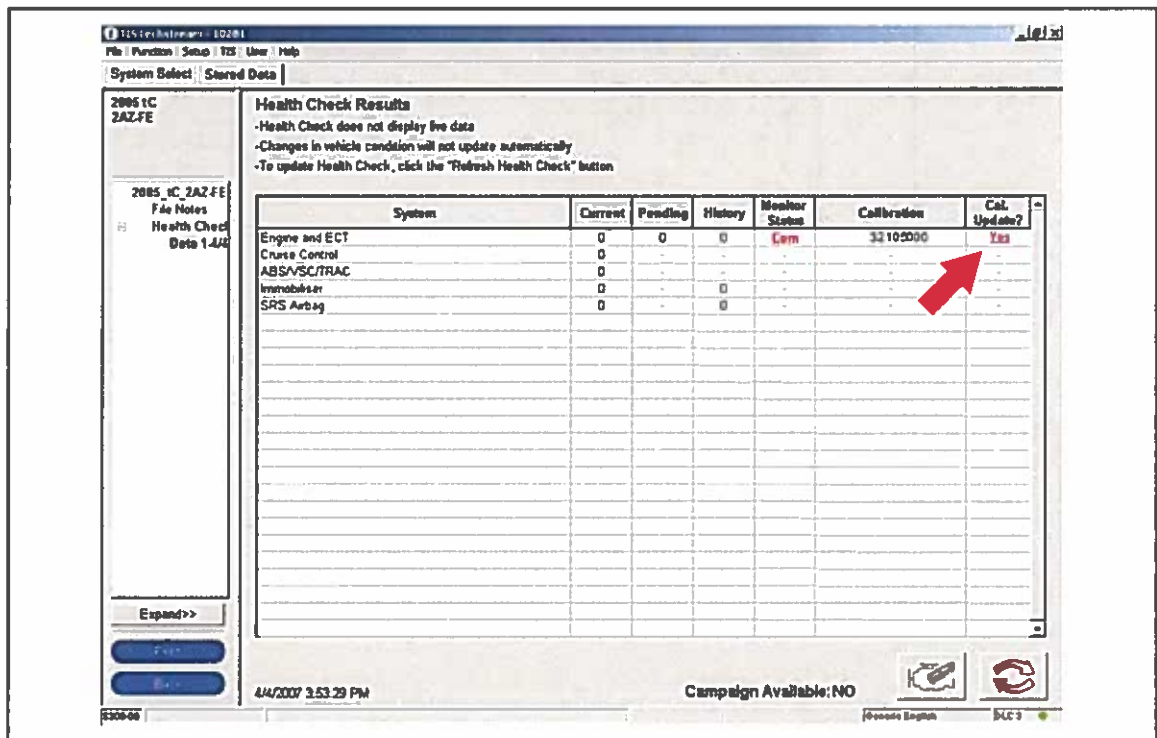
Figure 5.

- F. Available calibration updates are indicated by a **Yes** link in the *Cal. Update?* column. Click the **Yes** link to access the appropriate Service Bulletin on TIS.

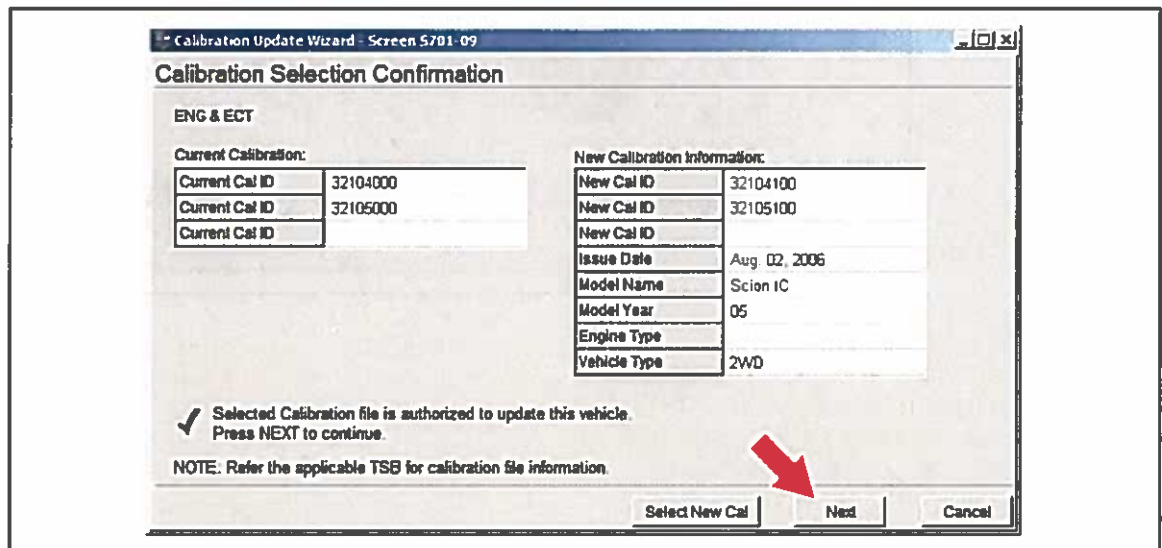
Figure 14.

- The total number of calibration IDs in the calibration file corresponds to the number of reprogrammable processors in the ECU.
- Each calibration file may contain up to three separate calibrations.
- Figure 14 shows an example of the update procedure for a two-processor ECU.

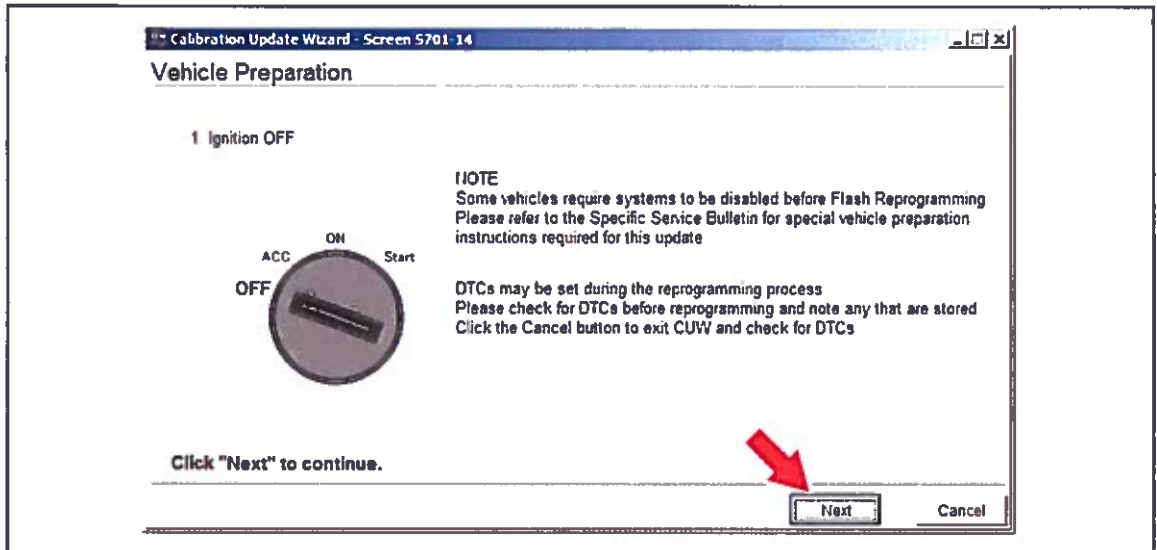
Figure 15.

G. Turn ignition OFF. Then click *Next*.

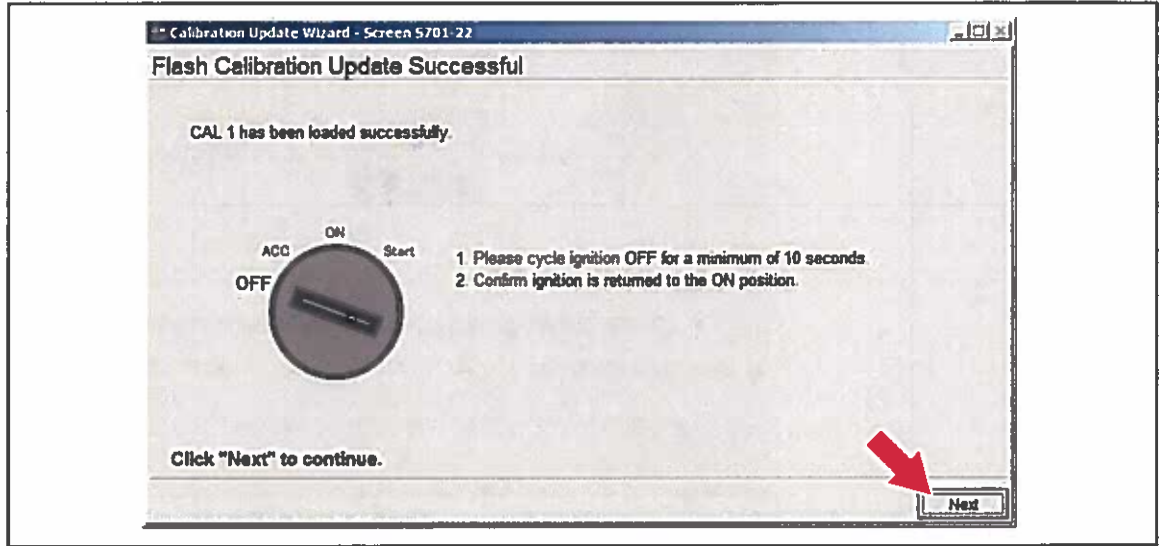
Figure 18.

- J. When Cal 1 has completed the update process, turn ignition OFF for a minimum of 10 seconds. Then click *Next*.

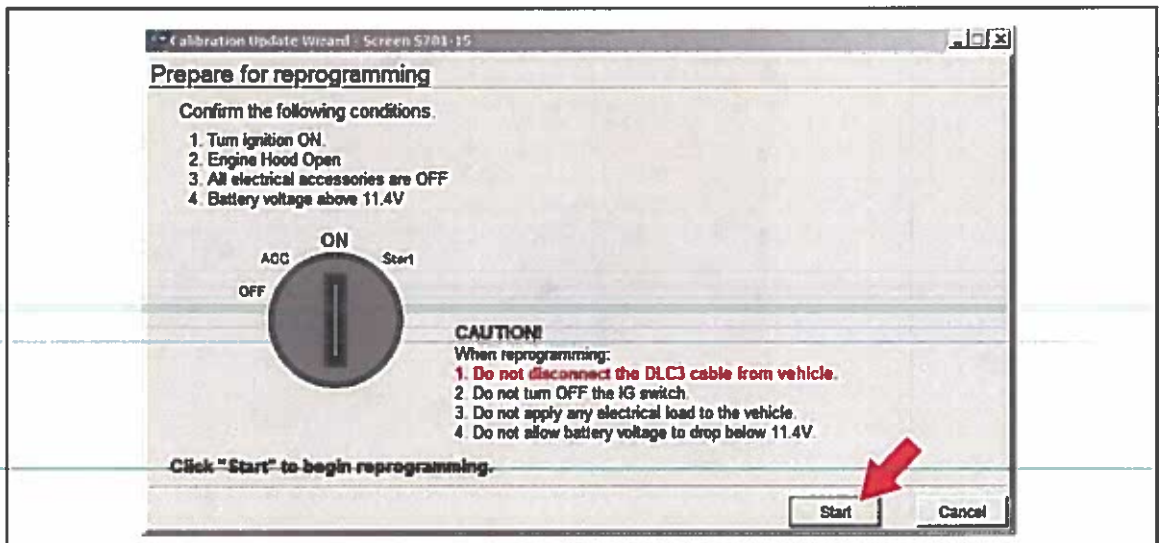
Figure 19.

- K. Turn ignition to the ON position. Then click *Start*.

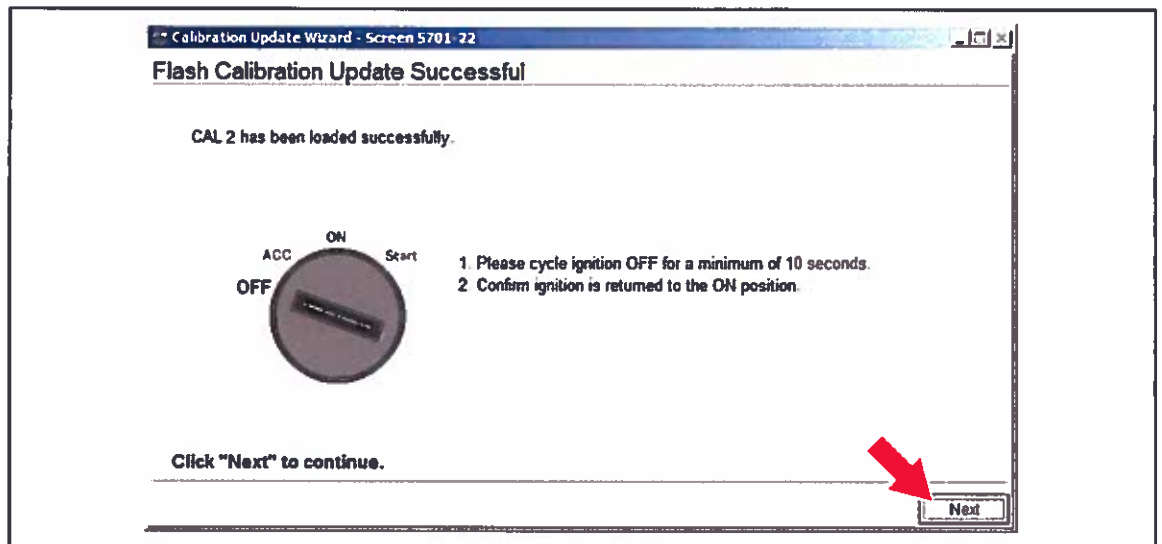
Figure 21.

- M. Turn ignition OFF for a minimum of 10 seconds. Then click *Next*.
