# Radio Screen Brightness Difference Between Modes

**Service Category** Audio/Visual/Telematics

| YEAR(S) | MODEL(S) | ADDITIONAL INFORMATION |
| 2013 | RAV4 | |

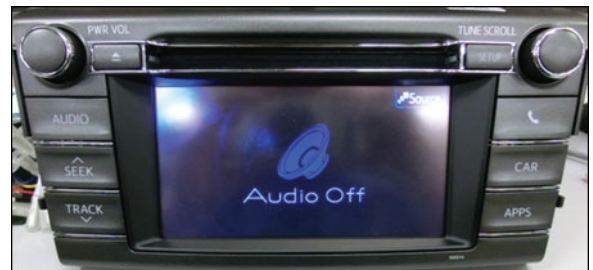
**Figure 2.**

3. Ensure that the audio function is turned OFF and that the screen reads "Audio Off."

The screen name and image may differ due to the language setting and/or the last mode used in Display Audio.

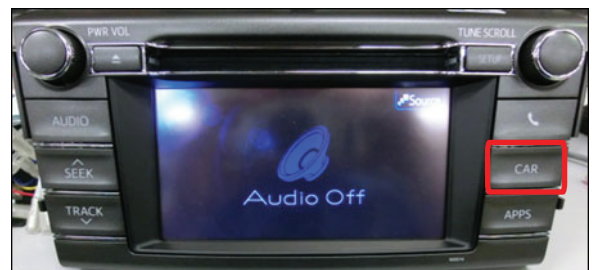
**Figure 3.**

4. Press and hold the CAR button.
