**NUMBER:** 08-026-14

**GROUP:** Electrical

Flash: RK4 RM4 RL4 UCONNECT 8.4N AM/FM/BT/NAV

This bulletin provides software to fix the following issues:

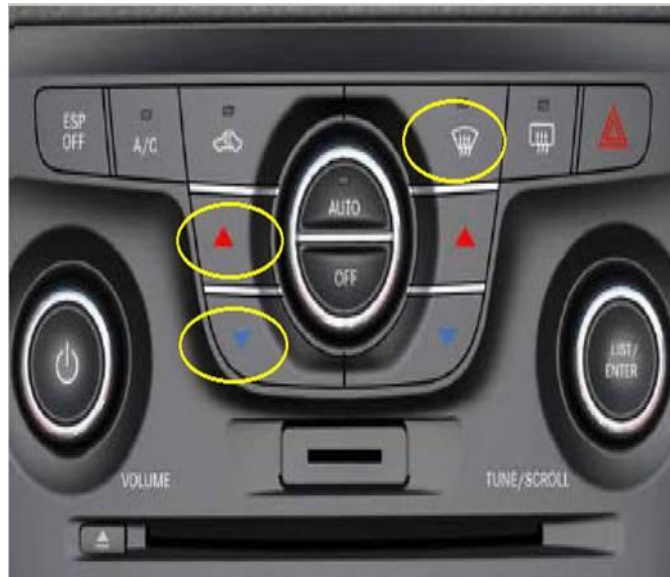
**Fig. 1 China, Japan, S.Korea Radio**

1. With the vehicle in park and parking brake on, start the engine.
2. Obtain the Radio Part Info in the Dealer Mode to determine this re-flash is applicable.
3. Press the Driver’s Temperature Up and Down, and Front Defrost buttons on the center bezel simultaneously and hold them for 5 seconds (Fig. 1).

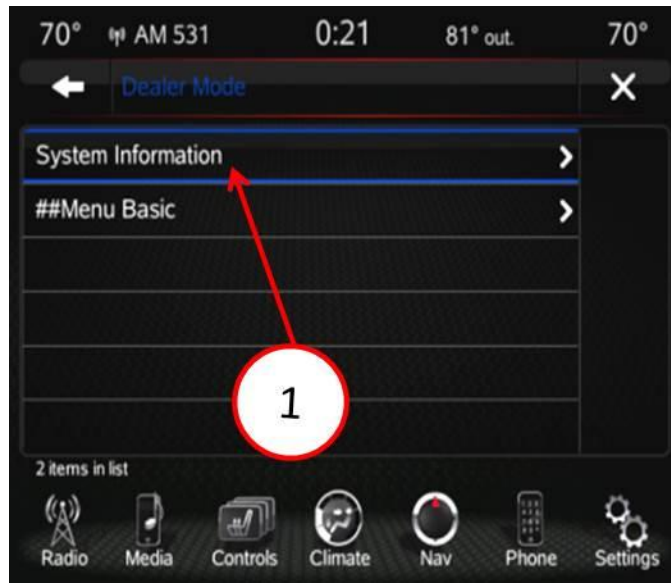
**Fig. 2 China, Japan, S.Korea Radio**

4. Select “System Information” (Fig. 2).

1 - System Information

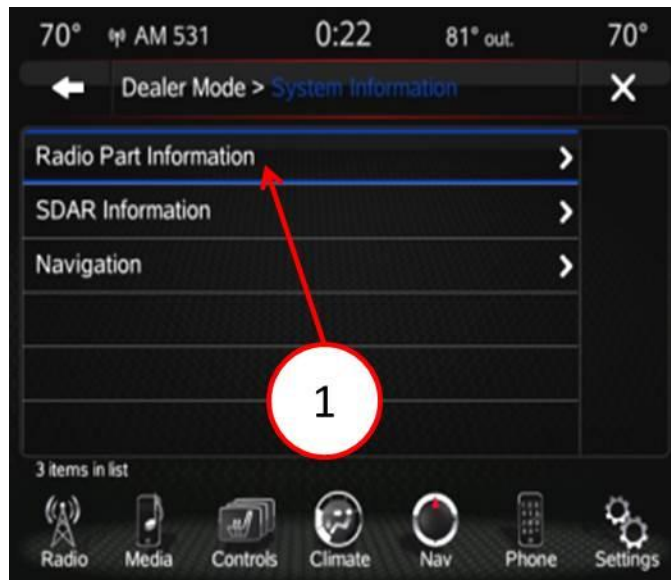
**Fig. 3 China, Japan, S.Korea Radio**

5. Select "Radio Part Information" from the Menu as shown in (Fig. 3).

1 - Radio Part Information

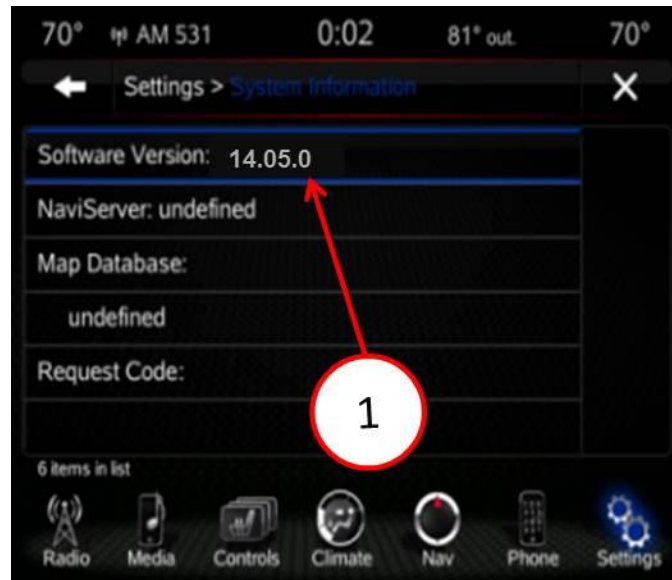
**Fig. 7 China Radio**

19. Proceed to [Step #11](#).
20. Verify the software application level has been updated in the Settings Menu under "System Information" as shown in ([Fig. 7](#)).

1 - Software Version

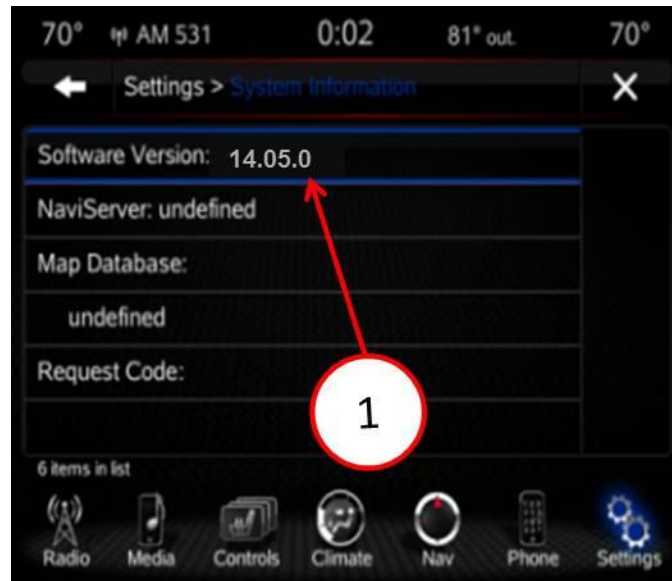
**Fig. 16 Japan Radio**

- 45. Select “NO” to return to user screen ([Fig. 15](#)).
- 46. Unplug the USB drive from the vehicle port.
- 47. Has it taken more than 20 minutes for screen to appear?
  - a. Yes >>>> Proceed to [Step #48](#).
  - b. No >>> Proceed to [Step #50](#).
- 48. Cycle the ignition off and wait 30 seconds.
- 49. Proceed to [Step #41](#).
- 50. Verify the software application level has been updated in the Settings Menu under “System Information” as shown in ([Fig. 16](#)).

1 - Software Version
