# Service Bulletin

Bulletin No.: PI1238

## PRELIMINARY INFORMATION

**Subject:** No XM on Start-Up when Manually Tuned and/or Using Voice Recognition, No Radio Wake-Up

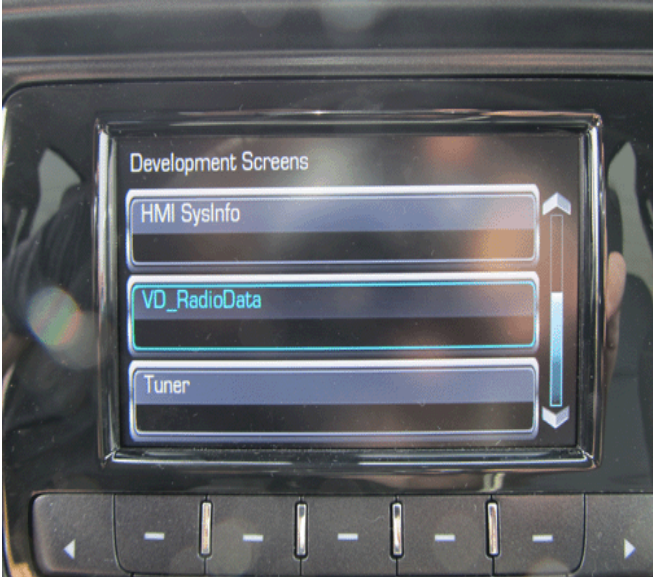
3826672

1. Press the button combination shown in the table above.

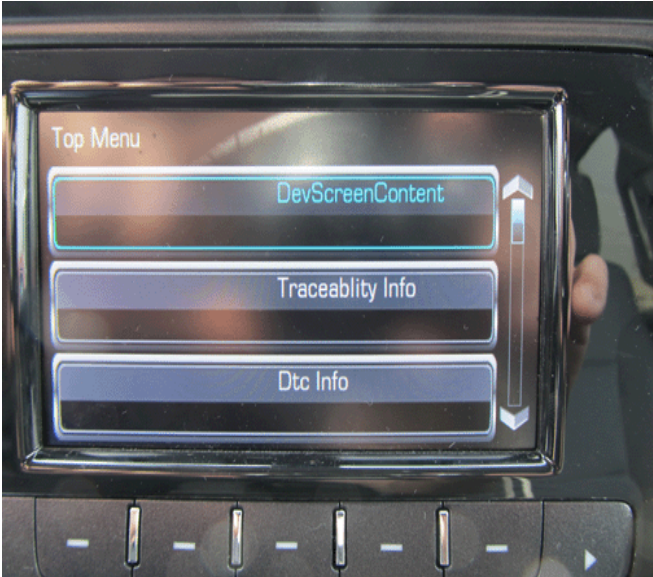
3826675

2. Select "Tuner."

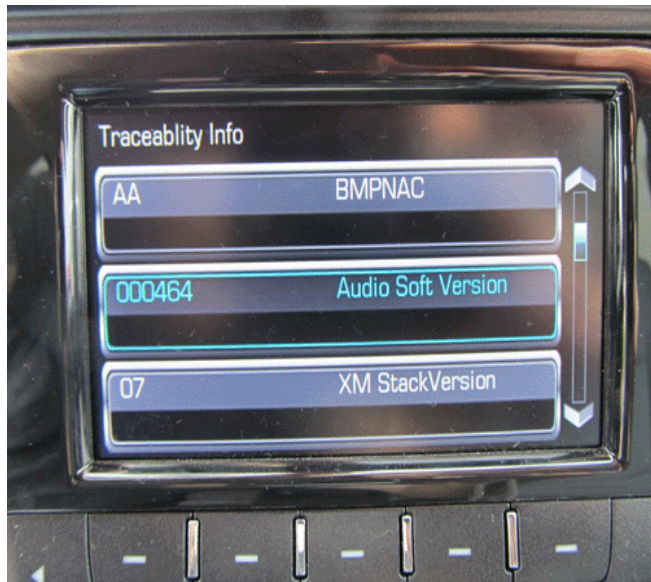
3826680

3. Select "Traceability Info."

4. Scroll down to "Audio Soft Version."

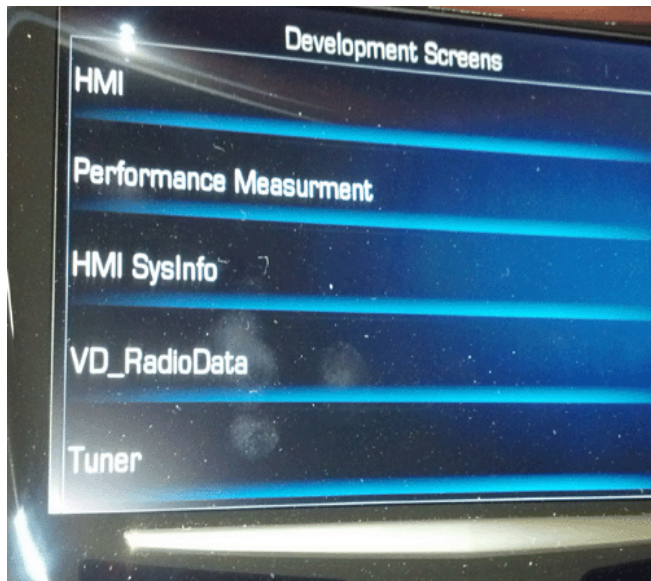
3825875

**IO4, IO5, IO6 (Escalade shown for reference)**

1. Press the button combination shown in the table above.

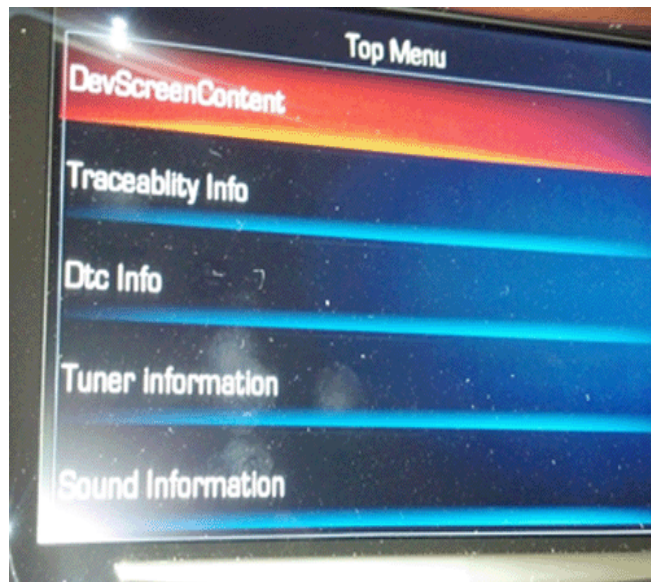
3825876

2. Select "Tuner."
