# Service Bulletin

Bulletin No.: PI1238A

**Subject:** No XM on Start-Up when Manually Tuned and/or Using Voice Recognition, No Radio Wake-Up

**Models:** 2014 Buick LaCrosse, Regal  
2013-2014 Cadillac ATS, SRX, XTS  
2014 Cadillac CTS Sedan (VIN A), ELR  
2015 Cadillac Escalade Models  
2014 Chevrolet Corvette, Impala, Silverado 1500  
2015 Chevrolet Silverado 2500/3500, Suburban, Tahoe  
2014 GMC Sierra 1500  
2015 GMC Sierra 2500/3500, Yukon Models  
Equipped with RPOs IO3, IO4, IO5, IO6 or (RAO -UA3) (ATS Base Radio)

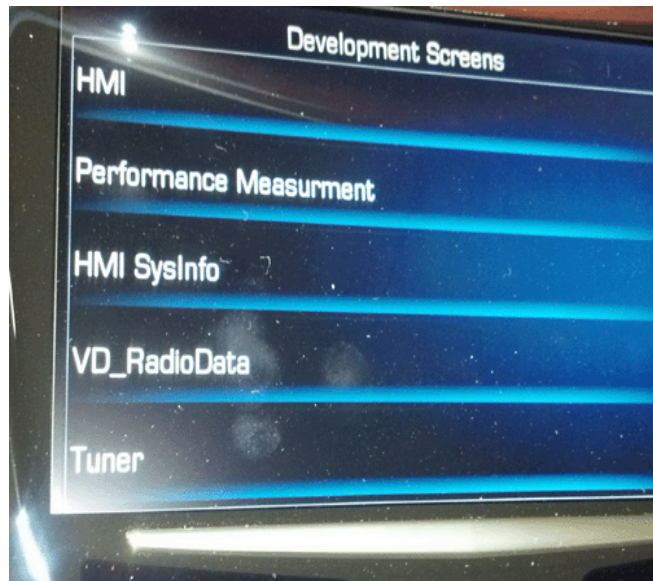
3825875

1. Press the button combination shown in the table above.

**IO4, IO5, IO6 (Escalade shown for reference)**
