NUMBER: 08-080-14

RA3 RA4 Radio Update To Improve Back Up Camera Display, Remote Audio Device Distortion, And WiFi Connectivity

2015 (UF) 200

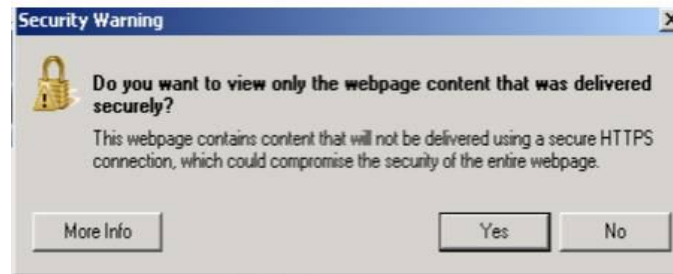
- b. No >>> Proceed to [Step #2](#).
2. Go to DealerCONNECT> Service> UCONNECT Information & Utilities> Uconnect Dealer software downloads to download the files.
3. If a security message appears “Do you want to view only the webpage content that was delivered securely?” see ([Fig. 1](#)). Press **No** to continue.

Fig. 1 Pop-up Security Message
