**Service Action: Program Control Units (OBD)**

I12 (i8)

If certain faults are stored, the OBD “freeze frame” data is not properly stored.

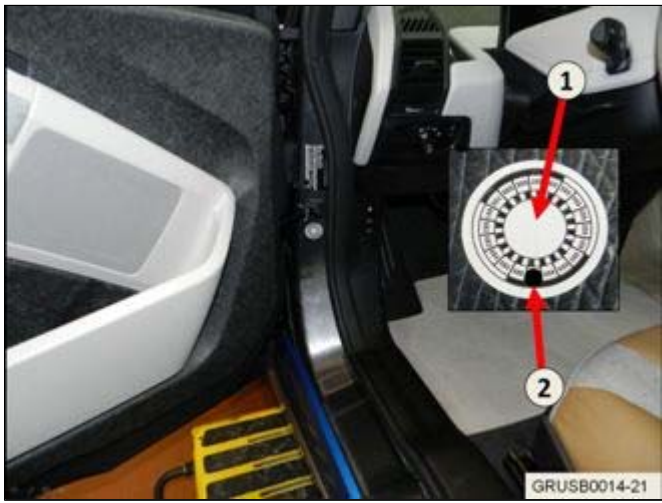
This Service Action has been assigned code number **702**. After the vehicle has been checked and/or corrected, obtain a label (SD 92-453) and:

- A. Emboss your BMW center

warranty number in the middle of the label (1);

- B. Punch out code number **702** (2), printed on the label; and
- C. Affix the label to the A-pillar as shown.

First check if a Service Action label with a code number **702** is already attached to the A-pillar.
