Service Action: Customer Care Package Software Update

I01 (i3 and i3 REx)

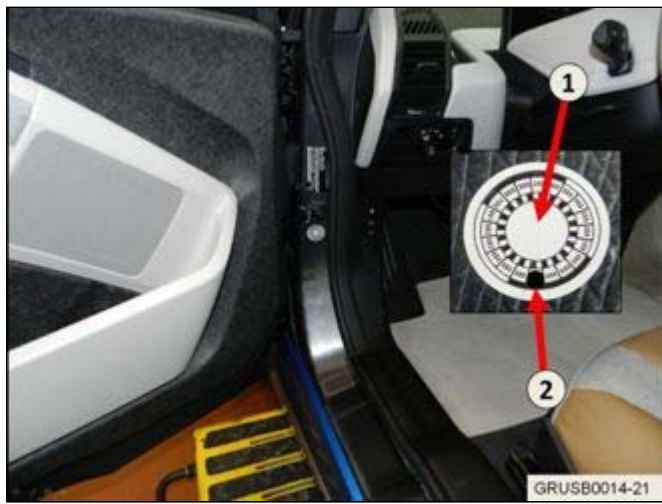
LABEL INSTRUCTIONS

This Service Action has been assigned code number **693**. After the vehicle has been checked and/or corrected, obtain a label (SD 92-439) and:

- A. Emboss your BMW center warranty number in the middle of the label (1);
- B. Punch out code number **693** (2), printed on the label; and
- C. Affix the label to the A-pillar as shown.

First check if a Service Action label with a code number **693** is already attached to the A-pillar.

If a code number **693** has been punched out, the Campaign has already been performed and no further action is necessary.
