Service Action: Program Control Units (Dynamic Stability Control [DSC] OBD error)

F15 (X5)

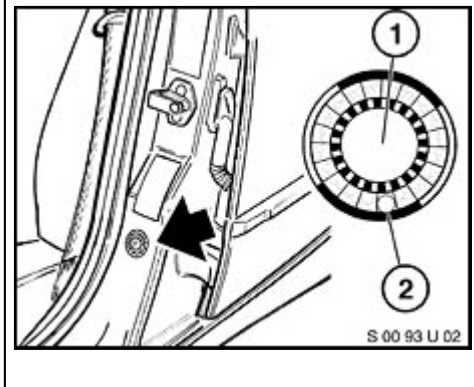
LABEL INSTRUCTIONS

<p>This Service Action has been assigned code number 683. After the vehicle has been checked and/or corrected, obtain a label (SD 92-439) and:</p> <ol style="list-style-type: none"> Emboss your BMW center warranty number in the middle of the label (1); Punch out code number 683 (2), printed on the label; and Affix the label to the B-pillar as shown.
--	--

First check if a Service Action label with a code number **683** is already attached to the B-pillar.

If a code number **683** has been punched out, the Campaign has already been performed and no further action is necessary.

If the vehicle already has a label from a previous Service Action/Recall Campaign, affix the new label next to the old one. Do not affix one label on top of another one because a number from an underlying label could appear in the punched-out hole of the new label.
