**Service Action: Check Underbody Panel**

I12 (i8)

Produced from May 16, 2014 to October 2, 2014

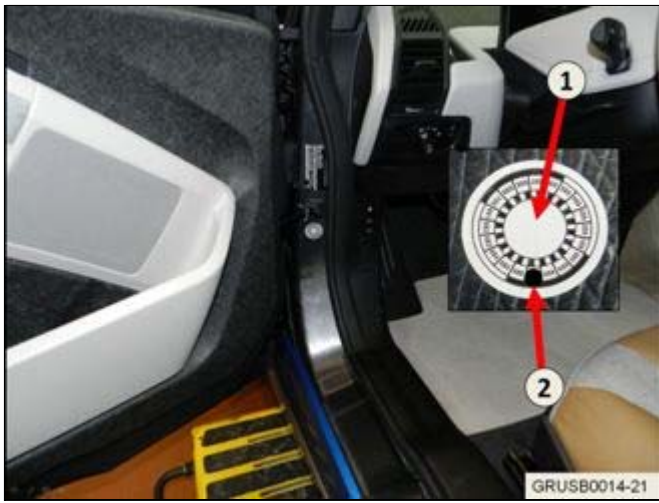
code number **718**. After the vehicle has been checked and/or corrected, obtain a label (SD 92-453) and:

- A. Emboss your BMW center warranty number in the middle of the label (1);
- B. Punch out code number **718** (2), printed on the label; and
- C. Affix the label to the A-pillar as shown.
