Service Action: Replace Oil Filter Housing Assembly

F56 (Cooper)

F56 (Cooper S)

A coolant leak could occur at the oil filter housing, resulting in overheating, loss of power and an engine warning light.

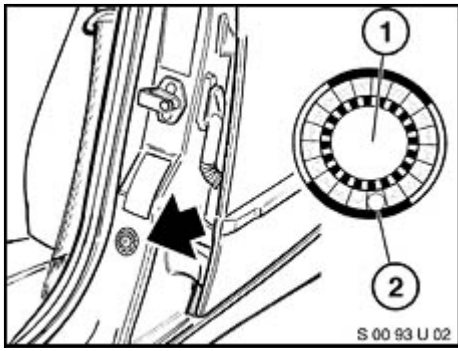
LABEL INSTRUCTIONS

This Service Action has been assigned code number **74**. After the vehicle has been checked and/or corrected, obtain a label (MD20-064) and:

- A. Emboss your MINI dealer warranty number in the middle of the label (1);
- B. Punch out code number **74** (2), printed on the label; and
- C. Affix the label to the B-pillar as shown.
