Service Action: Bluetooth Software (KISU Data) Update

MODEL

R55 (Cooper Clubman, Cooper S Clubman)

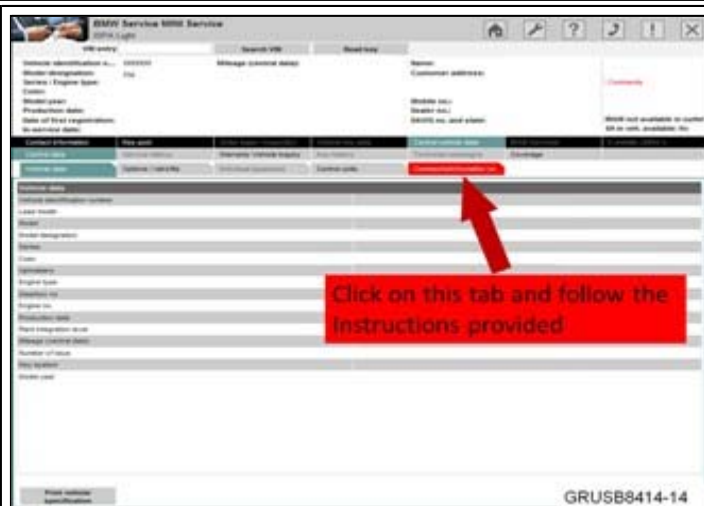
- This picture shows the “Comment Information” tab in ISPA Light highlighted.
- Open and follow the instructions.

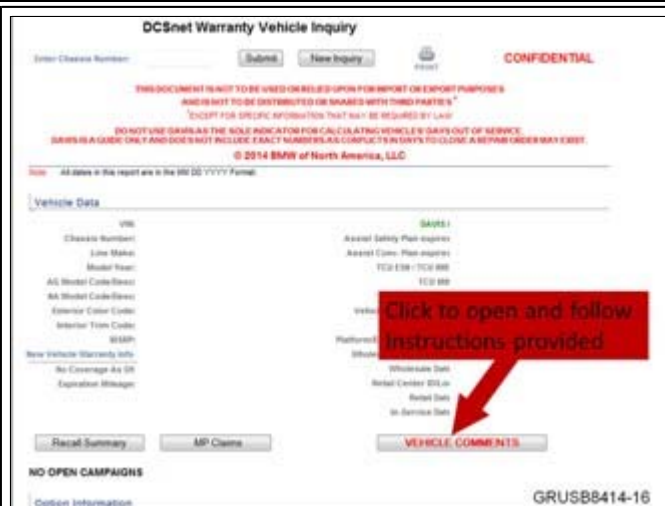
- This picture shows the “Vehicle Comments” tab in the DCS vehicle history highlighted.
- Open and follow the instructions.
