Service Action: Replace Fuel Tank Supply Unit

I12 (i8)

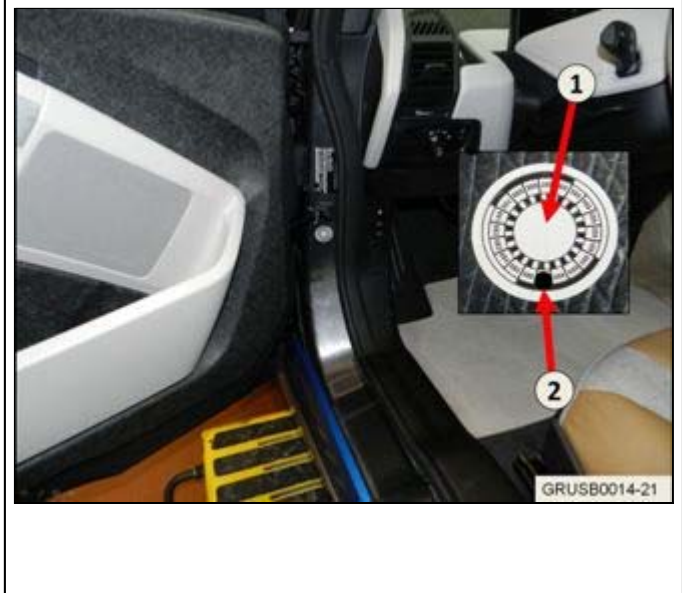
LABEL INSTRUCTIONS

<p>This Service Action has been assigned code number 713. After the vehicle has been checked and/or corrected, obtain a label (SD 92-453) and:</p> <ol style="list-style-type: none"> Emboss your BMW center warranty number in the middle of the label (1); Punch out code number 713 (2), printed on the label; and Affix the label to the B-pillar as shown.
---	--

If the vehicle already has a label from a previous Service Action/Recall Campaign, affix the new label next to the old one. Do not affix one label on top of another one because a number from an underlying label could appear in the punched-out hole of the new label.
