**NEW** Electro-Hydraulic Power-Assist Steering Pump (EHPS) and Cooling Fan: Limited Warranty Extension to 13 Years/150,000 Miles

**NEW** R50 (Cooper Hardtop)

**NEW** R52 (Cooper, Cooper S Convertible)

**NEW** R53 (Cooper S, JCW Hardtop)

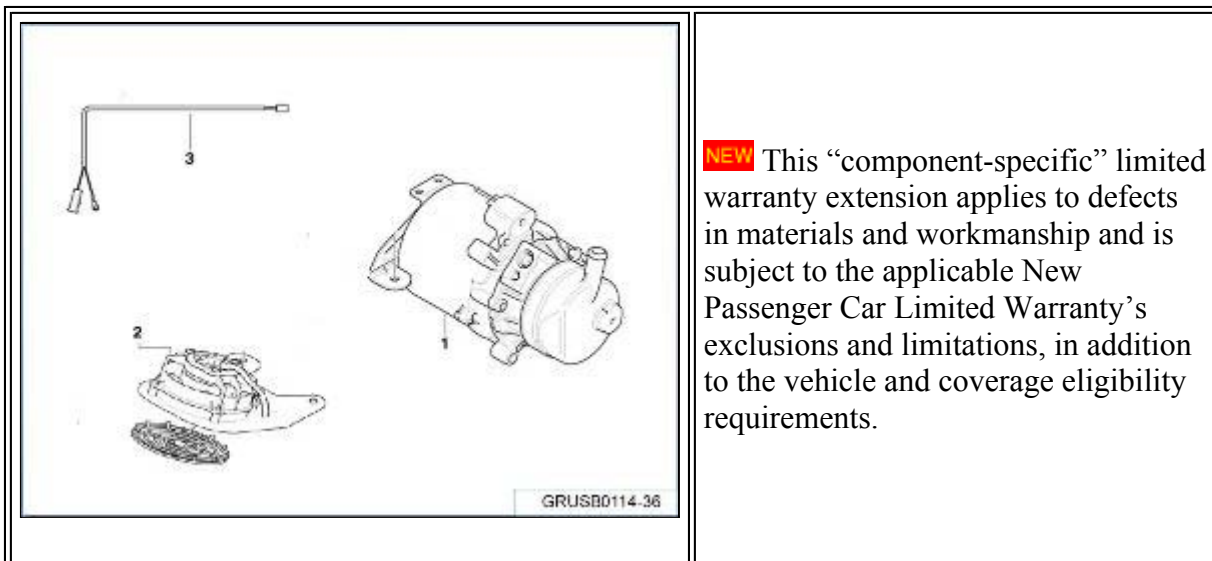
1. **NEW** Power steering pump (EHPS),
2. **NEW** Cooling fan, and its
3. **NEW** Auxiliary wiring harness
