Service Action: Program Control Units (Fuel Pressure Sensor)

F02H (ActiveHybrid 7)

F10H ActiveHybrid 5)

F30H (ActiveHybrid 3)

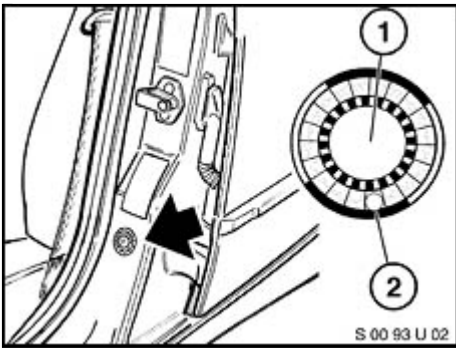
This Service Action has been assigned code number **708**. After the vehicle has been checked and/or corrected, obtain a label (SD 92-453) and:

- A. Emboss your BMW center warranty number in the middle of the label (1);

- B. Punch out code number **708** (2), printed on the label; and
- C. Affix the label to the B-pillar as shown.

If the vehicle already has a label from a previous Campaign, affix the new label next to the old one. Do not affix one label on top of another one because a number from an underlying label could appear in the punched-out hole of the new label.
