SERVICE BULLETIN

EC13-008b

SENTRA; INTERMITTENT LOW ENGINE RPM AT IDLE OR STOPS RUNNING COMING TO A STOP

APPLIED VEHICLE: 2013 and 2014 Sentra (B17)

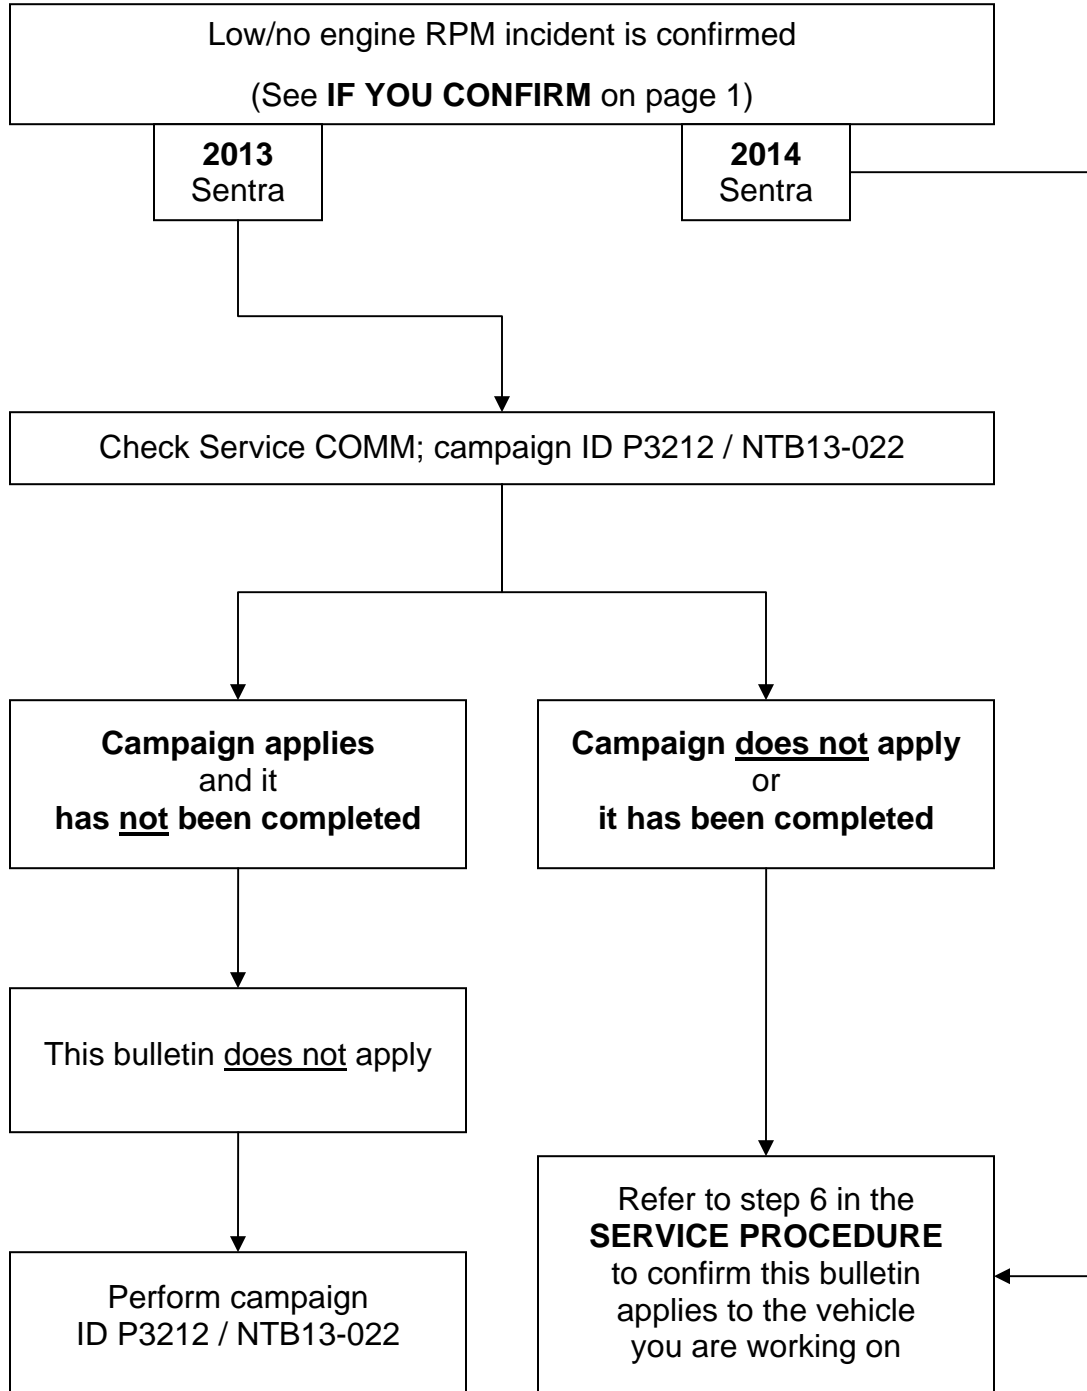
Repair Overview

1. Refer to the **Repair Overview** on page 2 to determine if this bulletin applies.

NOTE: On certain specific 2013 Sentra vehicles campaign ID P3212 / NTB13-022 may apply. Make sure to use the **Repair Overview** to determine if the campaign bulletin or this bulletin applies, or neither apply.

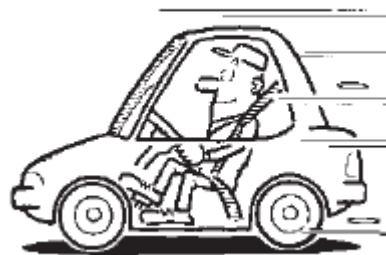
Figure A

- Most instructions for reprogramming with CONSULT-III plus (C-III plus) are displayed on the CONSULT PC screen.
- If you are not familiar with the reprogramming procedure, [click here](#). This will link you to the "CONSULT- III plus (C-III plus) Reprogramming" general procedure.
- Take the vehicle for a 10 minute drive in order to meet the following Idle Air Volume Learn (IAVL) conditions:
 - Engine coolant temperature: 70 -100°C (158 -212°F)
 - Battery voltage: More than 12.9V (At idle)
 - Transmission: Warmed up

- Connect the GR8 to the vehicle 12 volt battery and set to ECM power supply mode. If the vehicle battery voltage drops below 12.0V or rises above 13.5V during reprogramming, the ECM may be damaged.
- Be sure to turn OFF all vehicle electrical loads. If a vehicle electrical load remains ON, the ECM may be damaged.
- Be sure to connect the AC Adapter. If the CONSULT PC battery voltage drops during reprogramming, the process will be interrupted and the ECM may be damaged.
- Turn off all external Bluetooth® devices (e.g., cell phones, printers, etc.) within range of the CONSULT PC and the VI. If Bluetooth® signal waves are within range of the CONSULT PC during reprogramming, reprogramming may be interrupted and the ECM may be damaged.

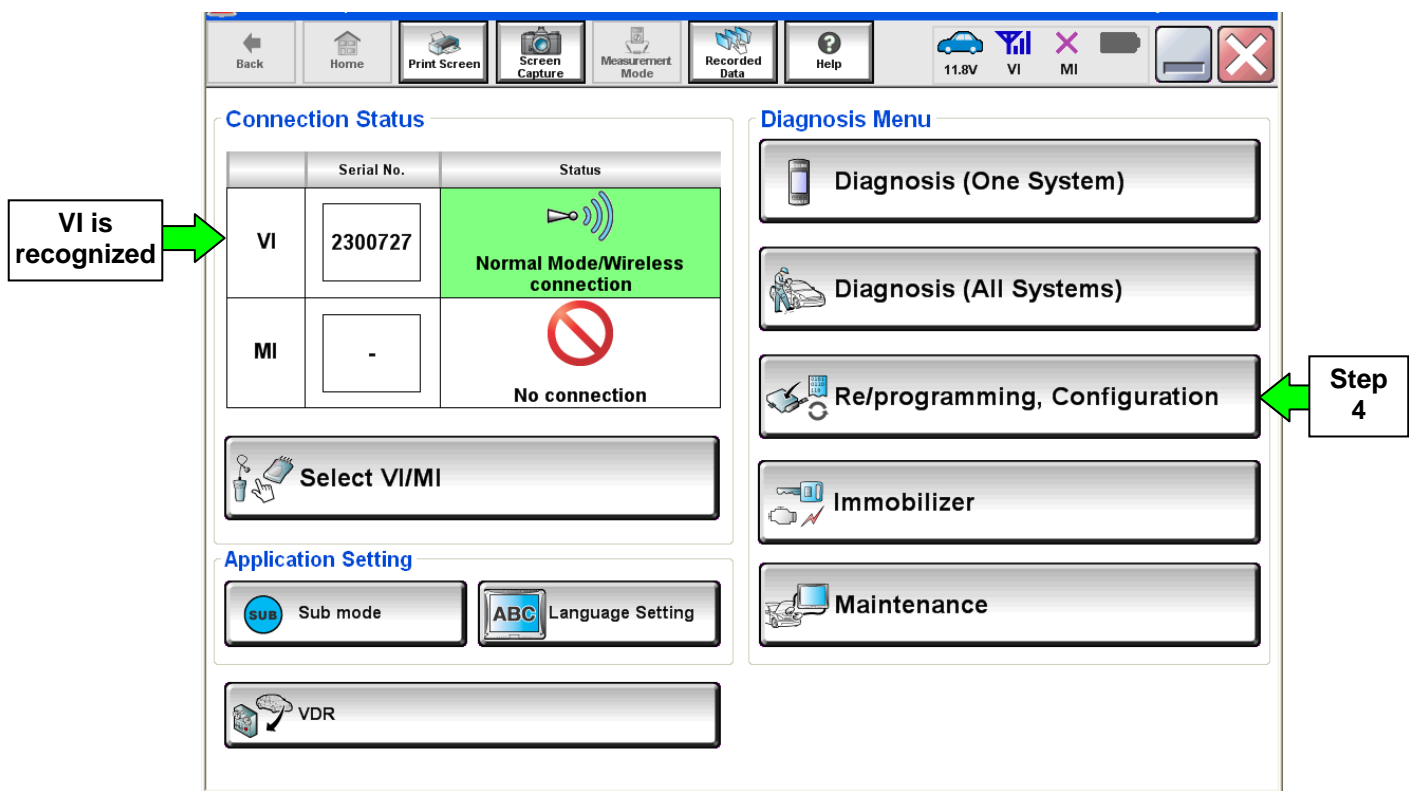
Figure 1

1. Connect the CONSULT PC to the vehicle to begin the reprogramming procedure.
2. Open C-III plus.
3. Wait for the plus VI to be recognized.
 - Serial number will display when the plus VI is recognized.
4. Select **Re/programming, Configuration**.

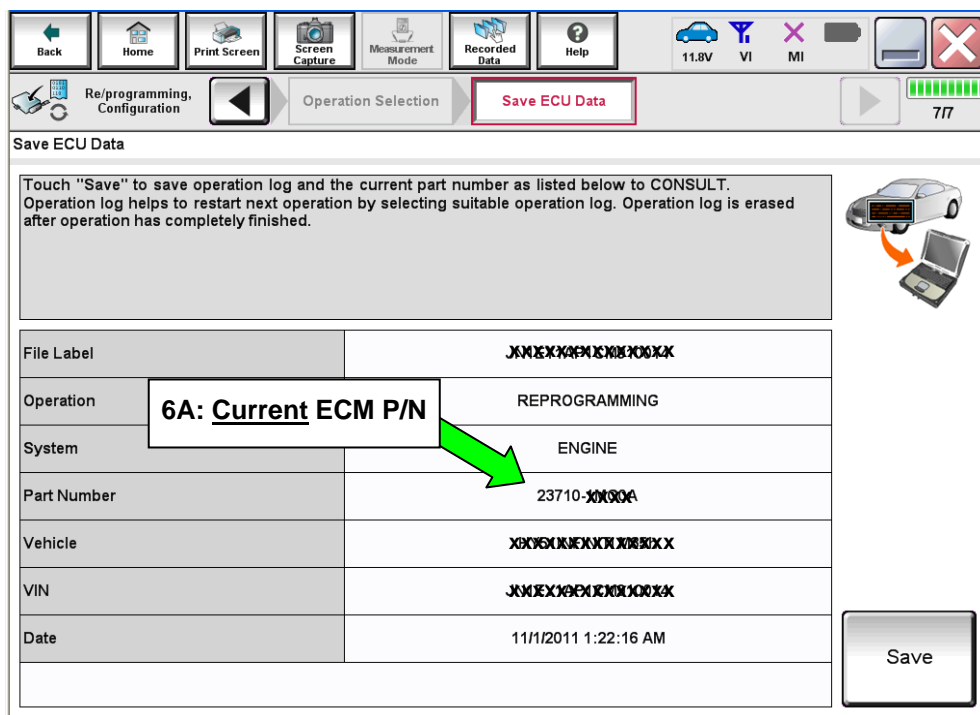
6. When you get to the screen shown in Figure 2, confirm this bulletin applies as follows.

A. Find the ECM **Part Number** and write it on the repair order.

NOTE: This is the current ECM Part Number (P/N).

5. Follow the on-screen instructions and navigate the C-III plus to the screen shown in Figure 2 on the next page.

B. Compare the P/N you wrote down to the numbers in the **Current ECM Part Number** column in **Table A** below.

- (1) Reference the Repair Order and use the current ECM P/N written down in step 6 of the Service Procedure as the PFP.
- (2) Reference the current Nissan Warranty Flat Rate Manual and use the indicated FRT.

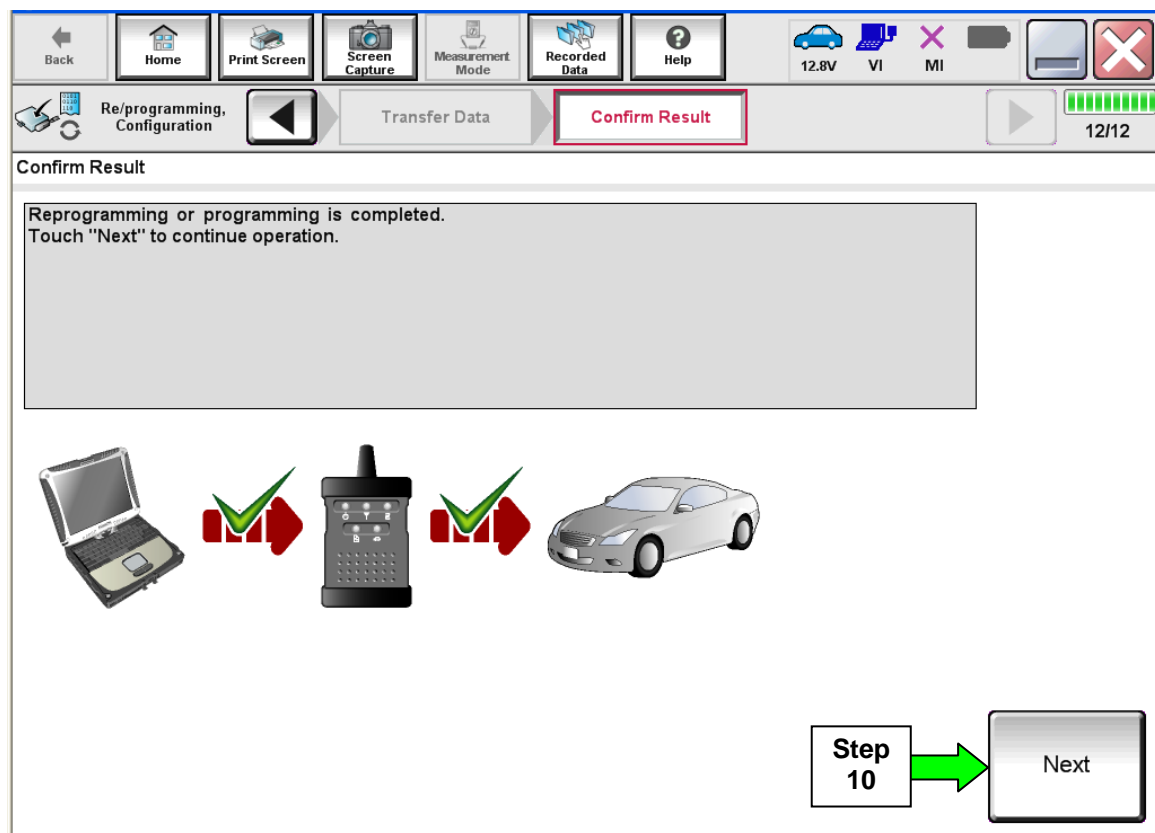
8. When the screen in Figure 4 displays, reprogramming is complete.

NOTE: If the screen in Figure 4 does not display (reprogramming does not complete), refer to the information on the next page.

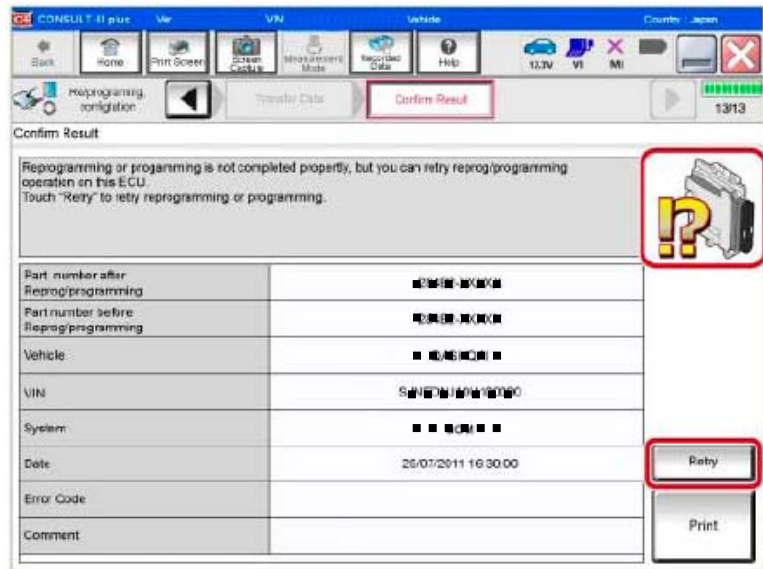
Figure 5

If reprogramming does not complete and the “!?” icon displays as shown in Figure 5:

- Check battery voltage (12.0–15.5 V).
- Ignition is ON, engine OFF.
- External Bluetooth® devices are OFF.
- All electrical loads are OFF.
- **Select retry and follow the on screen instructions.**
- “Retry” may not go through on first attempt and can be selected more than once.

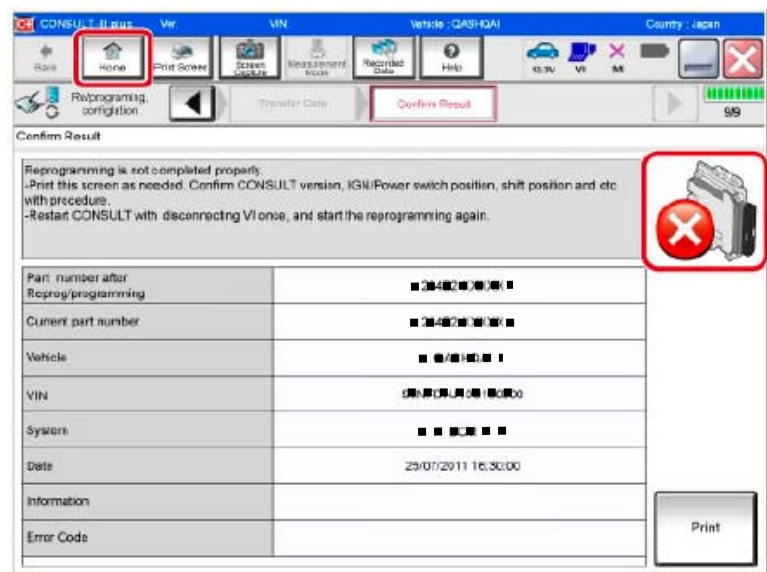
Figure 6

If reprogramming does not complete and the “X” icon displays as shown in Figure 6:

- Check battery voltage (12.0 – 15.5 V).
- CONSULT A/C adapter is plugged in.
- Ignition is ON, engine OFF.
- Transmission is in Park.
- All C-III plus / VI cables are securely connected.
- All C-III plus updates are installed.
- **Select Home, and restart the reprogram procedure from the beginning.**

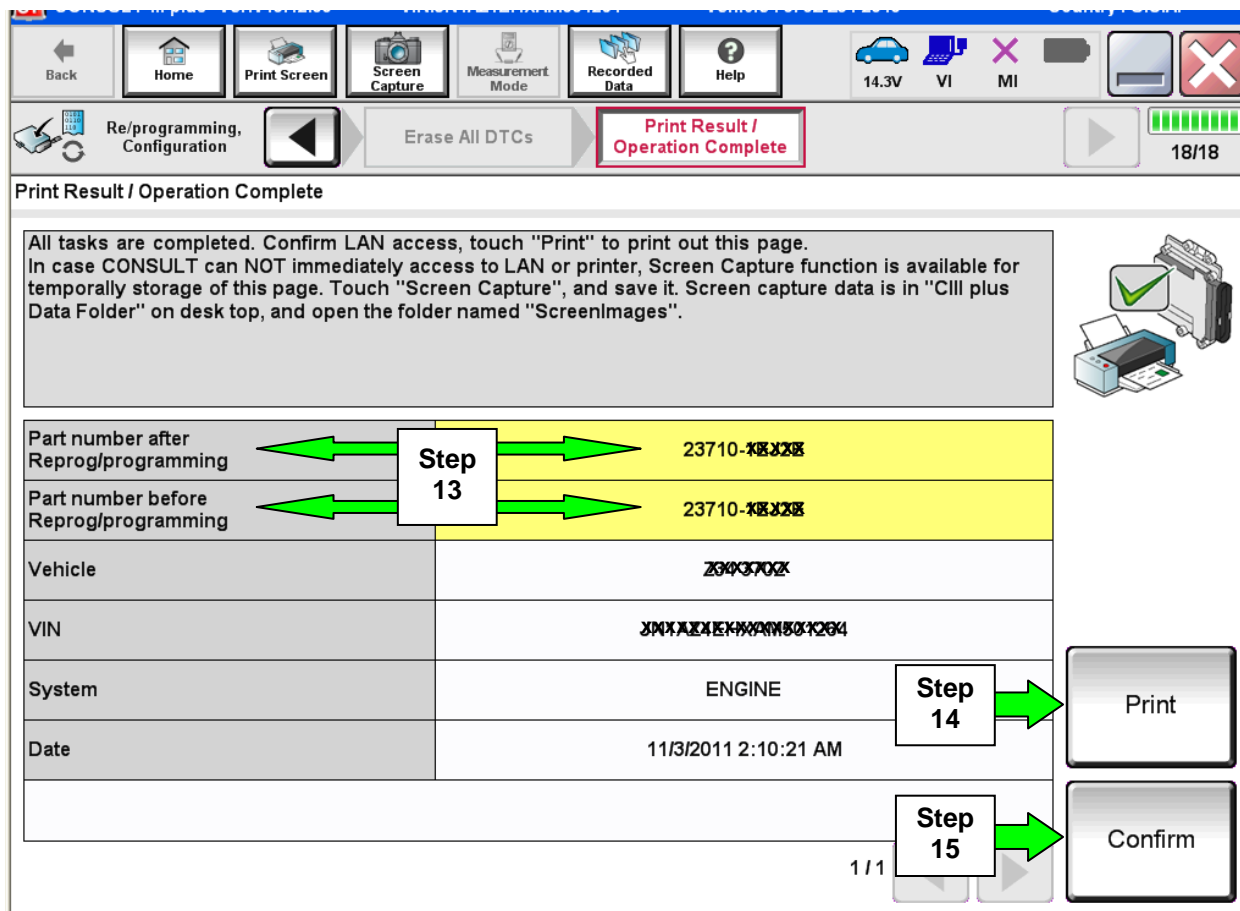
12. When the entire reprogramming process is complete, the screen in Figure 7 will display.
13. Verify the before and after part numbers are different.
14. Print a copy of this screen (Figure 7) and attach it to the repair order for warranty documentation.
15. Select **Confirm**.
