**NUMBER:** 08-059-14

**GROUP:** Electrical

Flash: RE2 RE6 RB5 RB6 Radio Software Enhancements

2014	(PF)	Dart
2013	(PF)	Dart

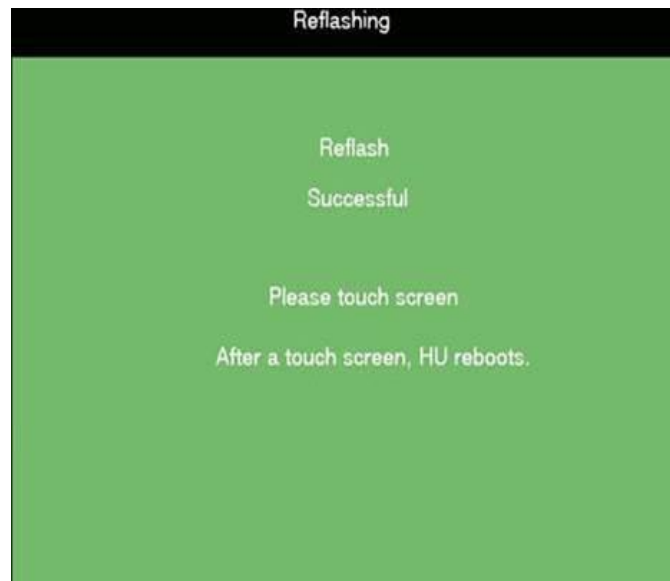
***Fig. 3 Touch Screen Instruction***

14. When the update is completed, the screen will read “Reflash Successful”. Remove the USB stick and touch the screen anywhere to initiate the radio to reboot. See (Fig. 3).

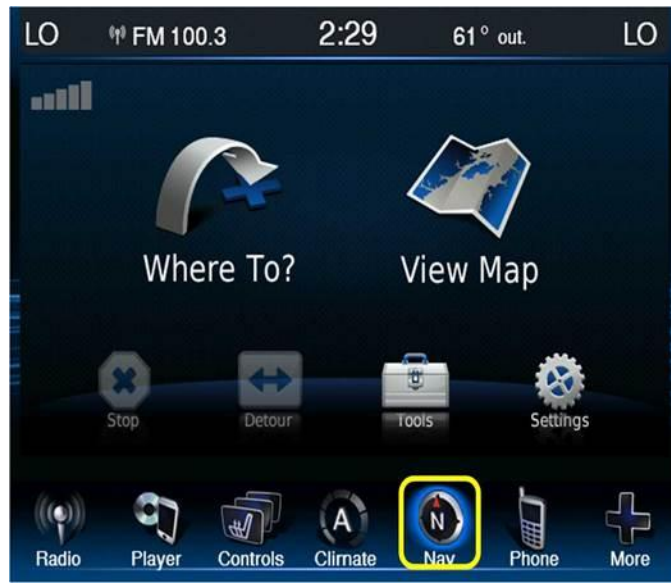
**Fig. 4 Nav Screen Icon**

18. Press the Nav icon on the radio screen to enter the navigation system main menu. See (Fig. 4).

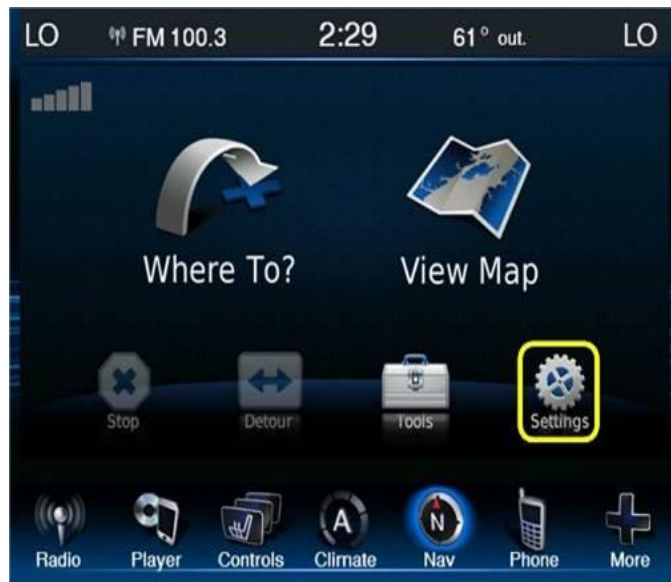
**Fig. 5 Settings Screen Icon**

19. Select the Settings Icon. See (Fig. 5)

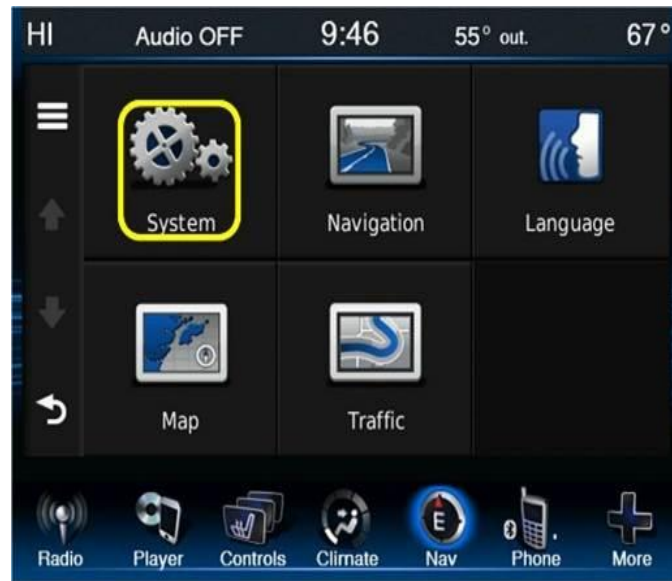
**Fig. 6 System Screen Icon**

20. Select the System Screen icon and then the About icon to display the Garmin System Information. See (Fig. 6) and (Fig. 7).
