NUMBER: 08-059-14 REV. A

GROUP: Electrical

Flash: RE2 RE6 RB5 RB6 Radio Software Enhancements

This bulletin involves updating the radio software.

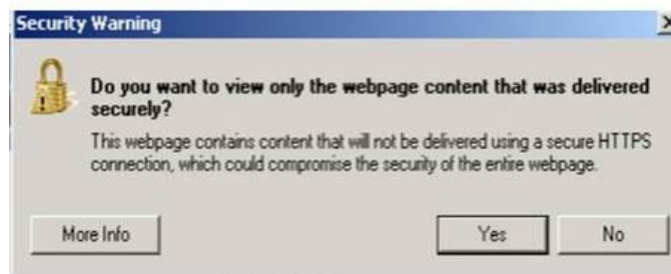
Fig. 1 Pop-up Security Message

1. Has a USB flash drive been created with the current software update?
 - a. Yes >>> Proceed to [Step #6](#).
 - b. No >>> Proceed to [Step #2](#).
2. Go to DealerCONNECT>Service>UCONNECT Information & Utilities> Uconnect Dealer software downloads to download the files.
3. If a security message appears “Do you want to view only the webpage content that was delivered securely?” See ([Fig. 1](#)). Press **No** to continue.

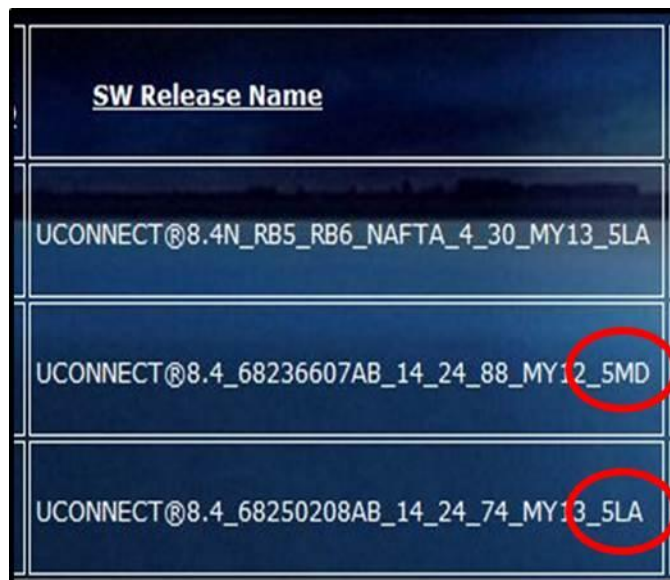
Fig. 2 Website Software Files

4. To download the software files to a USB flash drive, follow the on screen instructions and perform the following.
 - a. Acquire a blank USB flash drive with at least 4 gb of space.
 - b. Download the software update file to your local pc's desktop.
 - c. Be sure to extract the file before copying it to the blank USB flash drive.
 - d. A blank USB flash drive will be needed one for each radio update, additional updates can not be on the same USB stick.
 - e. Once the file is saved to the USB flash drive, it is recommended you physically label the USB flash drive with the bulletin number and radio sales codes.
5. **For 2013 Model Year Only.** You may have multiple choices available for the radio control head software. Please choose the correct software file based on your sales codes (5MD or 5LA) and label the USB flash drive accordingly. See (Fig. 2).

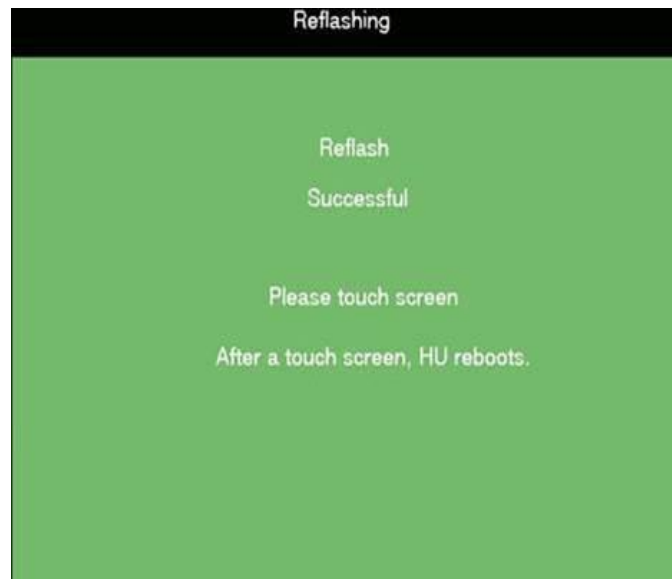
14. When the update is completed, the screen will read “Reflash Successful”. Remove the USB flash drive and touch the screen anywhere to initiate the radio to reboot. See (Fig. 3).

Fig. 3 Touch Screen Instruction

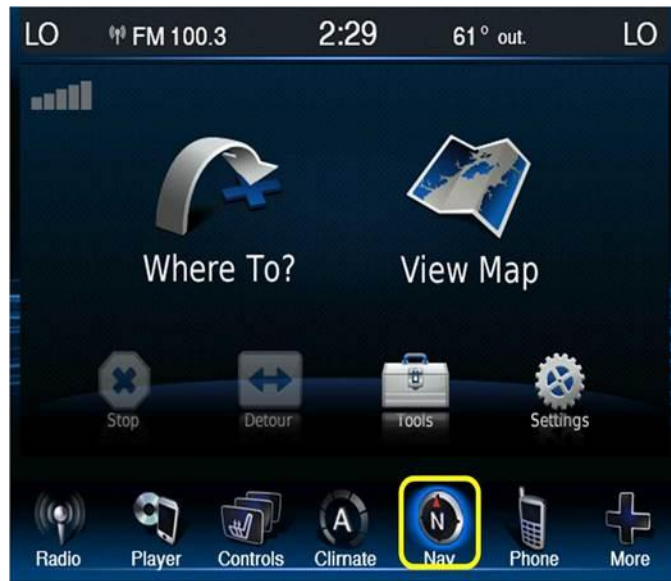
18. Press the Nav icon on the radio screen to enter the navigation system main menu. See (Fig. 4).

Fig. 4 Nav Screen Icon

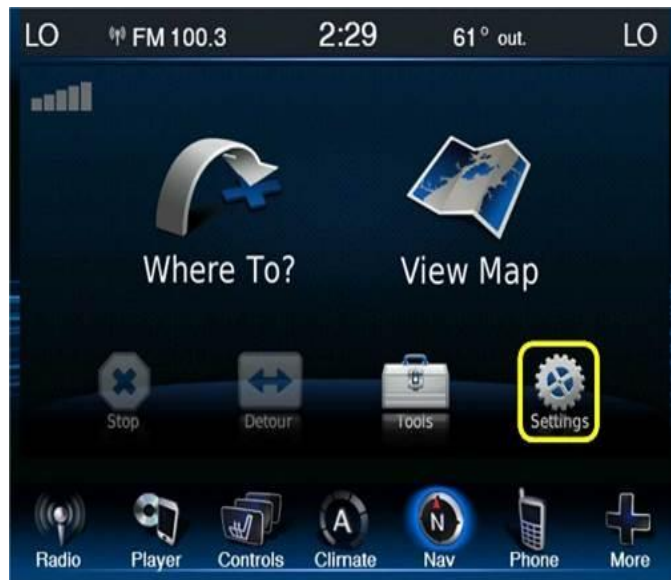
19. Select the Settings Icon. See (Fig. 5).

Fig. 5 Settings Screen Icon

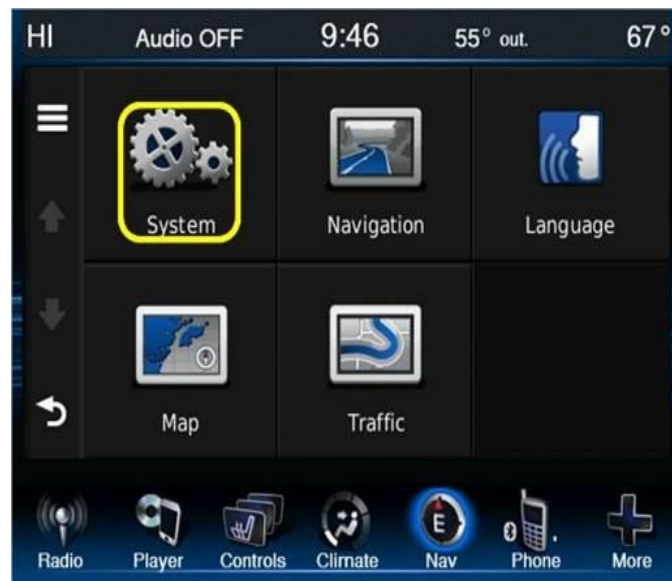
Fig. 6 System Screen Icon

20. Select the System Screen icon and then the About icon to display the Garmin System Information. See (Fig. 6) and (Fig. 7).

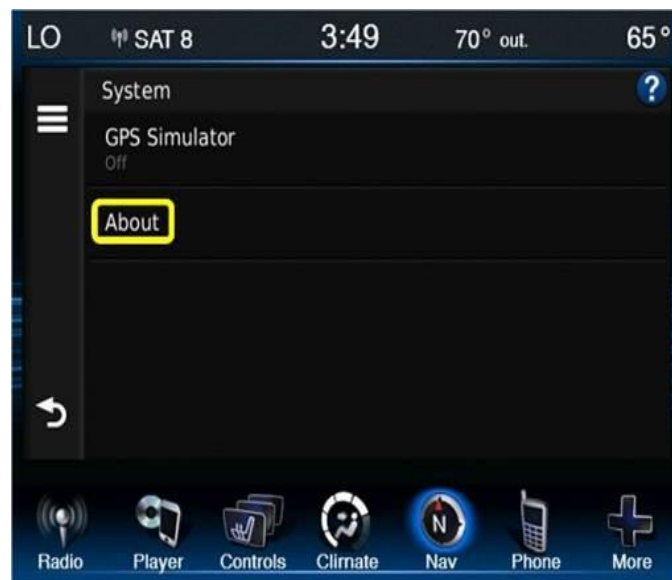
Fig. 7 About Screen Icon

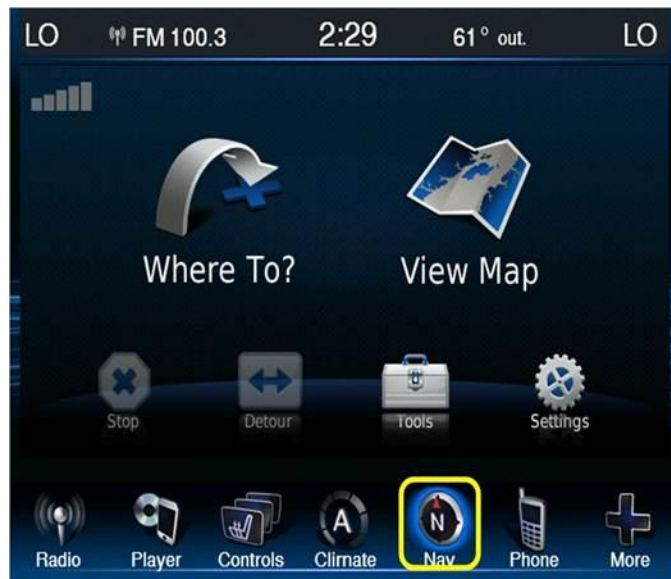
- 25. Once the software update has completed down loading, the screen will automatically change to the Garmin main screen. See (Fig. 9).

Fig. 9 Update Complete
