SERVICE BULLETIN

APPLICABILITY: 2013-14MY Legacy and Outback Models with
2.5L FB Engine

NUMBER: 02-157-14R

SUBJECT: Surface Treatment Change To Oil Control Piston Rings

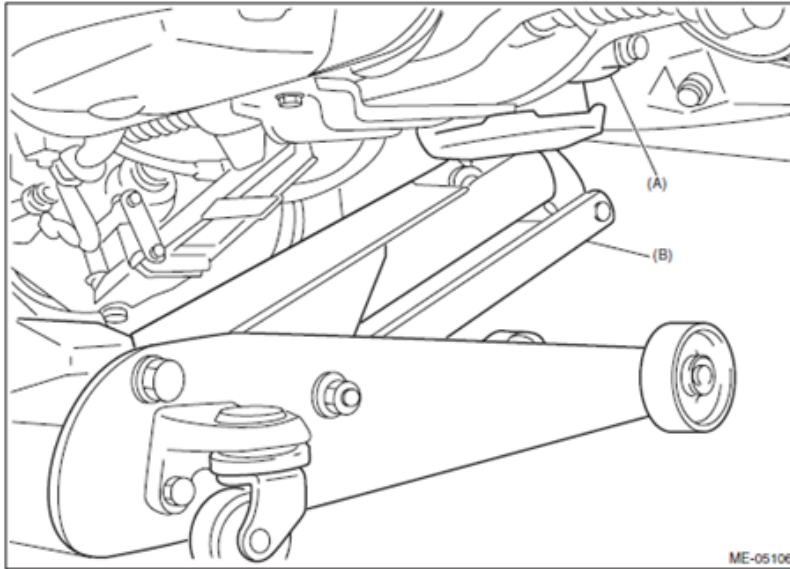
- When draining the engine oil, do not remove the engine oil filter. Leave the existing oil filter in place through engine disassembly, reassembly, installation and initial startup after engine reassembly.
- When removing the engine, there is no need to remove the transmission case cover (CVT only) or to disconnect / disturb any of the transmission harness connectors. While raising the transmission with the service jack placed under the front differential as shown in the illustration below, **only raise it enough to access and remove the engine mounting hardware**. Raising it too high can push the transmission up into the bulkhead / transmission tunnel and possibly cause damage.

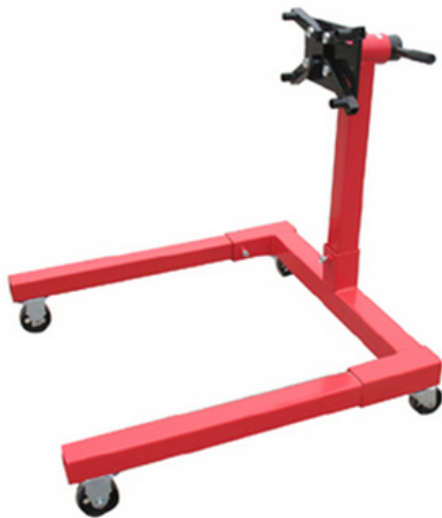
ME-05926

- Once the engine is removed, if you are using a generic engine stand (preferable since engine rotation is necessary), use the four mounting holes on the engine block shown below to mount it. **NOTE:** Do not use the mounting studs in the upper oil pan.

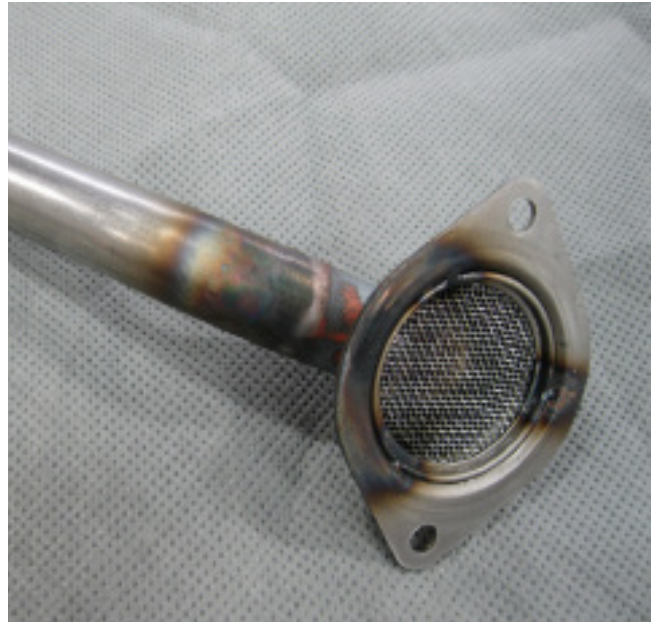
- Don't forget to clean (**without removing**) the filter screens in the cam carriers (one filter in each carrier). In addition, always be sure to do a thorough inspection and cleaning of the oil pan, pick-up tube and screen as shown in the photos below before reassembly.

Oil Pick Up Tube/Filter Screen Assembly

- Before installing the upper and lower oil pans, **always thoroughly clean and inspect the pick-up tube and screen.** Always use new o-rings on the pick-up tube and both oil pans during reassembly.

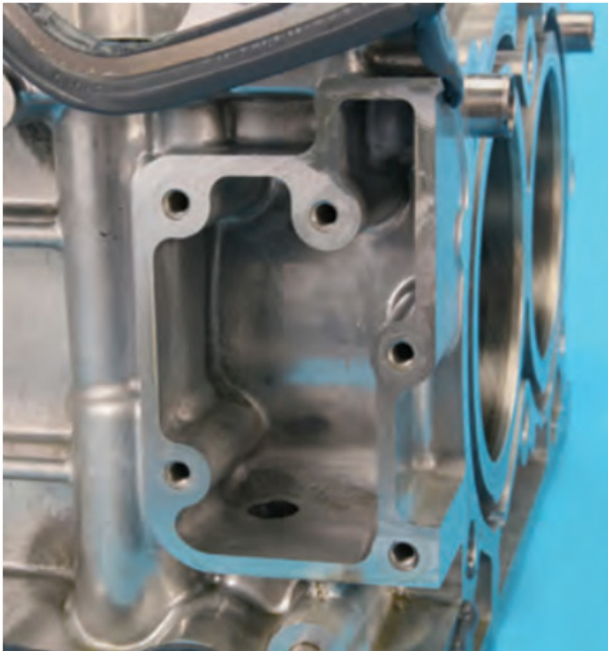
- Install the new **one-time use** PCV adapter. **NOTE:** Never try to reuse the original.
- Swap over the PCV assembly and the PCV baffle plate onto the front of the block.
NOTE: No sealer is used between the baffle plate and the block.

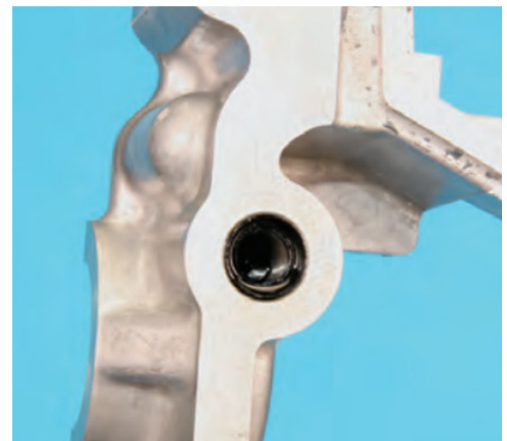
- **After cleaning the upper oil pan assembly, replace the oil level switch assembly as shown in the illustration below. Torque the 2 retaining bolts to 6.4 Nm (56 inch-pounds).**

IMPORTANT NOTE: At this time, this step for replacement of the oil level sensor is **NOT APPLICABLE** to 2012MY IMPREZA MODELS.

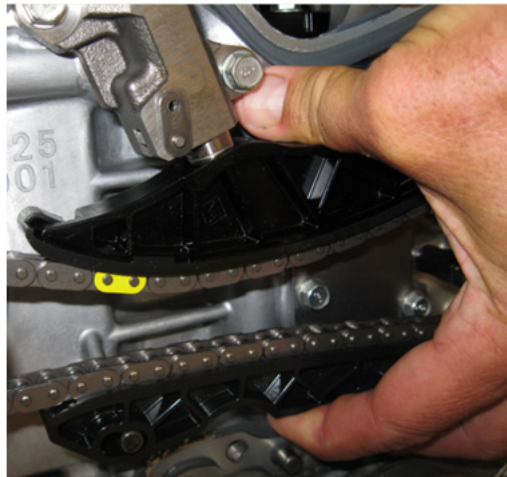
- Install the chain guides and tensioner. Once proper positioning has been confirmed, pull the pin to release the tensioner. With your hand, grab and squeeze the upper and lower chain / guides together as shown in the reference photo below to allow the plunger in the tensioner to fully extend and click into its furthest notch.
