Technical Bulletin

91 14 01 February 06, 2014 2036310

UMI Software Update for Various Bluetooth® Concerns

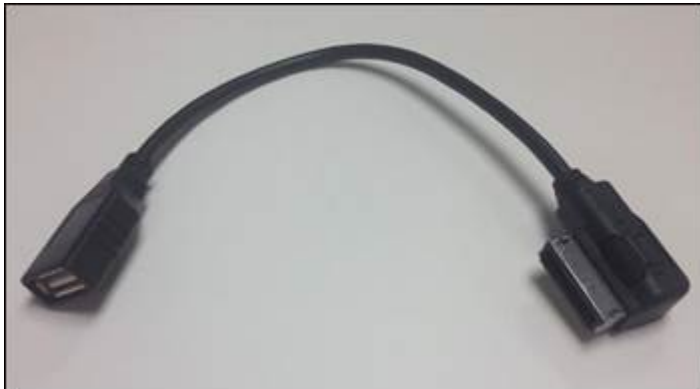
- Connect Midtronics InCharge 940 (INC 940) Tester/Charger to the vehicle's battery.
- Remove the iPod cable from the UMI module connector (located either in the center console or glove box depending on vehicle model).

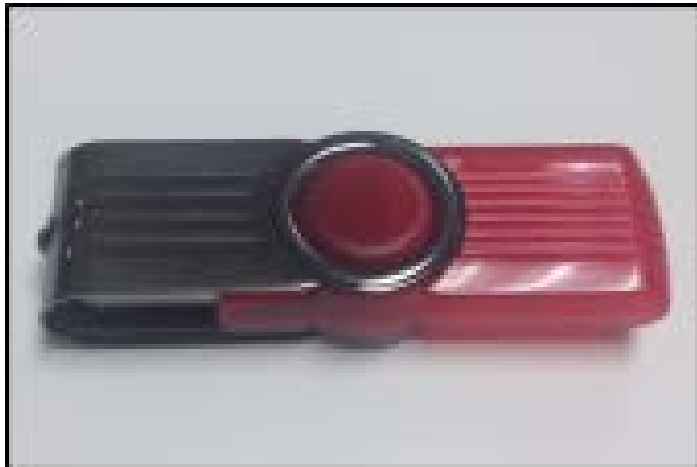
- Plug the USB stick containing the correct software into the USB cable.

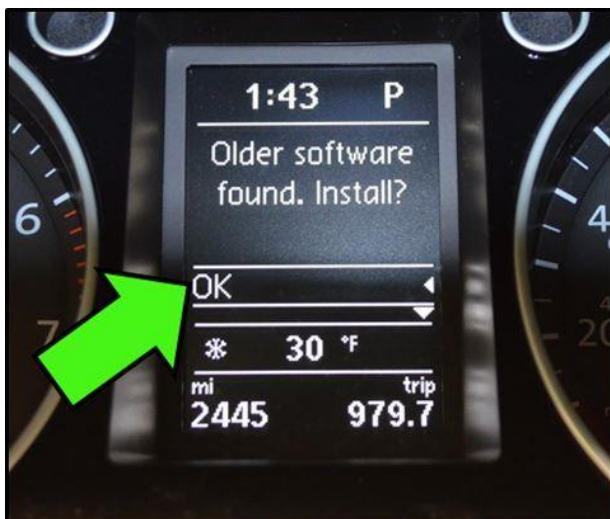
- Monitor the MFI messages (on high line instrument cluster equipped vehicles) and audible messages after the USB stick is installed. Note that on low line instrument cluster equipped vehicles, there will be no MFI direction. Only the audible messages will be present. Follow the prompts from the MFI messages and/or voice prompts.

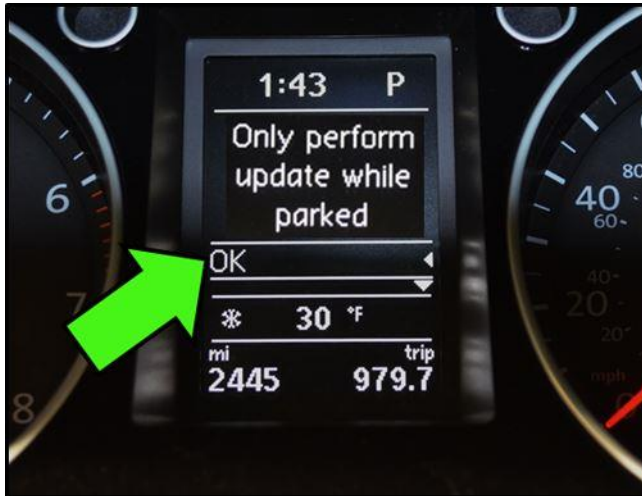
- On vehicles with high line cluster, select “OK” again <arrow>.

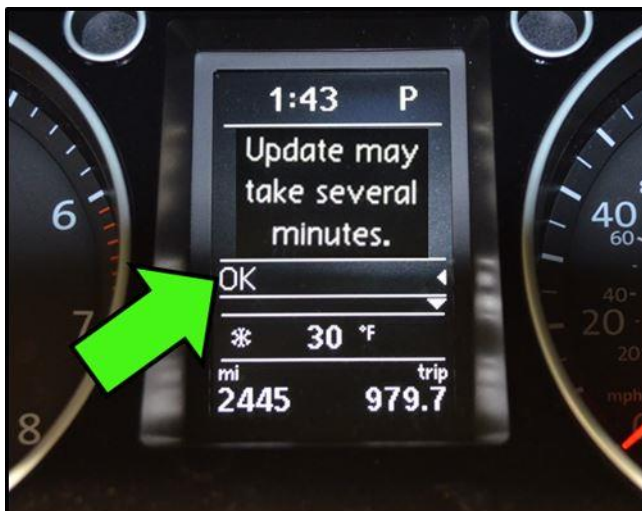
- On vehicles with high line clusters select “OK” button on the steering wheel <arrow>. An audio confirmation is played over the vehicle speakers. Follow audio guidelines as necessary.

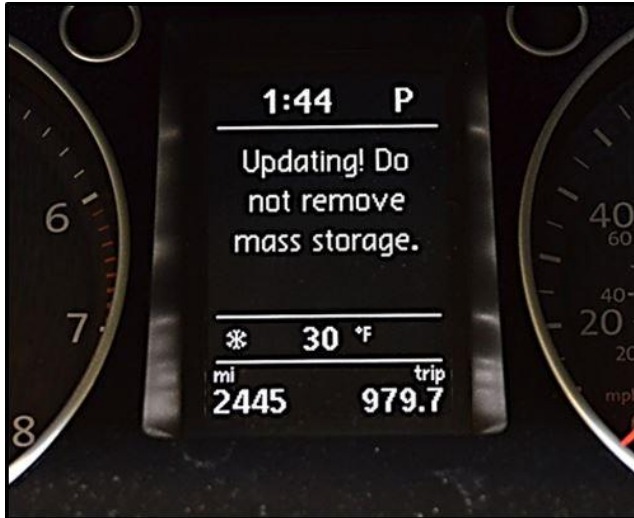
- On high line instrument cluster vehicles, the software update message <as shown> is displayed during the update.

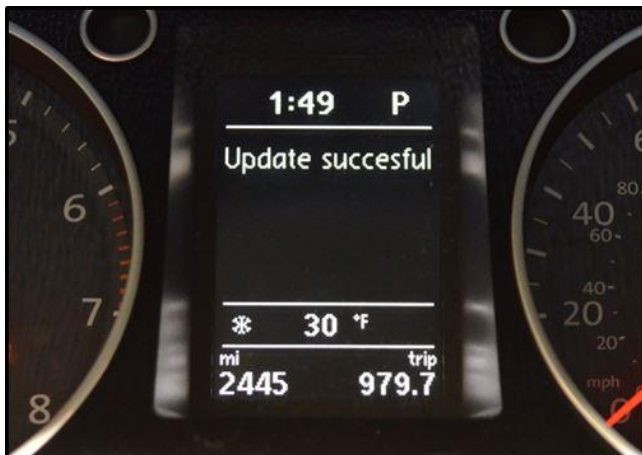
- Once software update is complete an audio confirmation is played over the vehicle speakers on all vehicles. On vehicles equipped with the high line instrument cluster, the message "Update successful" will also appear.
- Remove USB memory stick and adapter cable when prompted.
- After a few minutes, the audible message will state: "The language for voice recognition has been changed to English". It is necessary to wait for this message before proceeding to Section B.
- Proceed to Section B.

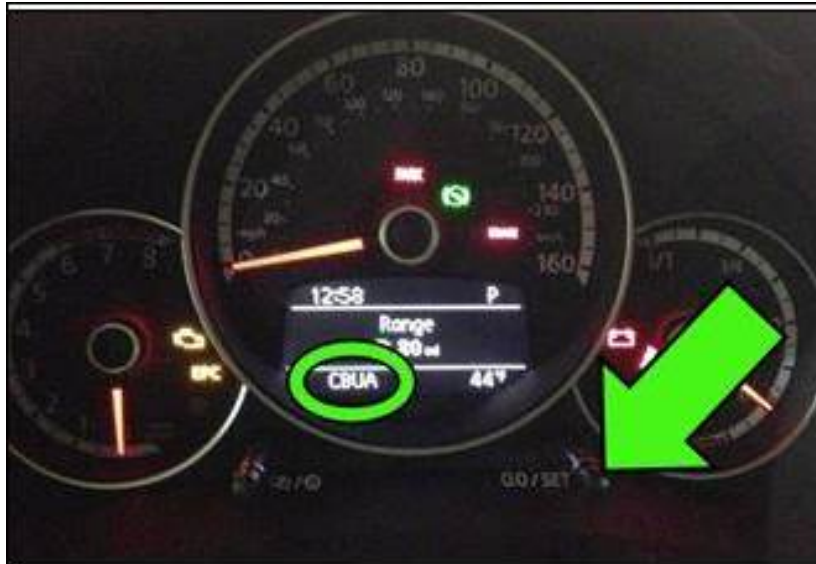
To obtain the engine code, press and hold the "0.0/SET" button for approximately 10 seconds. The engine code will appear as shown.

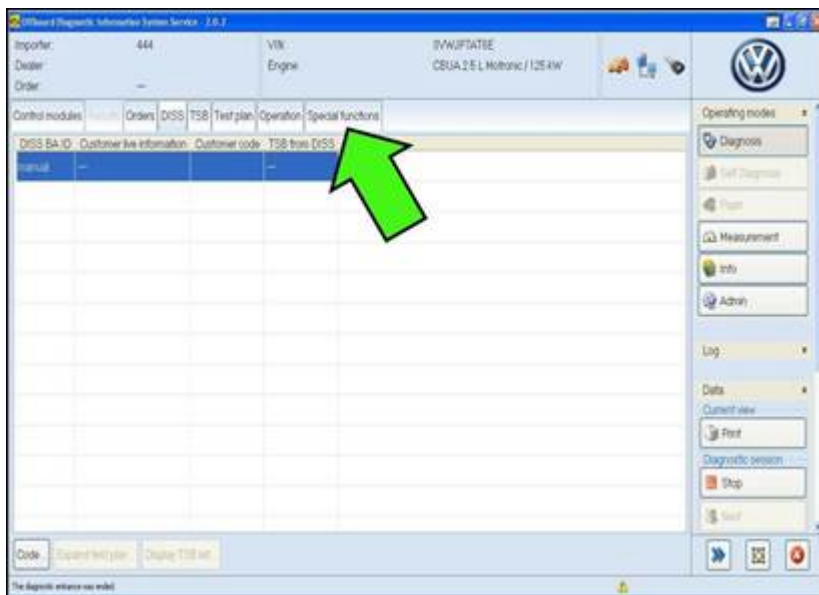
- Launch ODIS application, select "Diagnosis", select "Start Diagnosis" and identify the vehicle.
- After the control units are identified, select the "Special Functions" tab.
