SERVICE BULLETIN

EC13-008a

2013 SENTRA; INTERMITTENT LOW ENGINE RPM AT IDLE OR STOPS RUNNING COMING TO A STOP

APPLIED VEHICLE: 2013 Sentra (B17)

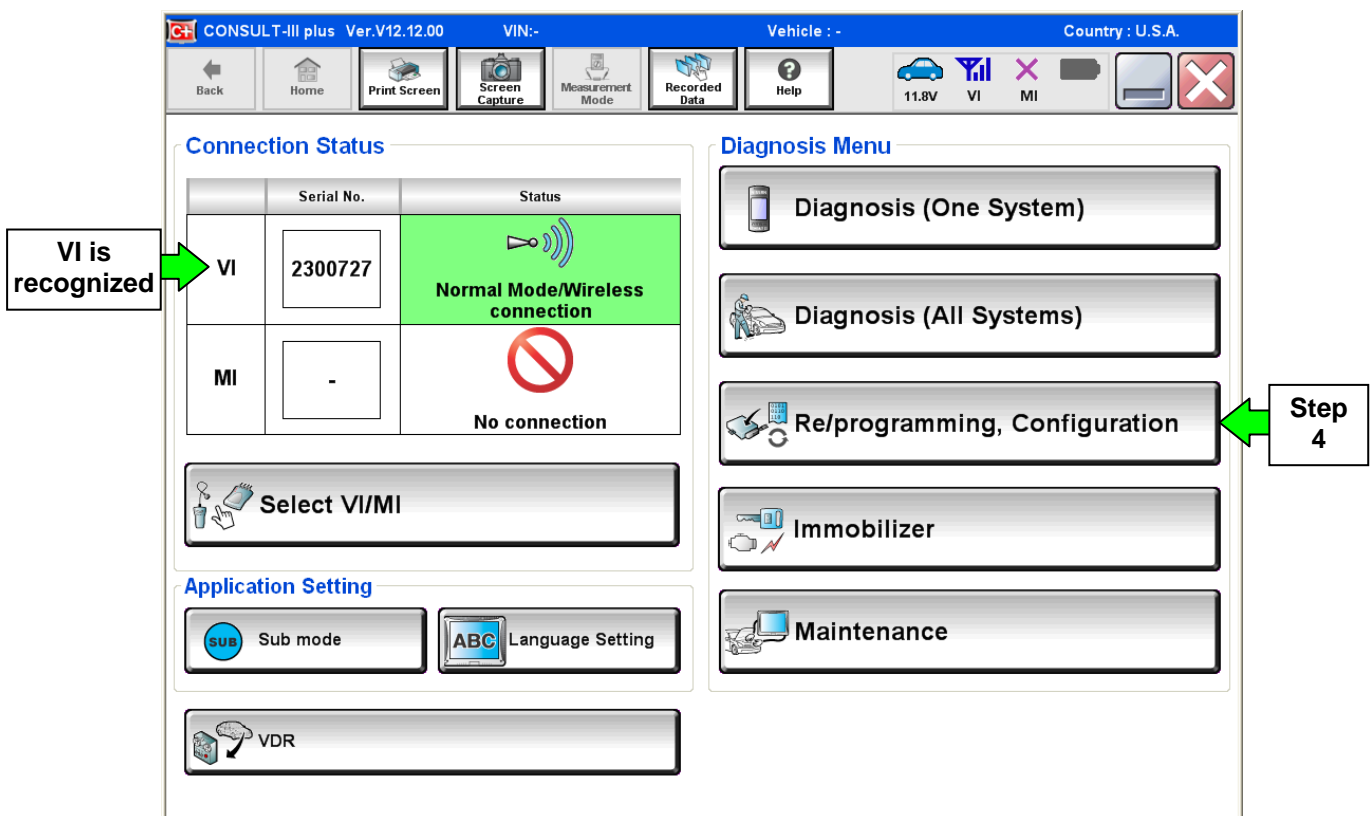
Figure 1

1. Connect the CONSULT PC to the vehicle to begin the reprogramming procedure.
2. Open ASIST on the CONSULT PC and start C-III plus.
3. Wait for the plus VI to be recognized.
 - Serial number will display when the plus VI is recognized.
4. Select **Re/programming, Configuration**.

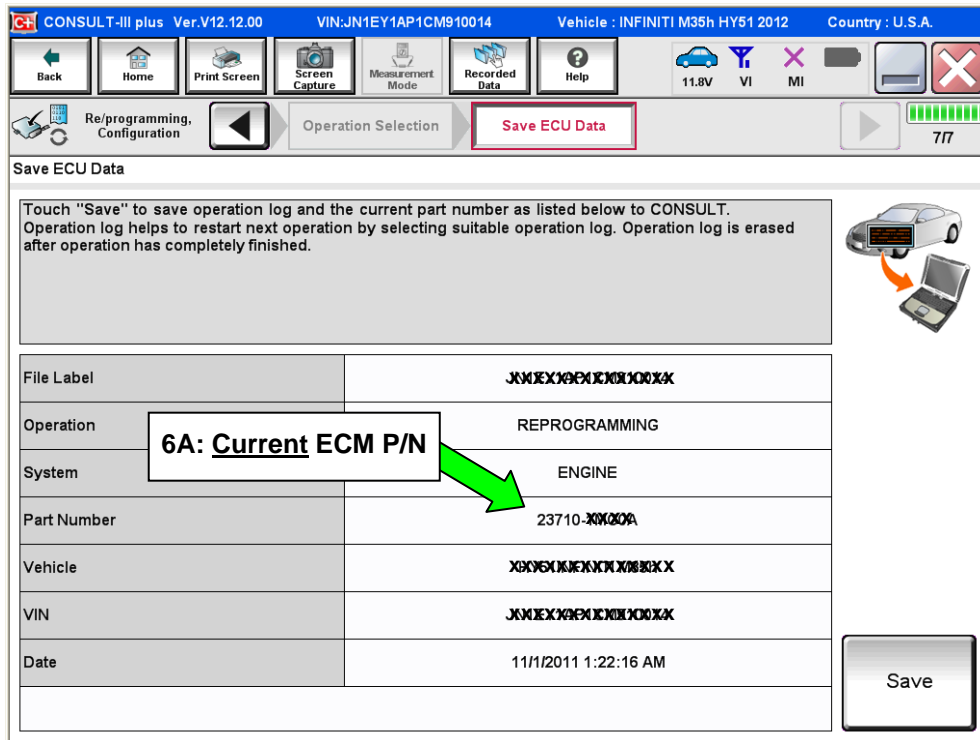
6. When you get to the screen shown in Figure 2, confirm this bulletin applies as follows.

A. Find the ECM **Part Number** and write it on the repair order.

NOTE: This is the current ECM Part Number (P/N).

5. Follow the on-screen instructions and navigate the C-III plus to the screen shown in Figure 2 on the next page.

B. Compare the P/N you wrote down to the numbers in the **Current ECM Part Number** column in **Table A** below.

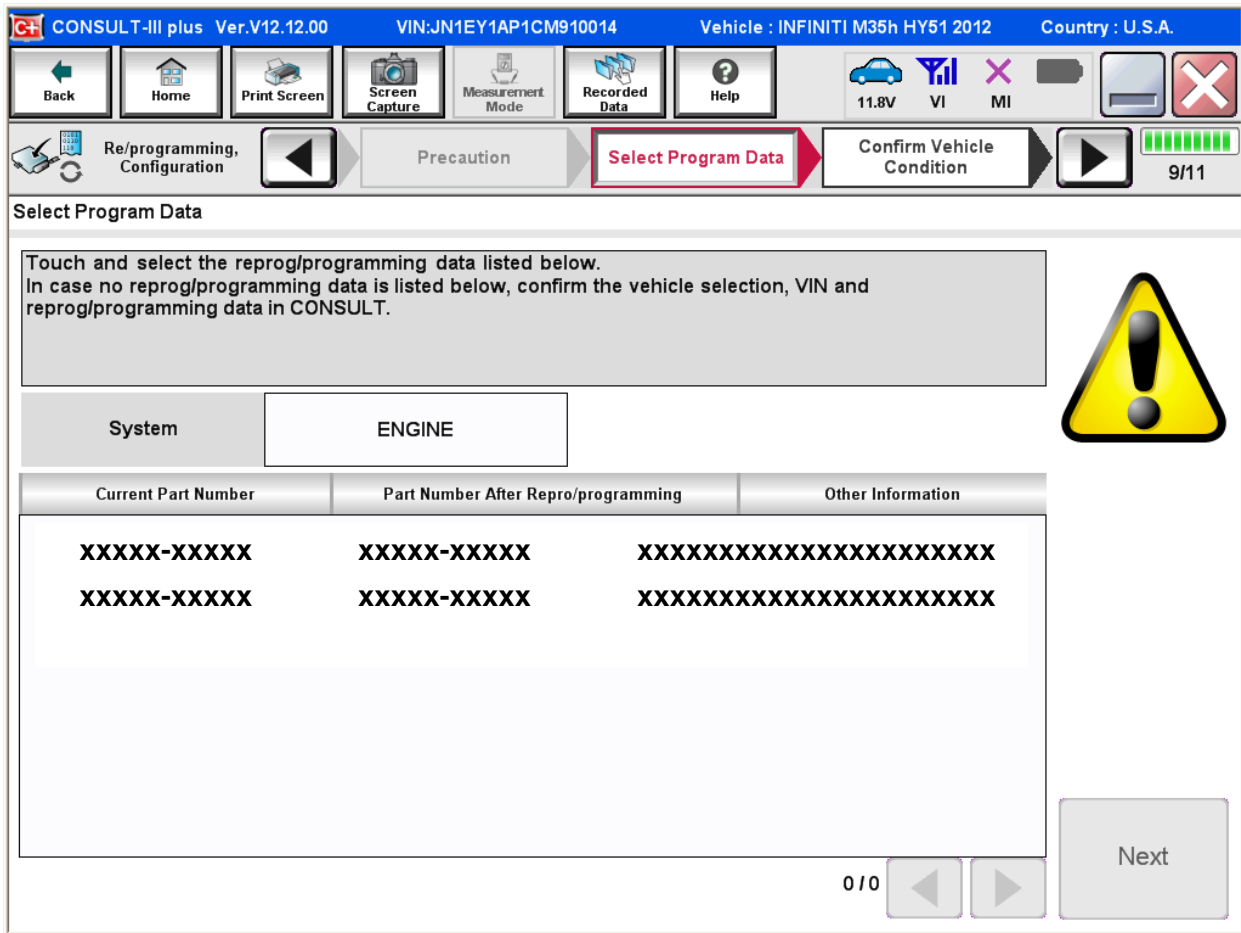
- In some cases, more than one new P/N for reprogramming is available.
 - In this case, the screen in Figure 3 displays.
 - Select and use the reprogramming option that **does not** have the message “Caution! Use ONLY with NTBXX-XXX”.
- If you get this screen and it is blank (no reprogramming listed), it means there is no reprogramming available for this vehicle. Close C-III plus and refer back to ASIST for further diagnosis.

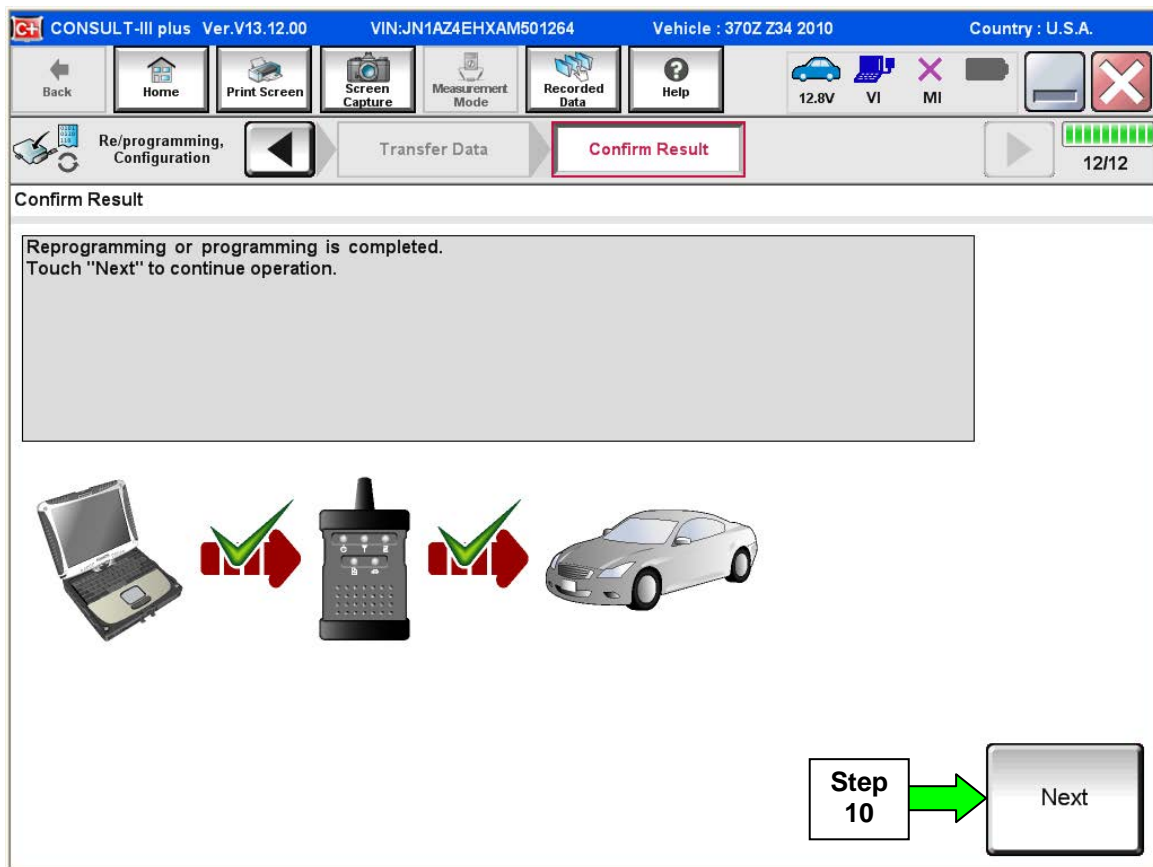
8. When the screen in Figure 4 displays, reprogramming is complete.

NOTE: If the screen in Figure 4 does not display (reprogramming does not complete), refer to the information on the next page.

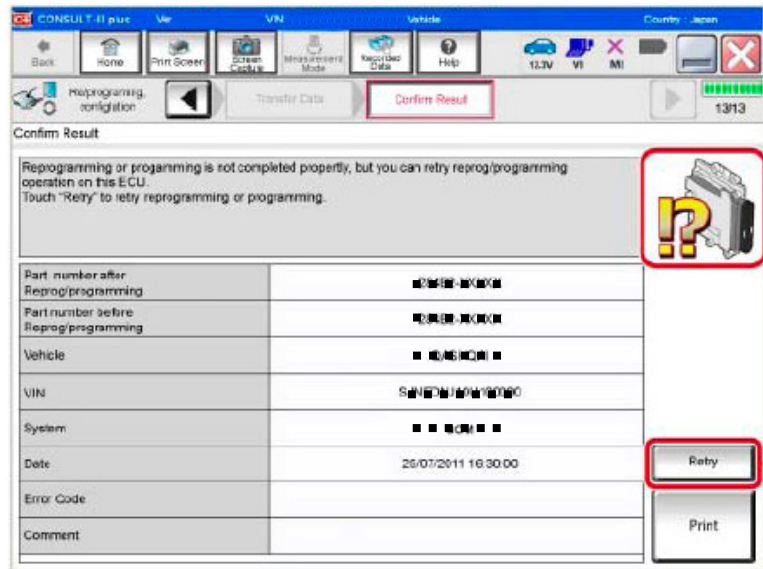
Figure 5

If reprogramming does not complete and the “!?” icon displays as shown in Figure 5:

- Check battery voltage (12.0–15.5 V).
- Ignition is ON, engine OFF.
- External Bluetooth® devices are OFF.
- All electrical loads are OFF.
- **Select retry and follow the on screen instructions.**
- “Retry” may not go through on first attempt and can be selected more than once.

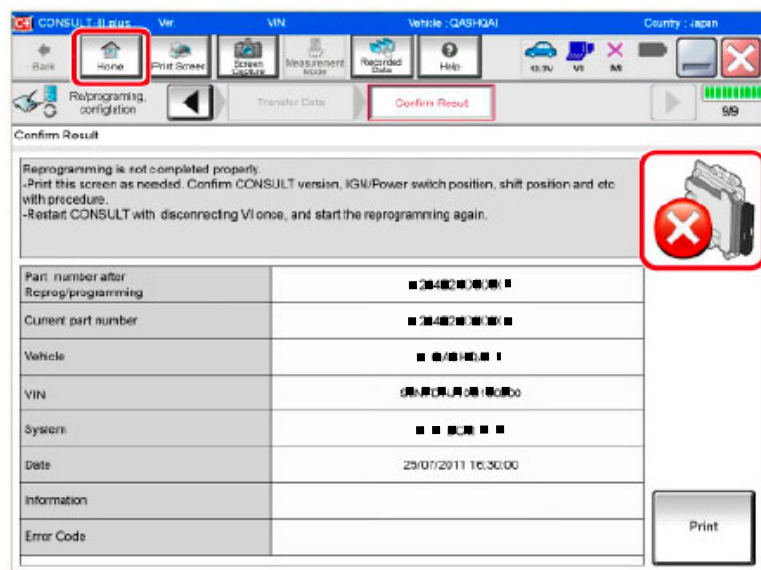
Figure 6

If reprogramming does not complete and the “X” icon displays as shown in Figure 6:

- Check battery voltage (12.0 – 15.5 V).
- CONSULT A/C adapter is plugged in.
- Ignition is ON, engine OFF.
- Transmission is in Park.
- All C-III plus / VI cables are securely connected.
- All C-III plus updates are installed.
- **Select Home, and restart the reprogram procedure from the beginning.**

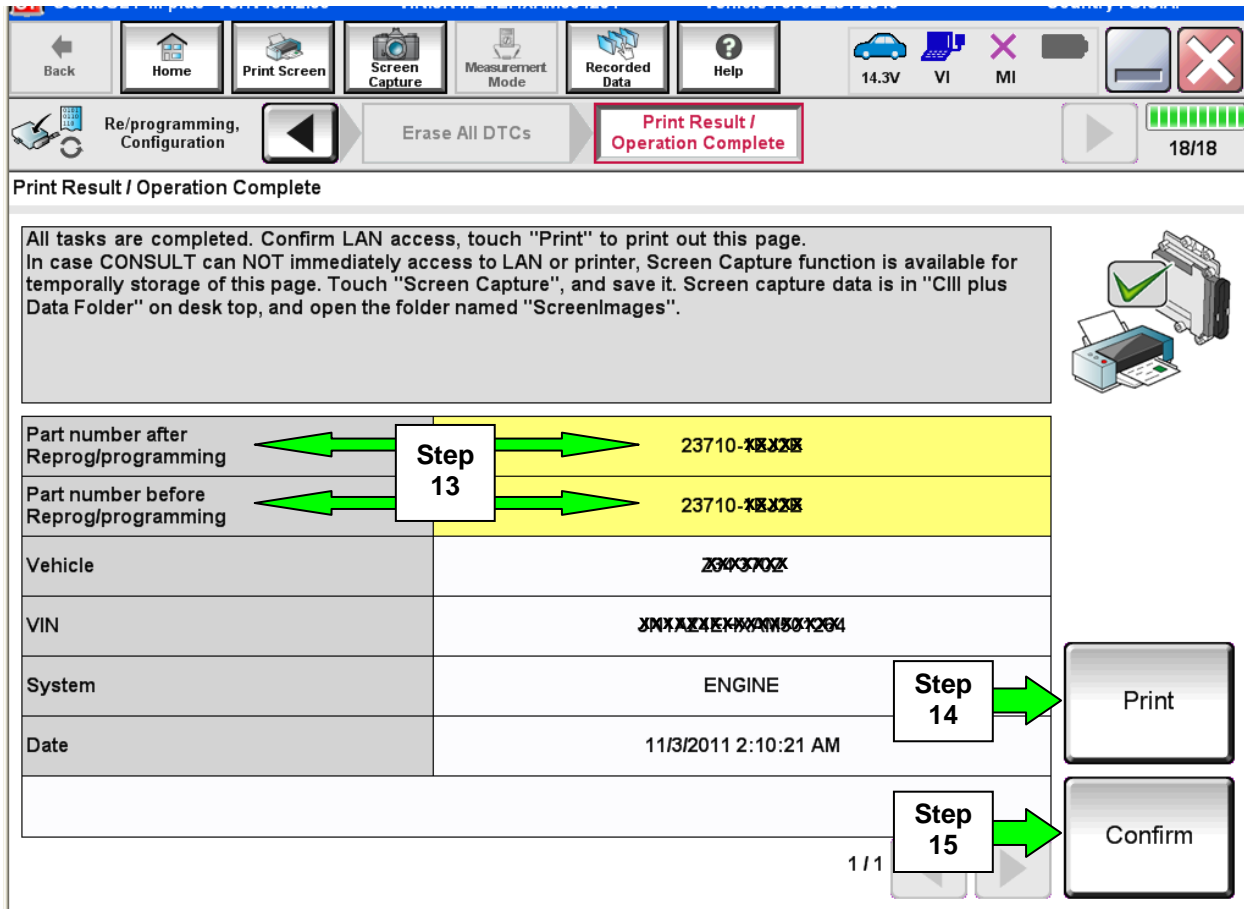
12. When the entire reprogramming process is complete, the screen in Figure 7 will display.

13. Verify the before and after part numbers are different.

14. Print a copy of this screen (Figure 7) and attach it to the repair order for warranty documentation.
