sB-10053270-8304 Service Bulletin

Applies To: 2013 Accord Equipped with HFL (HFT) Control Units – ALL 2013 Crosstour Equipped with HFL (HFT) Control Units – ALL August 23, 2013

Updating Programmable HFL (HFT) Control Units - Accord and Crosstour

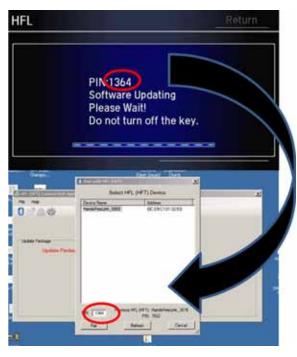
11. In the HFL update tool, once the Bluetooth device has been detected, enter the four-digit PIN code from the vehicle's display screen into the lower left hand corner of the pop-up window. Click **Pair** to begin the pairing process.
