# SERVICE BULLETIN

Classification: EC13-012b	Reference: NTB13-100b	Date: January 29, 2014
------------------------------	--------------------------	---------------------------

## VERSA SEDAN AND VERSA NOTE; ENGINE TURNS OFF OR HESITATES WHEN ACCELERATING FROM A STOP DURING HOT AMBIENT TEMPERATURES (+100° F)

**APPLIED VEHICLES:** 2012-2014 Versa Sedan (N17)  
2014 Versa Note (E12)

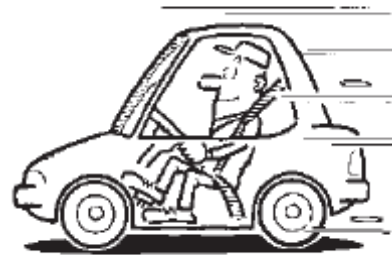
Figure A

- For 2013 Versa Sedan only: This procedure may require reprogramming of the **ECM and TCM** which means most steps in this procedure may need to be done twice.
- Most instructions for reprogramming with CONSULT-III plus (C-III plus) are displayed on the CONSULT PC screen.
- If you are not familiar with the reprogramming procedure, click here. This will link you to the "CONSULT- III plus (C-III plus) Reprogramming" general procedure.
- Take the vehicle for a 10 minute drive in order to meet the following Idle Air Volume Learn (IAVL) conditions:
  - Engine coolant temperature: 70 -100°C (158 -212°F)
  - Battery voltage: More than 12.9V (At idle)
  - Transmission: Warmed up
