SERVICE BULLETIN

EC13-012a

VERSA SEDAN AND VERSA NOTE; ENGINE TURNS OFF OR HESITATES WHEN ACCELERATING FROM A STOP DURING HOT AMBIENT TEMPERATURES (+100°F)

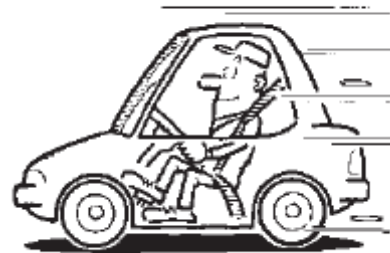
Figure A

- For 2013 Versa Sedan only: This procedure may require reprogramming of the **ECM and TCM** which means most steps in this procedure may need to be done twice.
- Most instructions for reprogramming with CONSULT-III plus (C-III plus) are displayed on the CONSULT PC screen.
- If you are not familiar with the reprogramming procedure, click here. This will link you to the "CONSULT- III plus (C-III plus) Reprogramming" general procedure.
- Take the vehicle for a 10 minute drive in order to meet the following Idle Air Volume Learn (IAVL) conditions:
 - Engine coolant temperature: 70 -100°C (158 -212°F)
 - Battery voltage: More than 12.9V (At idle)
 - Transmission: Warmed up

- After reprogramming is complete, you will be required to perform Throttle Valve Closed Position, Idle Air Volume Learn, Accelerator Closed Position, and DTC erase.
