ECM and ACM Software Updates
OBD2013, MP7, MP8, MP10
CHU, CXU, GU, LEU, MRU, TD

PI0826, ECM and ACM Software Updates

(October 2013)

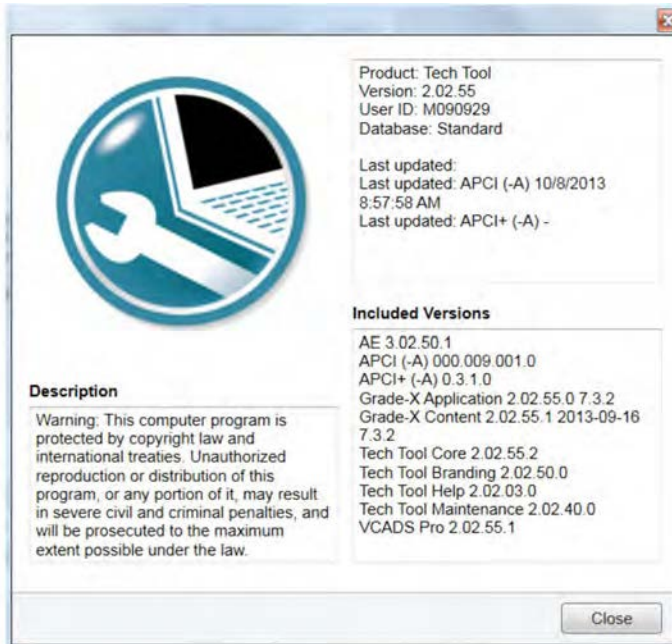
W2085456

Check Premium Tech Tool version by clicking on Help tab and then click on "About Tech Tool".

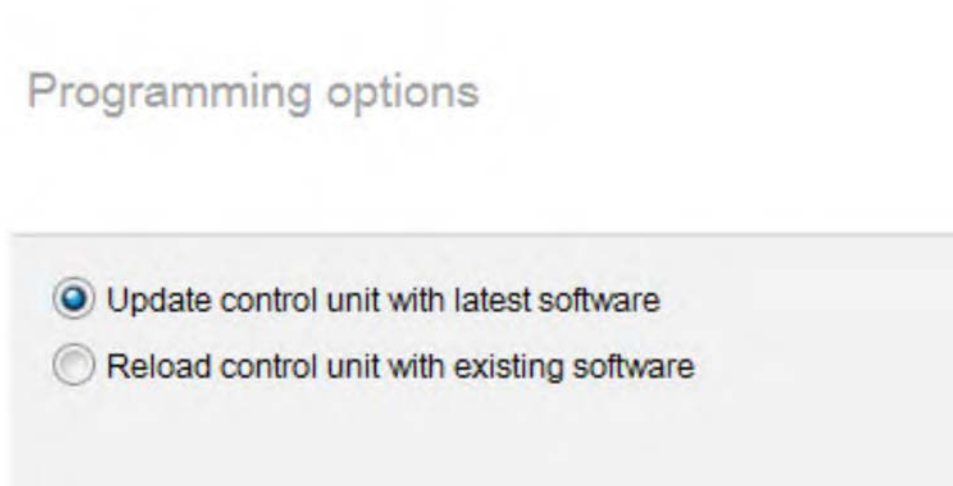
W2085461

- 9 Select Program to update the control unit with the latest software.

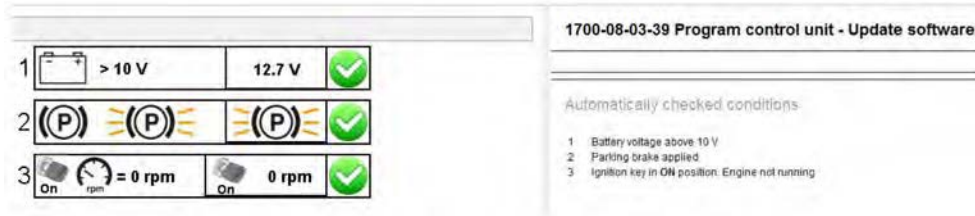
W2080113

10 Certain conditions must be met to continue with programming: battery voltage above 10v, parking brake applied, and ignition key in ON position with engine not running. When all conditions have been met, click Continue to proceed with programming.
