**Mack Trucks, Inc.**  
Greensboro, NC USA

## **SB-10054123-8585**

ECM and ACM Software Updates  
OBD2013, MP7, MP8, MP10  
CHU, CXU, GU, LEU, MRU, TD

## **PI0826, ECM and ACM Software Updates**

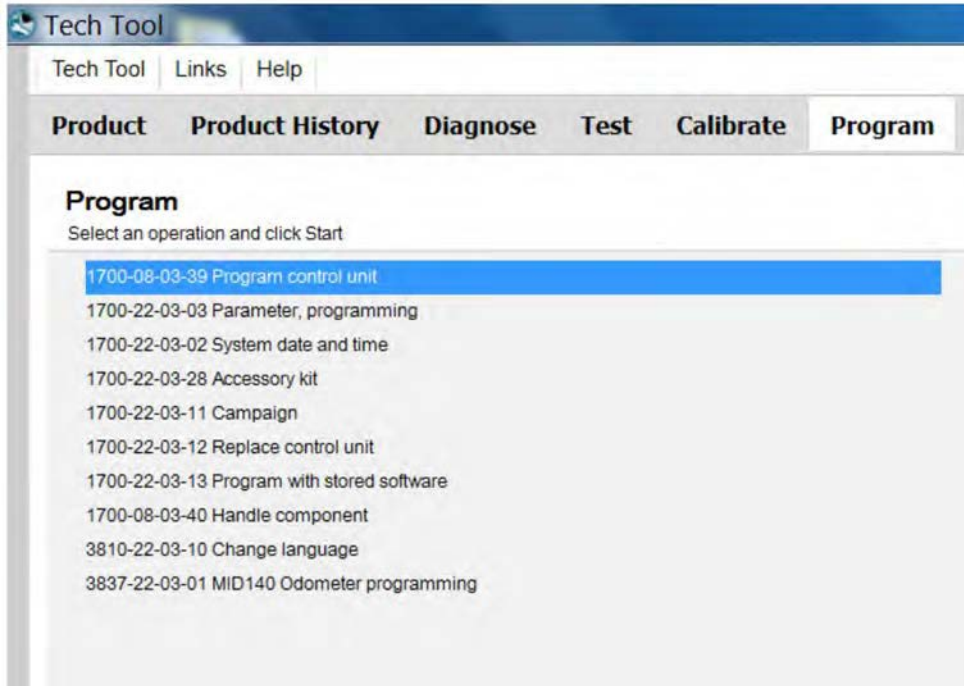
W2085457

- 7 From the Main Menu select Program and **then** Program Control Unit 1700-08-03-39. Then click Start.

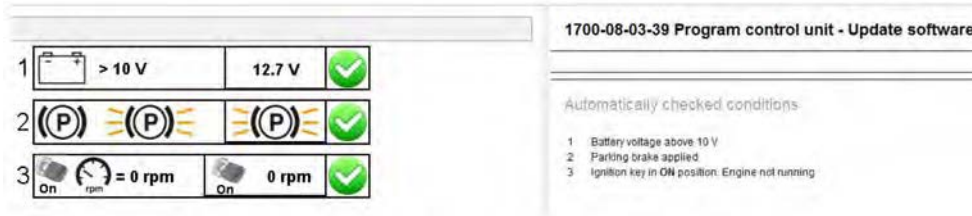
W2080113

10 Certain conditions must be met to continue with programming: battery voltage above 10v, parking brake applied, and ignition key in ON position with engine not running. When all conditions have been met, click Continue to proceed with programming.

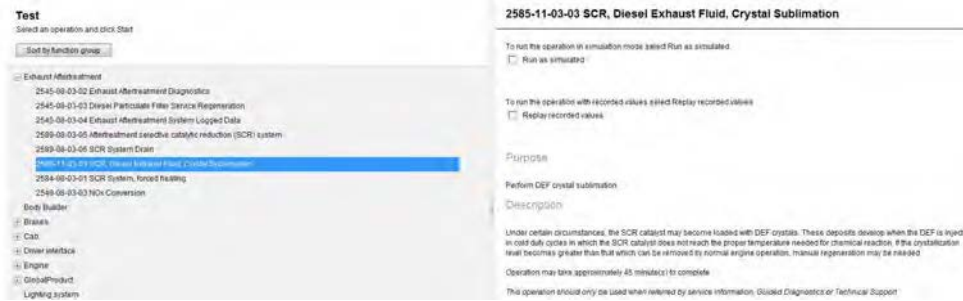
W2083561

17 When the HEST light goes off, select Test from the Main Menu. Select 2585-11-03-03 SCR, Diesel Exhaust Fluid, Crystal Sublimation and click on Start.

**Note:** Start the Crystal Sublimation process within 2 minutes of engine coming back to idle.
