**TECHNICAL SERVICE BULLETIN**

Bulletin Number: I-14-01  
Model Year(s): 2014

**SUBJECT: 2014 Indian Motorcycle – Gear Position Sensor Fault**

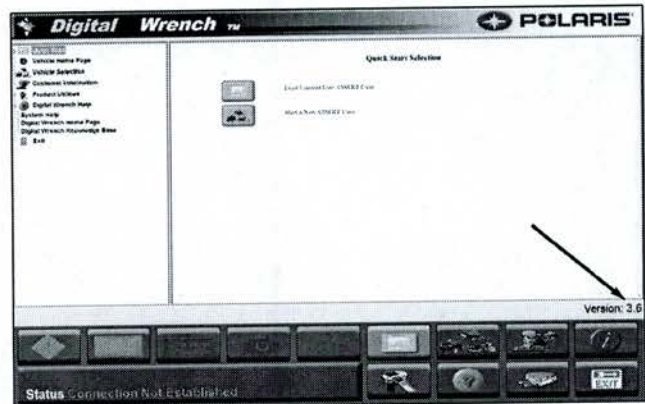
1. Verify that Digital Wrench version 3.6 or higher has been installed on your PC or laptop and proceed to STEP 3.

*If you do not have version 3.6 or higher installed, you must first download it before proceeding with the reflash.*

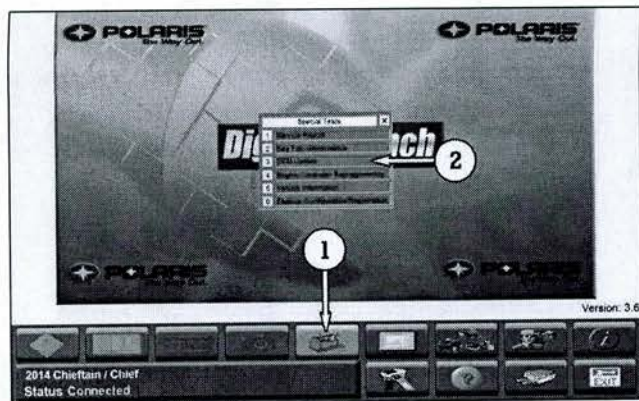
6. Select the **Special Tests** icon (1).
7. Select **VCM Update** (2)
8. Follow the on-screen prompts until you are asked to obtain an Authorization Key from the dealer web site.

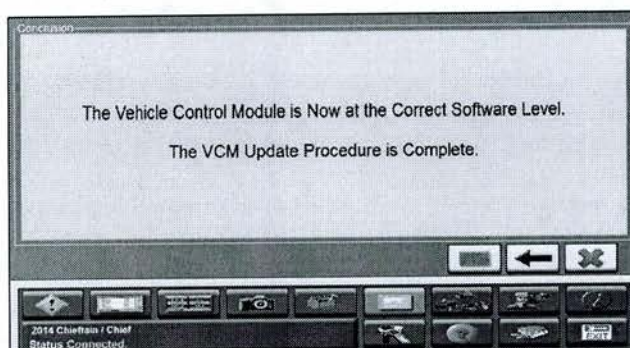
15. Once the reprogramming process is complete, Digital Wrench will indicate that **"The Vehicle Control Module is Now at the Correct Software Level / The VCM Update Procedure is Complete."**

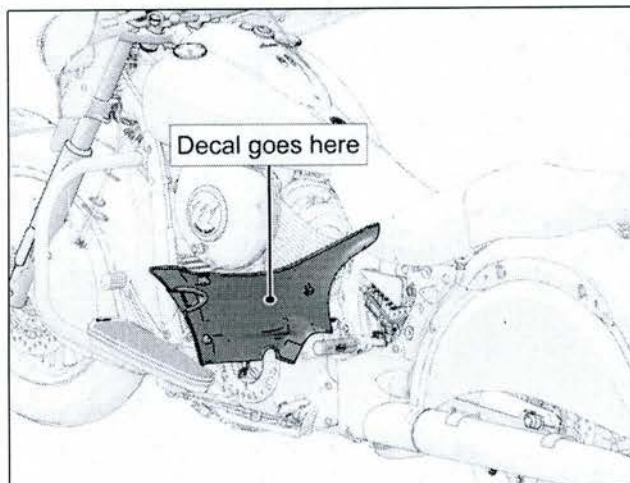
A Service Bulletin Completion Decal must be completed for this bulletin repair. Place the decal on the unit as shown (inside LH upper side cover). If you require more decals, order them through normal parts ordering channels.
