HYUNDAI NEW THINKING. NEW POSSIBILITIES. Technical Service Bulletin	GROUP	NUMBER
	CAMPAIGN	14-01-010
	DATE	MODEL
	FEBRUARY 2014	VELOSTER (FS)
2013 VELOSTER (FS) 1.6L ECM & TCM UPDATE (SERVICE CAMPAIGN TS6)

Description: This bulletin provides a procedure to update the ECM and TCM software on certain 2013 Veloster (FS) 1.6L vehicles with dual clutch transmissions.

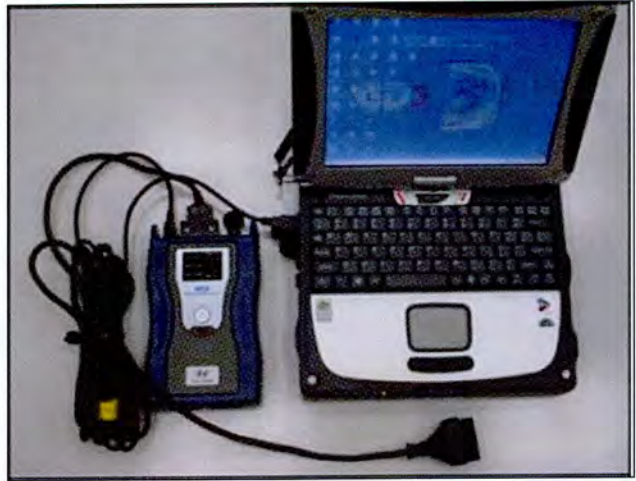
- Connect the USB cable between the GDS and the VCI.
- Connect the 16-pin DLC connector from the VCI into the DLC located under the driver's side dash.

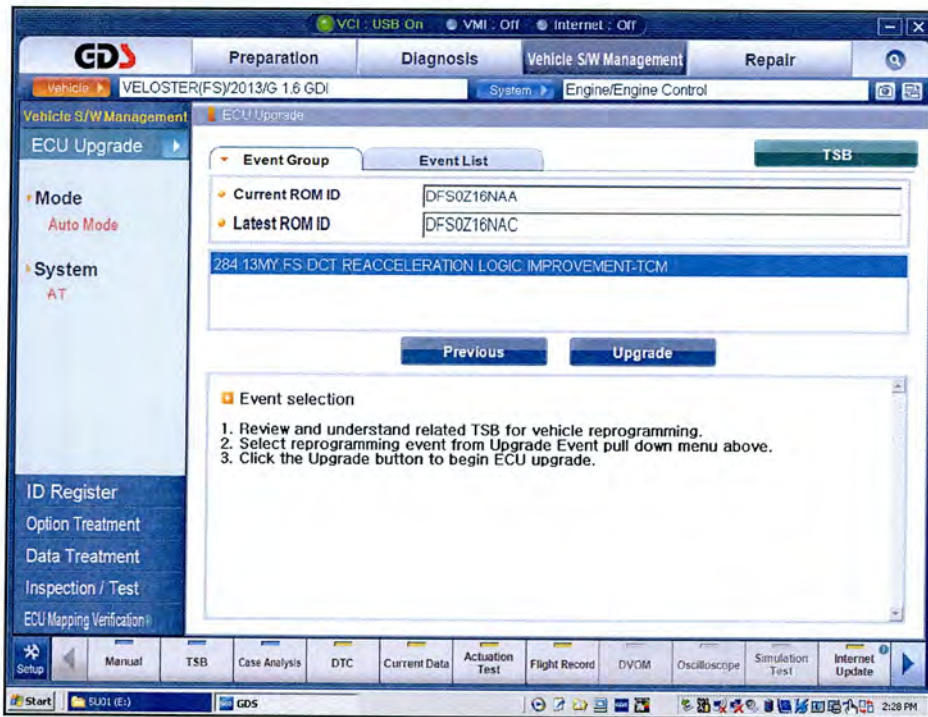
1. From the GDS home page, select **ECU Upgrade**. If necessary, select the VIN.
2. Select **AT** as the system and then select **OK**.
3. Select **Auto Mode** and then select **Next**.
4. From the **System** tab, select **AT** and then select **OK**. The GDS will read the ROM ID. Confirm the ROM is applicable as shown on Page 1, "ROM ID Information".
5. Update event #**284 13MY FS DCT REACCELERATION LOGIC UPDATE - TCM** will display. Select **Upgrade**.
