Technical Service Bulletin

GROUP	NUMBER
CAMPAIGN	14-01-019-1
DATE	MODEL(S)
	SONATA (YF),
MAY 2014	SONATA (YF HEV),
	AZERA (HG)

REAR LOWER CONTROL ARMS REPLACEMENT (SERVICE CAMPAIGN TP3)

Description: This bulletin describes the procedure to replace the rear lower control arms on some Sonata (YF), Sonata Hybrid (YF HEV), and Azera (HG) vehicles.

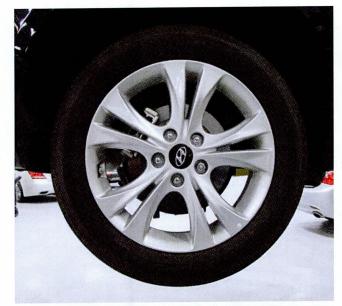
* NOTE

Tightening torque: 88.3~107.9 Nm (9.0~11.0 kgfm, 65.1~79.6 lb-ft)

2. Position a transmission jack under the right rear control arm by the spring seat.

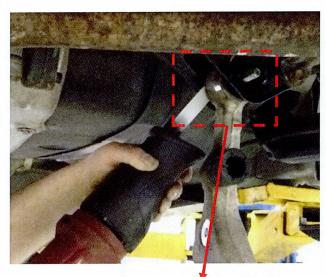
6a. If the control arm bolt(s) or other fasteners are difficult to remove, it may be necessary to cut the bolt(s) to remove the control arm.

Saw type used in photos: Chicago brand 4 ½" Reciprocating Saw, 6 amp, 7/8" stroke.

Blade type used in photos: Milwaukee Sawzall 24 TPI 6" blade.

Use caution when removing the fasteners to not damage the rear subframe, fuel tank, or surrounding area.

Replace the hardware on both left and right sides of the vehicle.

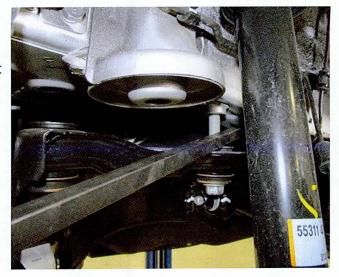
8. Use a pry bar to pull the subframe downwards slightly to create enough clearance between the control arm bolt and the fuel tank. Remove the bolt, and the right side rear lower control arm.
