Bulletin No.: P11273

Service Bulletin

Subject: Service Power Steering Message Displayed on DIC, DTC C056D-39 Set

Models: 2014 Chevrolet Silverado 1500
2014 GMC Sierra 1500
Built Prior to the VIN Breakpoints in the Table Below:

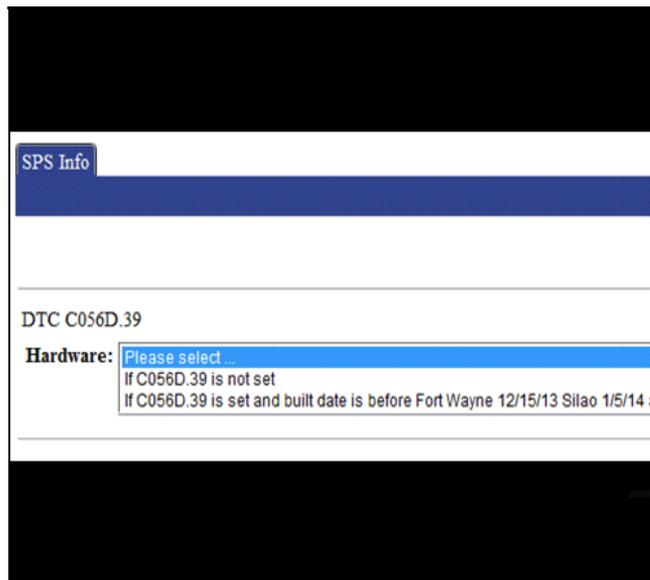
3793518

2. Select K43 Power Steering Control Module – Programming.

3. Select whether C056D.39 is set or not.
