Technical Service Bulletin

SB-10056331-6397

SUBJECT:			No: TSB-14-13-001
ECM REPROGRAMMING FOR MIL ILLUMINATES, WITH DTC P061A OR P0068 STORED IN ECM			DATE: July, 2014
			MODEL: See below
CIRCULATE TO:	<input type="checkbox"/> GENERAL MANAGER	<input checked="" type="checkbox"/> PARTS MANAGER	<input checked="" type="checkbox"/> TECHNICIAN
<input checked="" type="checkbox"/> SERVICE ADVISOR	<input checked="" type="checkbox"/> SERVICE MANAGER	<input checked="" type="checkbox"/> WARRANTY PROCESSOR	<input type="checkbox"/> SALES MANAGER

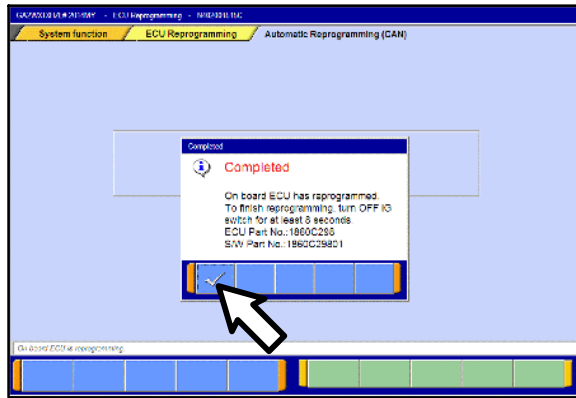
- o. This message will display when ECM reprogramming is successfully completed. Confirm the “New S/W P/N” displayed matches the table at the beginning of this TSB. Then click the check mark to clear the message.
2. Click the UP arrow at the lower left corner of the page to return to the System Function page.
