<b style="font-size: 1.2em; margin-left: 10px;">HYUNDAI NEW THINKING. NEW POSSIBILITIES. <h2 style="text-align: center; margin: 0;">Technical Service Bulletin</h2>	GROUP DUAL-CLUTCH TRANSMISSION	NUMBER 14-AT-011
	DATE JULY, 2014	MODEL(S) VELOSTER (FS)
SUBJECT: DUAL CLUTCH TRANSAXLE TCM SOFTWARE UPDATE

Description: This bulletin provides a procedure to update the TCM software on certain 2012 Veloster (FS) vehicles equipped with Dual Clutch transmission to reduce gear crunch noise when decelerating to a stop.

Applicable Vehicles: Certain 2012 MY Veloster (FS) with 1.6L engines and automatic Dual Clutch transaxles.

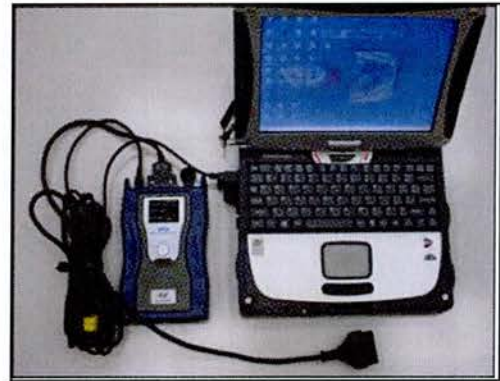
- Connect the USB cable between the GDS and the VCI.
- Connect the 16-pin DLC connector from the VCI into the DLC located under the driver's side dash.
