HYUNDAI NEW THINKING, NEW POSSIBILITIES.	GROUP CAMPAIGN	NUMBER 14-01-035
	DATE SEPTEMBER 2014	MODEL(S) EQUUS (VI)
Technical Service Bulletin		
SUBJECT: LDWS UPDATE – MIL ON WITH DTC C1702, C2721 (SERVICE CAMPAIGN TR3)

Description: This bulletin provides information related to the 14MY Equus (VI) 5.0L Lane Departure Warning System (LDWS) software update. Certain Equus vehicles may display a malfunction indicator lamp illuminated with the following LDWS system-related DTC(s):

Applicable Vehicles: 14MY EQUUS (VI) 5.0L

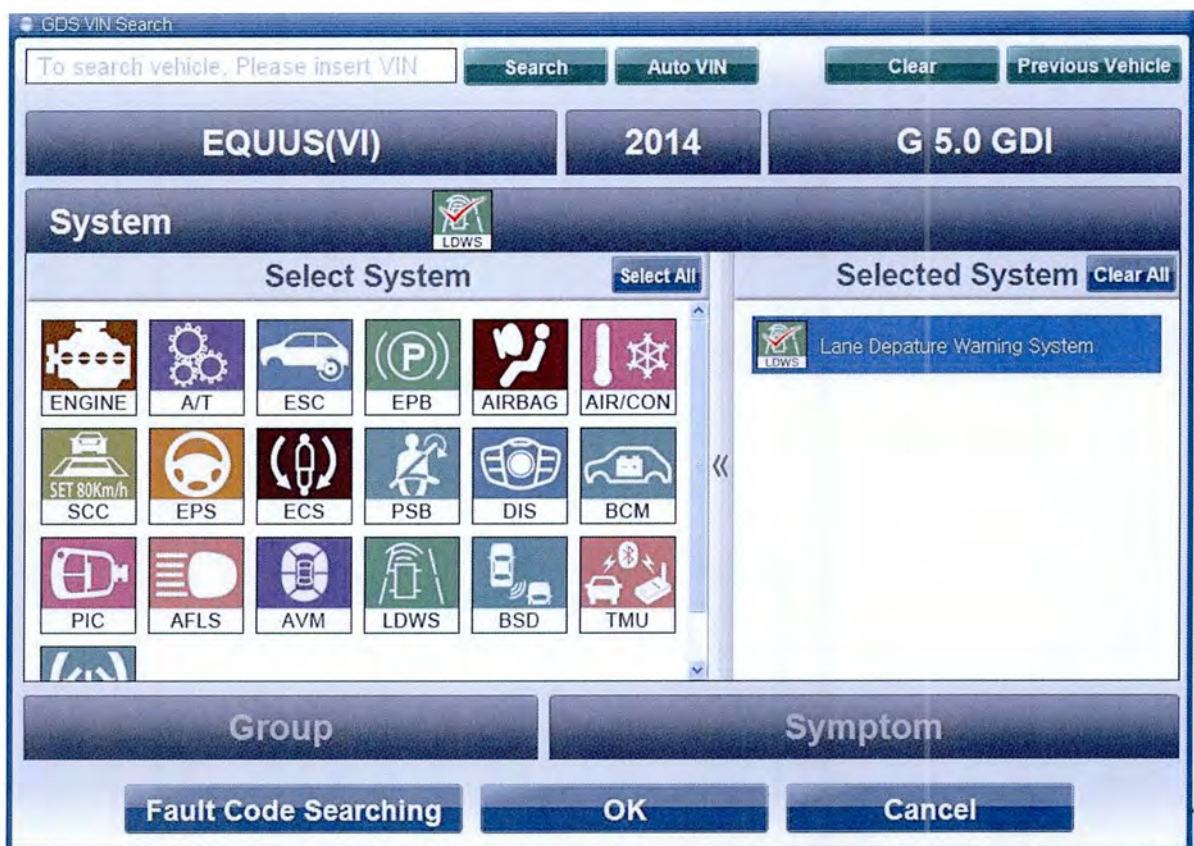
- Choose **VIN** or **ECU Update** on the initial screen.
- Enter the vehicle information by pressing the **VIN Auto Detect** button, entering the vehicle's VIN or selecting the vehicle model, model year, engine/fuel type. Select **LDWS** as the system and then click **OK**.

- Select **ECU Update** on the initial screen after entering the vehicle information.

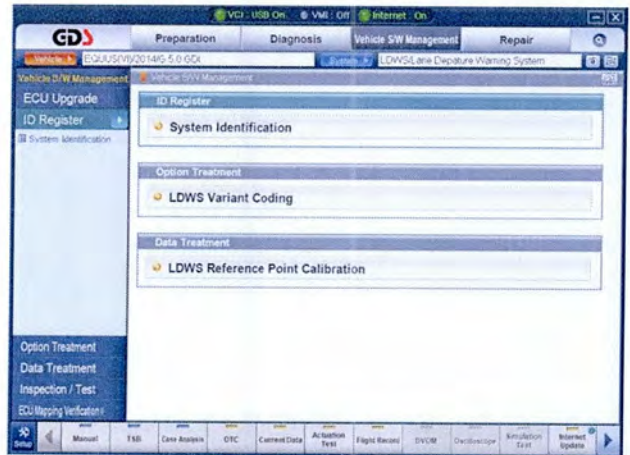
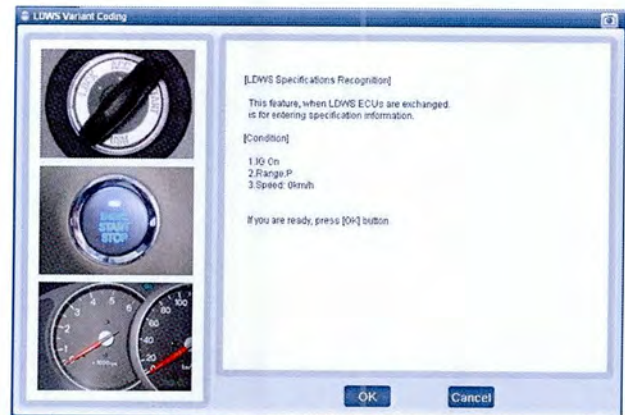
1. Select LDWS Variant Coding.

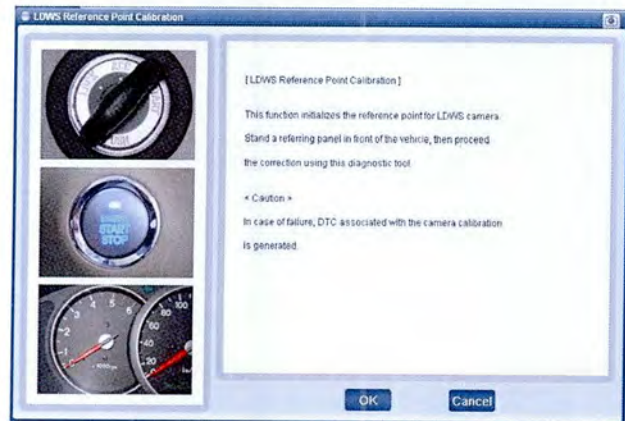
4. Select LDWS Reference Point Calibration.
