WE44 - Re-programming DME Control Unit (Workshop Campaign)

Model Year: 2015

Vehicle Type: Cayenne S (92A)/Cayenne Turbo (92A)

Concerns: DME control unit

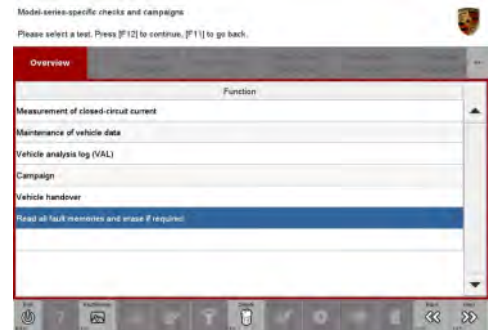
Erasing fault memories

- 1 In the control unit selection screen (⇒ 'Overview' menu), press •F7" to call up the Additional menu.
- 2 Select the function "Read all fault memories and erase if required" and press •>>" to confirm ⇒ *Erasing fault memories*.

The fault memories of the control units are read out.

- 3 Once you have read out the fault memories, delete the fault memory entries by pressing •F8" .
- 4 Press •F12" ("Yes") in response to the question as to whether you really want to erase all fault memory entries.

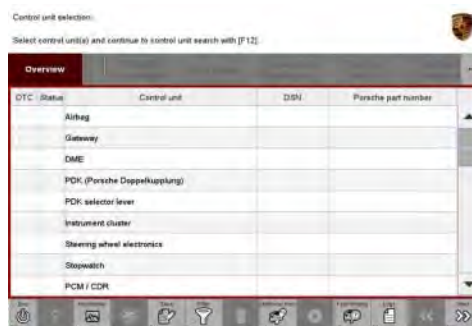
Control unit selection

- Once you have erased the fault memories, select the ⇒ **'Overview'** menu to return to the control unit selection screen ⇒ *Control unit selection*.

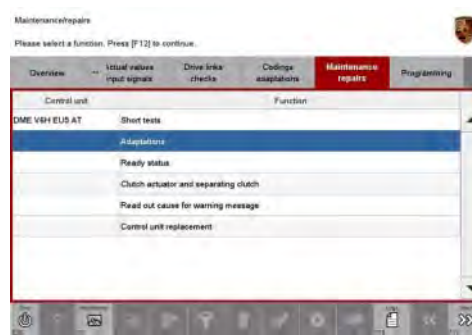
DME - Adaptations

- Select the **'DME'** control unit in the control unit selection screen (⇒ **'Overview'** menu) and press **•>>** to confirm your selection.
- Once the DME control unit has been found and is displayed in the overview, select the ⇒ **'Maintenance/repairs'** menu.
- Select menu item ⇒ **'Adaptations'** and press **•>>** to confirm your selection ⇒ *DME - Adaptations*.

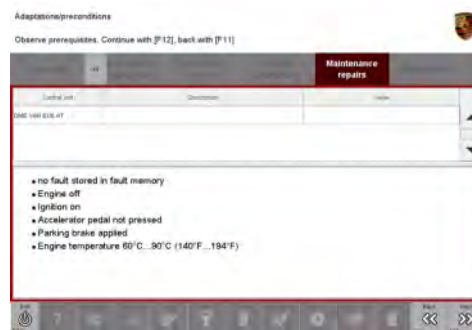
Adaptation preconditions

- Comply with the displayed preconditions and press **•>>** to confirm ⇒ *Adaptation preconditions*.

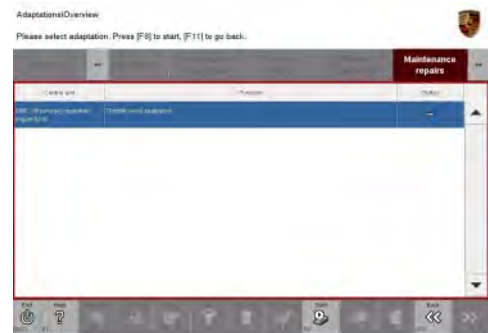
Throttle valve adaptation

- 5 Select the ⇒ **'Throttle valve adaptation'** function so that the corresponding text line turns blue and press •F8" to start the throttle valve adaptation ⇒ *Throttle valve adaptation*.

- 6 Follow the instructions on the PIWIS Tester while throttle valve adaptation is being performed.
Once throttle valve adaptation is complete, a tick will appear in the "Value" field on the PIWIS Tester display.
If throttle valve adaptation is **not** completed successfully, adaptation must be **repeated**.
- 7 Press •F8" ("Stop") to end throttle valve adaptation.

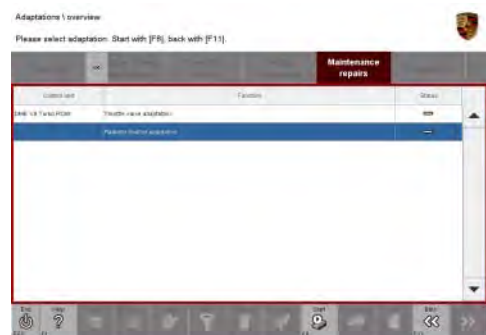
Radiator shutter adaptation

- 1 Select the ⇒ **'Radiator shutter adaptation'** function so that the corresponding text line turns blue and then press •F8" to start radiator shutter adaptation ⇒ *Radiator shutter adaptation*.

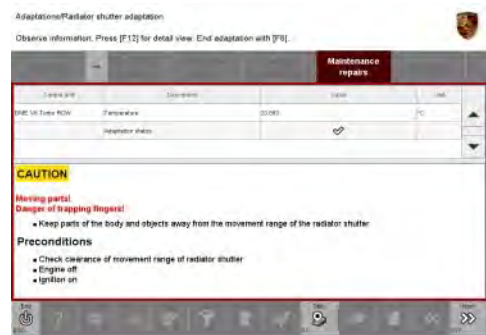
PIWIS instructions

- 2 Follow the instructions on the PIWIS Tester while radiator shutter adaptation is being performed ⇒ *PIWIS instructions*.

Once adaptation is complete, a tick will appear in the "Value" field on the PIWIS Tester display.

If radiator shutter adaptation is **not** completed successfully, the adaptation must be **repeated**.

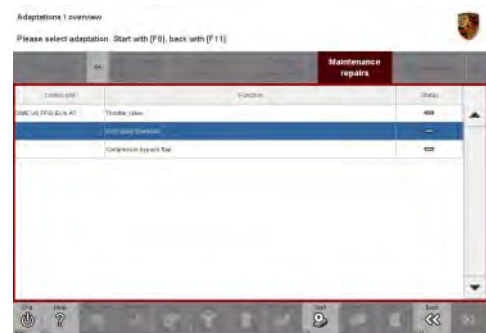
Kickdown threshold adaptation

- 1 Select the ⇒ **'Kickdown threshold'** function so that the corresponding text line turns blue and press •F8" to start kickdown threshold adaptation ⇒ *Kickdown threshold adaptation*.

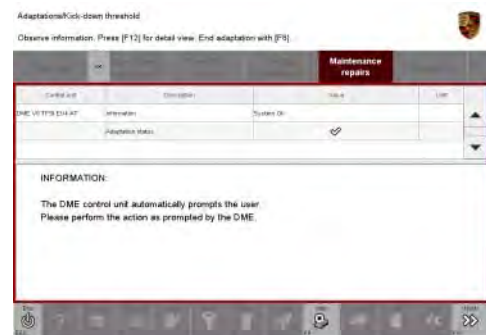
PIWIS instructions

- 2 Read and follow the instructions on the PIWIS Tester in order to perform kickdown threshold adaptation ⇒ *PIWIS instructions*.

Once kickdown threshold adaptation is complete, a tick will appear in the "Value" field on the PIWIS Tester display.

If kickdown threshold adaptation is **not** completed successfully, the adaptation must be **repeated**.

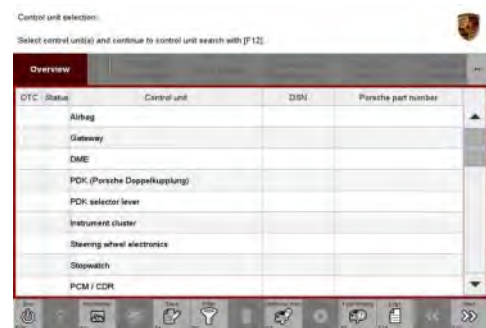
Control unit selection

- 3 End kickdown threshold adaptation by pressing •F8" ("Stop").
- 4 Press •<<" to return to the start page of the ⇒ **'Maintenance/repairs'** menu.
- 5 Select the ⇒ **'Overview'** menu and press •<<" to return to the control unit selection screen ⇒ *Control unit selection*.
